Implementation of ferritic steel as in vessel wall:

Lessons learnt and follow up

I. Zammuto^a, L. Giannone^a, A. Herrmann^a, A. Houben^b, A. Kallenbach^a, K.H. Schuhbeck^a, B. Sieglin^a, S. Vorbrugg^a and the ASDEX Upgrade Team

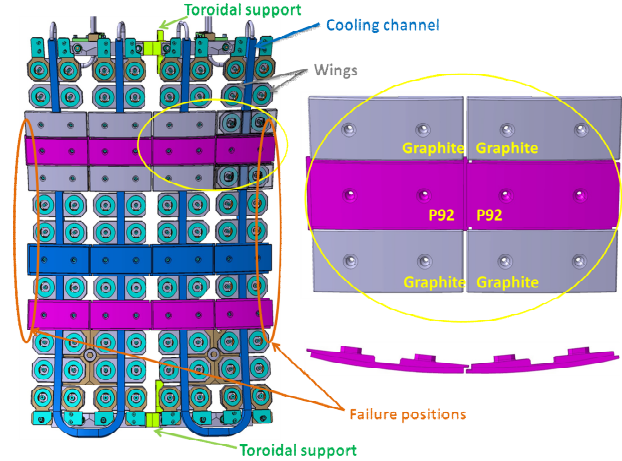
At first, our thoughts were completely focused on the new material. A deep examination of the damage configuration revealed that the HS supporting structure was moving inside AUG. In fact, the above mentioned damages were all placed between 2 VV octants (orange regions in Figure 2). Broadening our view, it was assumed that during a disruption with plasma displacement, the variation of the radial field could induce a current flowing in 2 adjacent HS supporting structures.

Figure 2 View of the 2 adjacent HS supporting structures belonging to a VV octant: ferromagnetic tiles installed first are in pink, the row installed in 2015 is in blue. The gray tiles are made of graphite. On the right hand side a detailed view of the tiles set up is shown: a labyrinth feature has been implemented together with the P92 tiles.

All the steel tiles, together with their contiguous graphite tiles, have been redesigned with a labyrinth feature (e.g. in Figure 2) in order to reduce the ECRH stray field [3].

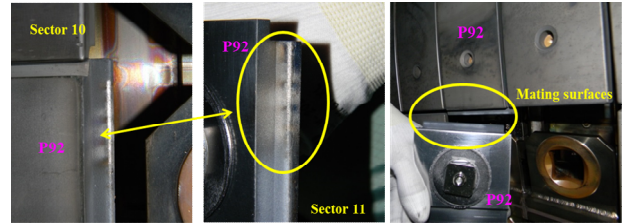
After the first campaign with the 2 steel rows, the inspection of the in vessel components disclosed some unexpected damage of the HS tiles. In particular, some steel tiles exhibited a coating failure as clear indication of a possible contact against the adjacent tiles. Some of them were burned along their poloidal edges. These damages are shown in Figure 3. Some of these steel tiles also had melted areas in the sectors placed opposite to Neutral Beam Injectors. The striking findings were observed on the graphite tiles adjacent to the P92 tiles. In many locations, the graphite tiles showed notches and in 5 positions their edges were broken (e.g. in Figure 4).

Figure 3 Damages on the P92 tiles in AUG: on the left hand side are shown the arc damages and on the right hand side the mating contact surface between tiles.

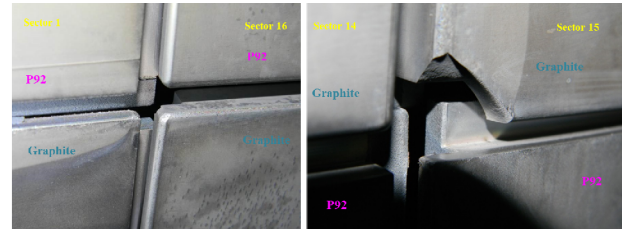
Inspection of the machine pointed out some hardware problems. The graphite tiles adjacent to the steel tiles were damaged. The graphite tiles had broken edges in 5 from 64 positions and notches in many others. The coating of the graphite and steel tiles, made of tungsten and TiO respectively, was damaged. At first glance it was clear that the steel tiles were moving but it was definitely unexpected. In understanding the process, the location of the damage was the crucial hint. In fact all failures were located at the boundary between 2 vacuum vessel octants. To justify this failure mode inside the vessel, a hypothesis (about current flowing in the heat shield supporting structure) was made and FEM analyses were carried out in this direction. With extreme caution, in 2015 just one additional row of steel tiles was added together with diagnostics that confirmed the hypothesis. Now that a clear understanding of the problem has been reached, the project to add further rows of steel tiles can be continued. For the next campaign it is planned to replace all the tiles in the middle region of the heat shield together with stiffening and modification of the supporting structure.

Figure 4 Damages on the graphite tiles adjacent to the P92 tiles in AUG: on the left hand side is shown an example of the notches and on the right hand side a representation of the broken edge of one graphite tile.

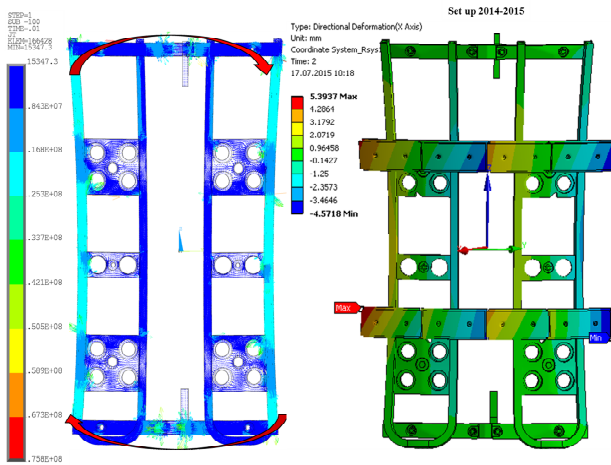
Indeed the current passes through the extreme poloidal legs of 2 contiguous HS cooling channel and it crosses the toroidal stiffeners and supports in the upper and lower positions. The calculated induced current is of the order of 7 kA, which for a toroidal magnetic field of 3 T at the plasma center, gives rise to radial forces of the order of 35 kN. These forces are acting on opposite directions into the extreme poloidal legs of the 2 contiguous cooling channels. The 2 forces end up producing a poloidal moment acting on the whole structure which is responsible for its rotation. This moment gives rise to a maximum relative free displacement between the extreme tiles of about 10 mm, as indicated on the right hand side of Figure 5.

Since the labyrinth feature creates an overlap between the adjacent tiles reducing the radial gap to 3 mm, this gap is easily closed during a disruption where a theoretical relative displacement of 10 mm is calculated. The energy introduced in the structure leads to severe and sudden impacts between graphite and steel tiles which caused the damage of the weakest material.

Figure 5 On the left: current density path through the HS structure for a uniform variation of radial field. On the right: corresponding displacement [mm] caused by 35 kN radial forces.

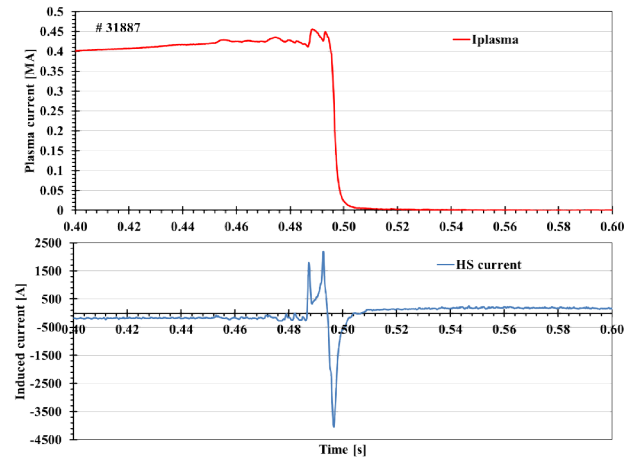
This new diagnostic aimed to confirm the hypothesis of the current loop in the HS support structure. In Figure 7, the measured current for the shot #31899 is reported. In this case the plasma current was quite low and a value of about 4 kA is recorded. A maximum value of 7.5 kA has been measured, perfectly in agreement with the calculations.

Figure 7 Induced current in the HS measured by the Rogowski coil for the shot # 31887: in correspondence of the plasma current disruption the current in the frame support increases.

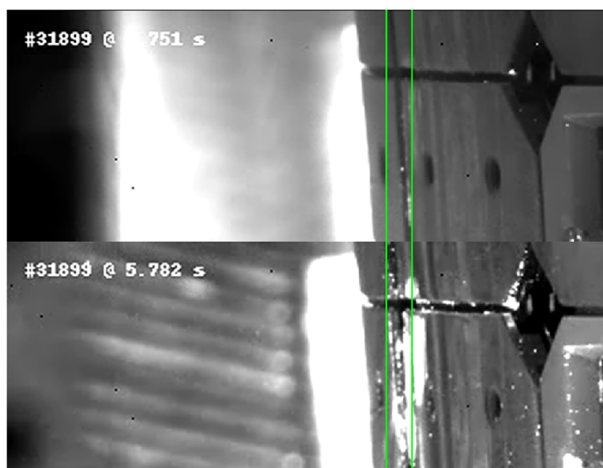
Being aware of the problem caused by the HS movement, a fast infrared camera [4] from time to time was pointing to the inner column. In Figure 8, two freeze frames of a video are reported. Comparing the position of the HS in still condition on the top, and during a disruption, on the bottom, a displacement can be observed in the region between the green lines.

A better understanding of the sudden movement of the HS is given unambiguously by the video footage. The sudden movement of the HS provokes the collision between adjacent tiles leading to the rupture of the graphite.

Figure 8 Infrared camera view of the HS for the shot # 31899: comparison between still condition on the top and in movement on the bottom. The green lines are limiting the displaced regions of the tiles.

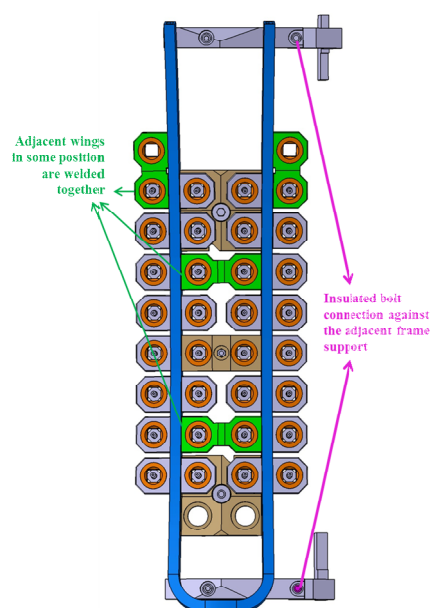
Figure 9 Modifications to the HS supporting structure are highlighted: in green welding between adjacent wings and in pink the electrical insulation between adjacent HS.

To reduce the induced current in the HS frame an electrical insulation will provide the separation of current path between the 2 adjacent supporting frames. In Figure 9 the insulated bolt connections are indicated in pink. The insulation is made with silicon nitride already used in other components inside AUG. With this precaution, the induced current will flow just on a single frame and the current should be reduced to a calculated value of 2.5 kA. Reducing the current means a reduction of the forces and therefore a decrease of the relative displacement of the tiles.

Nevertheless a stiffening of the supporting structure is required in order to cope with the additional electromagnetic forces arising in the ferromagnetic tiles: green wings in Figure 9 are welded together.

With the new set up, a relative tile movement less than 1 mm is expected, which would avoid the collision between tiles. A qualification of the welding process has been carried out to verify that the deformation given by the process would remain within acceptable limits. The reinforcement of the HS with welding is still ongoing, but most of the structures are already available for installation.
