Unveiling the Potential of Ultraviolet Fluorescence Imaging as a Versatile Inspection Tool: Insights from Extensive Photovoltaic Module Inspections in Multi-MWp Photovoltaic Power Stations

Claudia Buerhop-Lutz,* Oleksandr Stroyuk,* Oleksandr Mashkov, Jens A. Hauch, and Ian Marius Peters

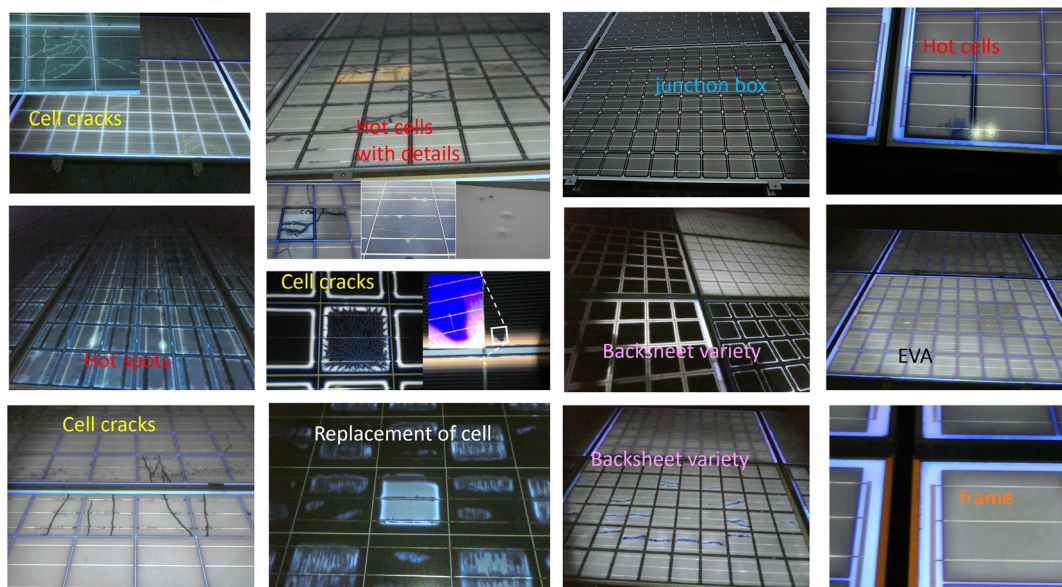
UVF images were recognized as a rich source of multiple data on both polymer BoMs and the degradation modes of PV modules. **Figure 1** illustrates the diversity of UVF patterns, showcasing examples of anomalies and changes that stand out in the regular structures. These observations include variations in the backsheet materials and EVA encapsulant properties, showing clear differences in their degradation patterns. Additionally, variations in the fluorescence intensity within the UVF patterns of EVA encapsulants indicate different levels of photochemical degradation, which can potentially impact the overall reliability and performance of the PV module.

Figure 1. Exemplary UVF images, displaying a variety of observations and findings.

through competing processes of UVF formation and oxidative quenching, allowing for simple quantification of cell crack type,^[23,24] distribution, and frequency. Local phenomena such as hot cells and hot spots can also be identified, indicating localized issues that may lead to further degradation if left unattended.

Furthermore, UVF imaging detects differences in junction box types, providing insights into the compatibility and reliability of various designs. Delamination, which is the separation of layers within the module, leading to moisture ingress and further degradation, can be observed in UVF images. Issues with the module frame and any material patches applied for repairs can also be assessed for their impact on module integrity.

UVF imaging also reveals inhomogeneities across the PV module area, as illustrated in Figure 1 (example marked by EVA), where the inner PV module area is darker, indicating lower UVF intensity, probably due to an inhomogeneous temperature profile during the lamination process or uneven distribution of components in the raw materials of the EVA foils. While this remains speculative and challenging to clarify without destructive measurements, it is easy to spot and map through UVF imaging.

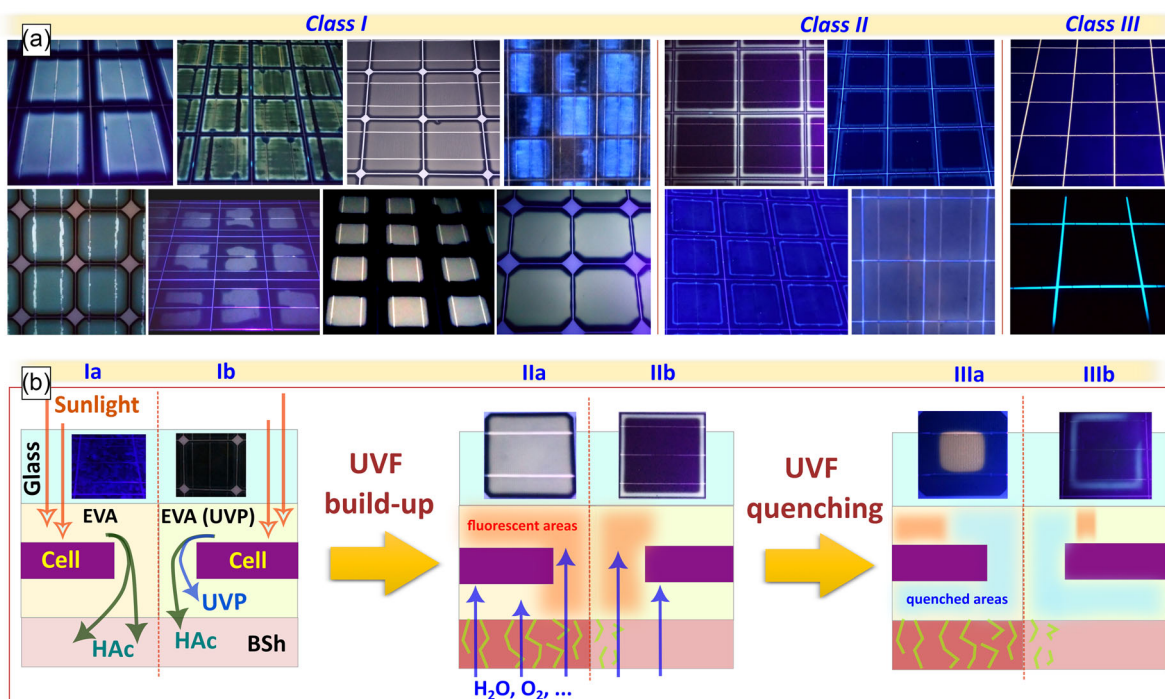
The pristine PV modules show no UVF emission (see photographs in Figure 2b, cases 1a, b). The modules exposed to solar irradiation undergo photochemical transformations generating acetic acid (HAc) and fluorescing species in the frontal EVA layer. The shape of the UVF pattern depends on additives present in the EVA matrix. With no UV absorbers present, the UVF intensity is distributed homogeneously across the UVF pattern, which mimics the underlying Si cell (case IIa). In the presence of UV absorbers that can migrate in the EVA matrix^[29] forming depleted edge areas, frame-like UVF patterns are observed (case IIb).

Photogenerated HAc penetrated the backsheet resulting in the hydrolytic degradation of backsheet components allowing more air oxygen inside the module that partially oxidizes fluorescent species in EVA and quenches UVF emission. As a result, the area of square/ring-shaped UVF patterns gradually decreases (case IIIa), while the frame-like patterns shrink and move from the Si cell edges to the center of the cells (case IIIb).

Figure 2. a) Exemplary UVF images collected for PV modules with different backsheet classes. b) Schematic illustration of primary photoinduced degradation and secondary oxidative degradation of polymer components of PV modules resulting in the formation of characteristic UVF patterns.^[5] UVP stands for a UV-protecting additive.

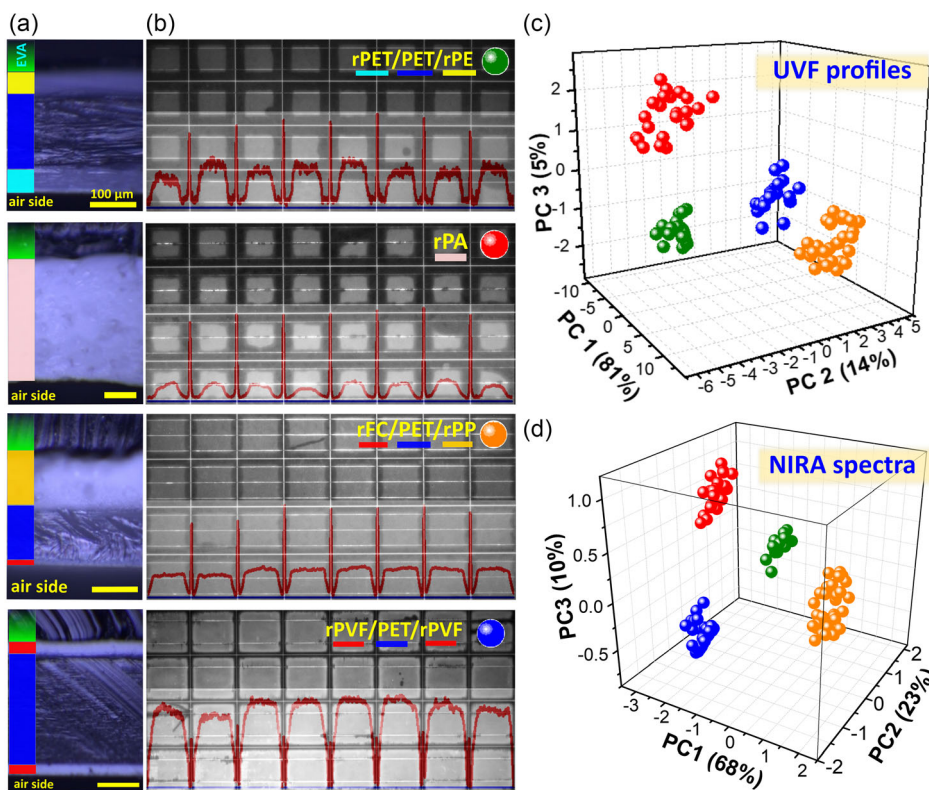
The UVF images of these backsheet types (Figure 3b) show clear distinctions in pattern geometry which can be translated into UVF intensity profiles (red lines in Figure 3b) and subjected to principal component analysis (PCA). The PCA yields distinct clusters for each of the backsheet types (Figure 3c) allowing the latter to be deduced solely from the UVF image provided this backsheet type is present in the database. The quality of clustering is similar to that obtained by analyzing NIRA spectra (Figure 3d).^[21] However, the UVF-imaging-based backsheet identification appears to be an order of magnitude faster than spectroscopic analysis.^[26]

Figure 3. Backsheet identification from UVF images: a) Cross-sections of exemplary backsheets; b) UVF images and UVF intensity profiles of corresponding PV modules; c,d) PCA plots for four selected backsheet types produced for c) UVF intensity profiles and d) NIRA spectra. Abbreviations in the figure: PE—polyethylene, PET—PE terephthalate, r—rutile titania, PA—polyamide, PP—polypropylene, PVF—polyvinyl fluoride.

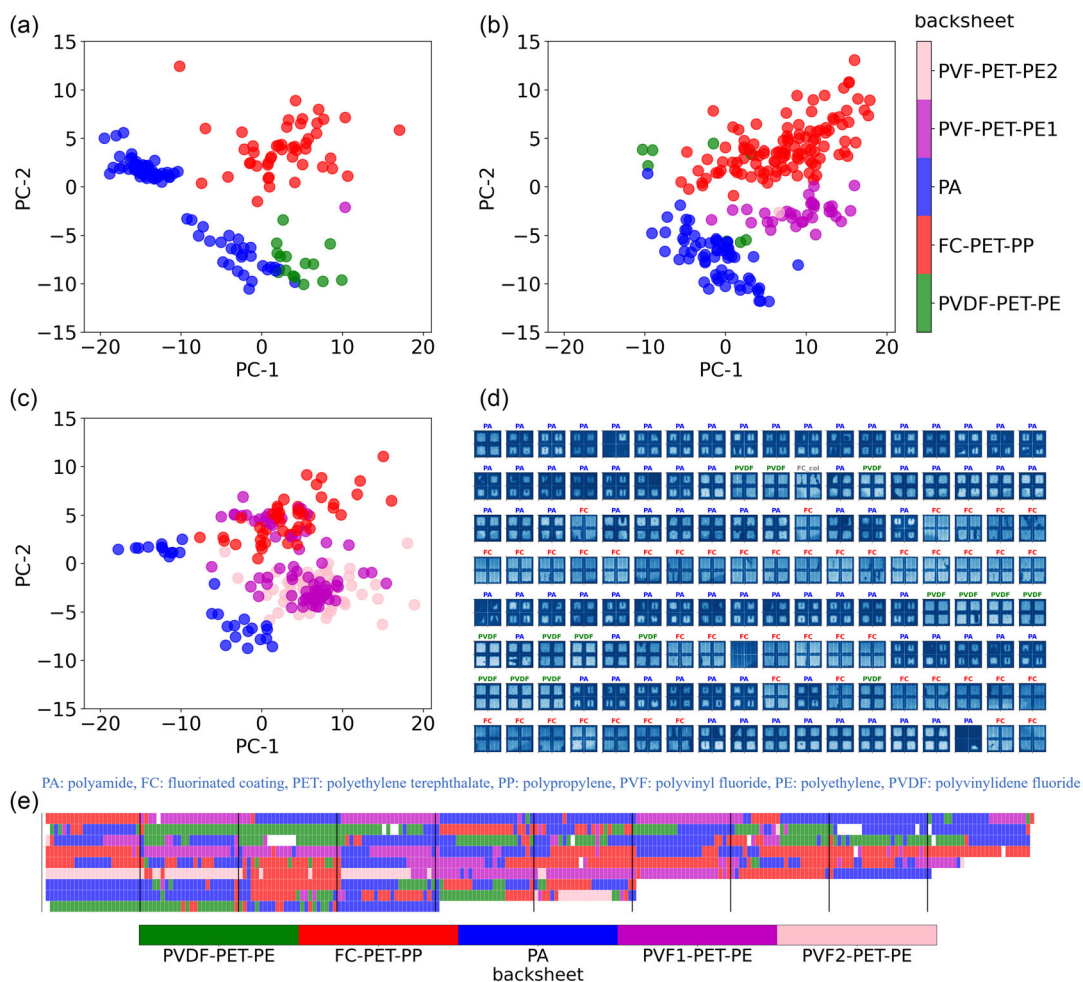
With this approach to backsheet identification being so fast, UVF imaging can be used independently to map BoMs over hundreds and thousands of PV modules at field inspection. **Figure 4** illustrates the variety of polymer materials in a single row and a map of backsheet types identified in a section of a multi-MWp PV power station. The formation of two PA clusters aligns with one PA cluster having corrosion, and the other not. Such extensive mapping by NIRA-supported UVF coupled with simultaneous

Figure 4. UVF imaging for backsheet classification, a–c) clustering of various backsheet types by principal component analysis for three rows for better visualization; d) visualization of cropped UVF images (2×2 cells), respectively backsheet distribution, for a single row with 144 PV modules (correspond to subfigure a); e) upscaling and mapping of backsheet type by combining UVF imaging and NIRA for a section of multi-MWp PV power station G (backsheet distribution of 1874 PV modules shown, ≈ 0.5 MWp). FC—fluorinated coating, PVDF—polyvinylidene fluoride.

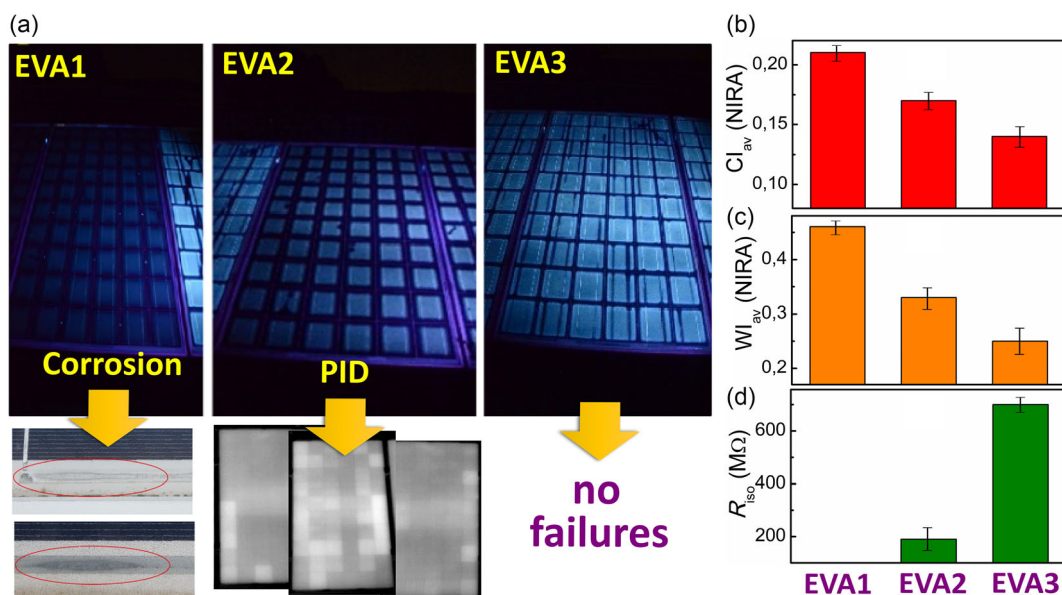
An example shown in **Figure 5** demonstrates three UVF patterns correlated to three polymer combinations (three EVA types, one backsheet type), as well as particular signs of degradation (corrosion) and failure (formation of PID). There is a clear trend with higher CI values corresponding to higher WI values. The higher degree of oxidative degradation negatively impacts the insulation resistance R_{iso} and leads to corrosion of metal interconnects. If R_{iso} values reach critically low levels, inverter issues arise, causing a loss of feed-in and revenue.^[7,8]

Figure 5. Different sorts of EVA for the same backsheet: a) representative UVF images of three different EVA sorts (EVA1, EVA2, and EVA3) found for the same PET/PET/PE backsheet and showing different failure modes, in particular, metal corrosion and PID (updated image^[27]); b) average CI and c) WI derived from NIRA; and d) “wet” leakage insulation resistance R_{iso} of PV modules with the same backsheet and different EVA types.

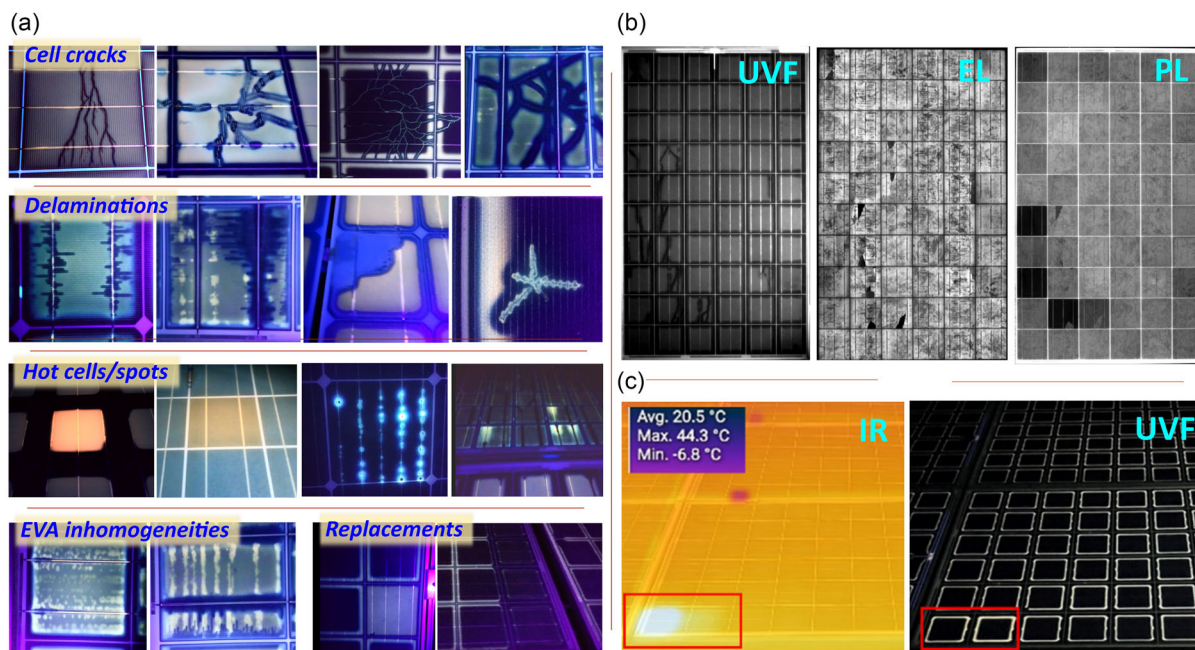
In addition to the innovative identification of BoM-related patterns mentioned above, more conventional non-BoM-related UVF features are also important for a comprehensive analysis of a PV plant. These features (see examples in Figure 6a) can

One prominent feature is the presence of cell cracks interrupting the regular UVF patterns of the PV modules (Figure 6b). According to our evaluation of more than 50 000 UVF images, on average 74% of the PV modules were found to exhibit crack structures, a finding consistent with Köntges' results.^[32,33]

UVF imaging also highlights very bright and intense patterns that correlate to hot cells and hot spots seen in IR imaging (Figure 6c). Our experience suggests that significant local temperature differences, well above $\Delta T \gg 5$ K for a prolonged period, are required to produce these UVF signatures. This contrasts with temperature increases from bypassed substrings or PID, which do not exceed ΔT of 5 K and do not appear in UVF imagery.^[14,37] Table 2 quantifies the findings of heat-related failures, like string, substring, PID, and hot cells, detected by IR and UVF imaging. IR observations of the hot spots are rare with an average of 0.7% of modules with thermal anomalies, which corresponds to numbers presented by Jordan.^[38]

Figure 6. a) A collection of UVF images illustrating cell cracks, various cases of encapsulant delaminations, hot cells, hot spots, local inhomogeneities in EVA quality, and cases of cell/polymer replacements. Comparative sets of b) UVF, EL, and PL, and c) IR and UVF images taken from the same modules.
