# Microstructure and cyclic oxidation behavior of APS TBC systems drilled with various laser methods

V. Ebrahimzade<sup>a,1</sup>, H. Uchtmann<sup>b</sup>, L. Singheiser<sup>a</sup>, M. Krüger<sup>a</sup>, J. Malzbender<sup>a</sup>,

<sup>a</sup>Forschungszentrum Jülich GmbH, Microstructure and Properties of Materials (IEK-2), Institute of Energy and Climate Research, 52425 Jülich, Germany

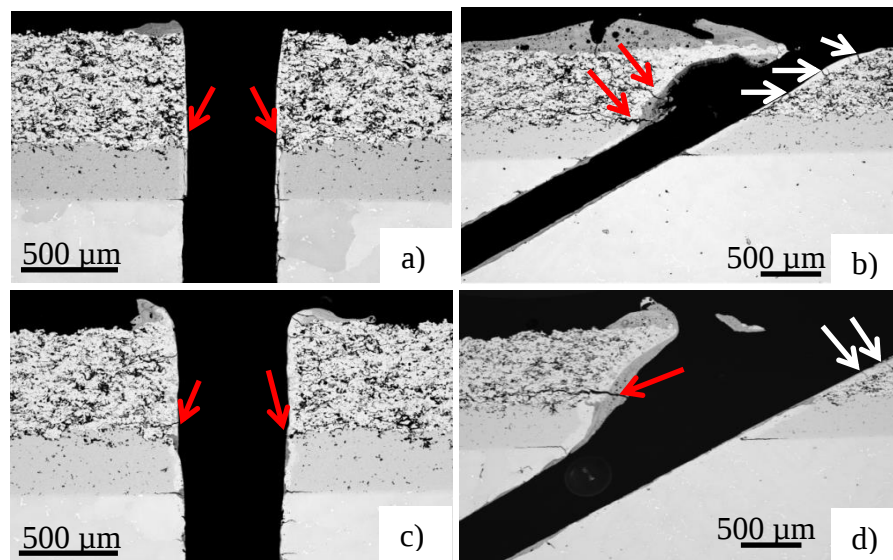
In the following microstructural analysis of flat laser drilled specimens of series one, see Table 1 and section 2.1 Laser drilling of TBC systems, drilled with different laser methods are presented. Cross-sections of the specimens having vertical and inclined holes drilled with fiber laser, in both percussion and trepanation mode, provide useful information about typical imperfections and defects at such holes. Typical defects resulting from laser drilling are i) deviation of cooling hole diameter, ii) cracking between TBC and BC or BC and substrate, iii) cracks at substrate grain boundaries, iiiii) recast layer as a consequence of insufficient removal of melt during laser processing, see Figure 5 and Figure 6. For both percussion and trepanation drilling with fiber laser, inclined holes showed longer cracks, see the trepanated specimens in Figure 5a-b. The crack length measurement results of all specimens are summarized in Table 5. Comparing percussion and trepanation drilling, it can be derived that a better hole quality, with shorter crack lengths, can be achieved using trepanation drilling.

Figure 5 SEM images of specimens drilled with fiber laser using trepanation mode for a) 90° and b) 30° holes, and percussion mode similarly for c) 90° and d) 30° holes. Arrows in red show cracks at TBC/BC interface, and arrows in white indicate cracks in TBC recast layer.

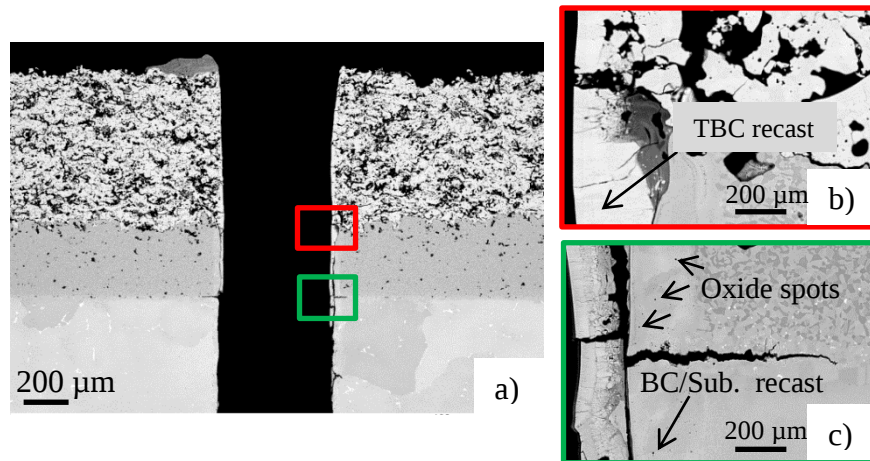
Typical microstructural defects of the specimen drilled with long-pulsed laser sources are shown in Figure 6, where a TBC recast layer with negligible pore density as well as the BC/substrate recast layer, including oxide particles, can be observed in Figure 6b and c.

Figure 6 a) A TBC system drilled by a ms-pulsed laser with b) TBC and c) substrate/BC recast layer.

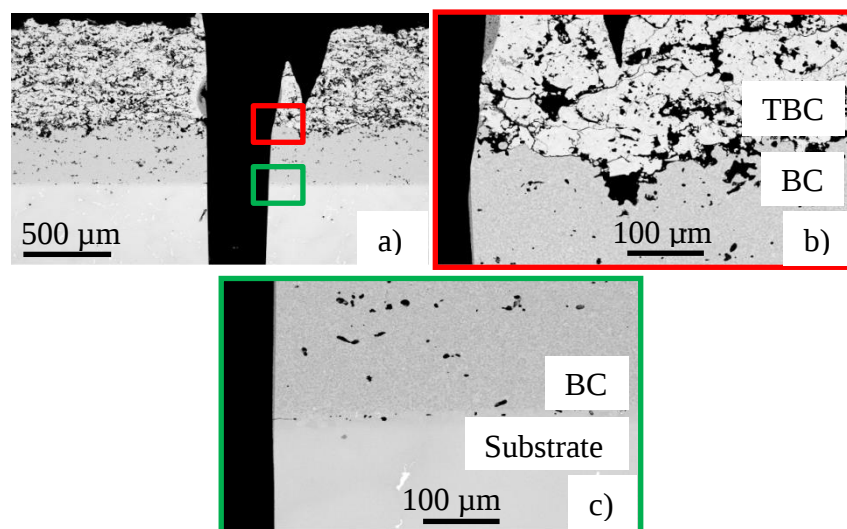
Figure 7 presents the SEM images of the specimen drilled with ultra-short pulsed laser. It can be observed that the density of the defects at the hole is negligible in comparison with other laser methods. However, the parameter set is still not fully optimized, as imperfections in the TBC layer can be observed.

Figure 7 SEM images of specimens drilled with a) ultra-short pulsed laser, and magnified image b) at TBC/BC interface, and c) at BC/substrate image.

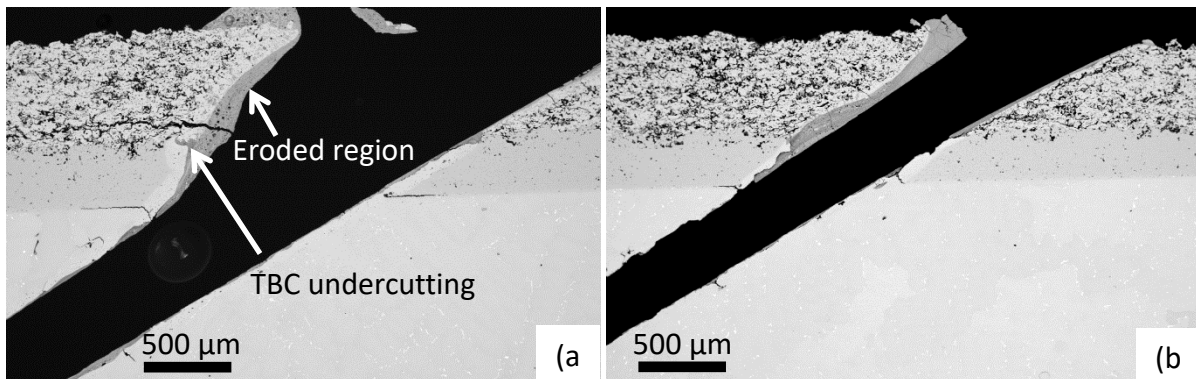
It is also clear from this table that larger defects occur for inclined holes. Additionally, in case of percussion drilling, fiber laser, probably due to larger pulse frequency, 60 Hz, compared with flash lamp laser, 20 Hz, more defects at the hole are induced at the TBC/BC as well as BC/substrate interfaces, as also reported by Sezer et al. [27]. However, they observed with increasing pulse frequency a decrease in the number of delamination cracks at BC/substrate interface, which is not the case in our observations. The upward melt ejection, and TBC undercutting at TBC/BC interface (especially for inclined holes), see Figure 8, increased with increasing pulse frequency, which is due to increased TBC wall temperature. The melt ejection process, TBC undercutting, as well as the eroded region on the leading edge, induces higher mechanical stress and moment at the TBC/BC interface initiating or propagating the delamination crack [27]. The thicker recast layer with increasing pulse frequency results also to larger solidification cracking especially at BC/substrate interface, [11]. For the case of flash lamp percussion, inclined drilling, the analyzed cross-section is slightly off the middle section of the hole. However, in comparison with fiber laser percussion drilling, the same trend is observed as for vertical holes.

Figure 8 The TBC undercutting observed for the case of a) fiber laser, percussion, compared with b) flash lamp, percussion laser drilling.

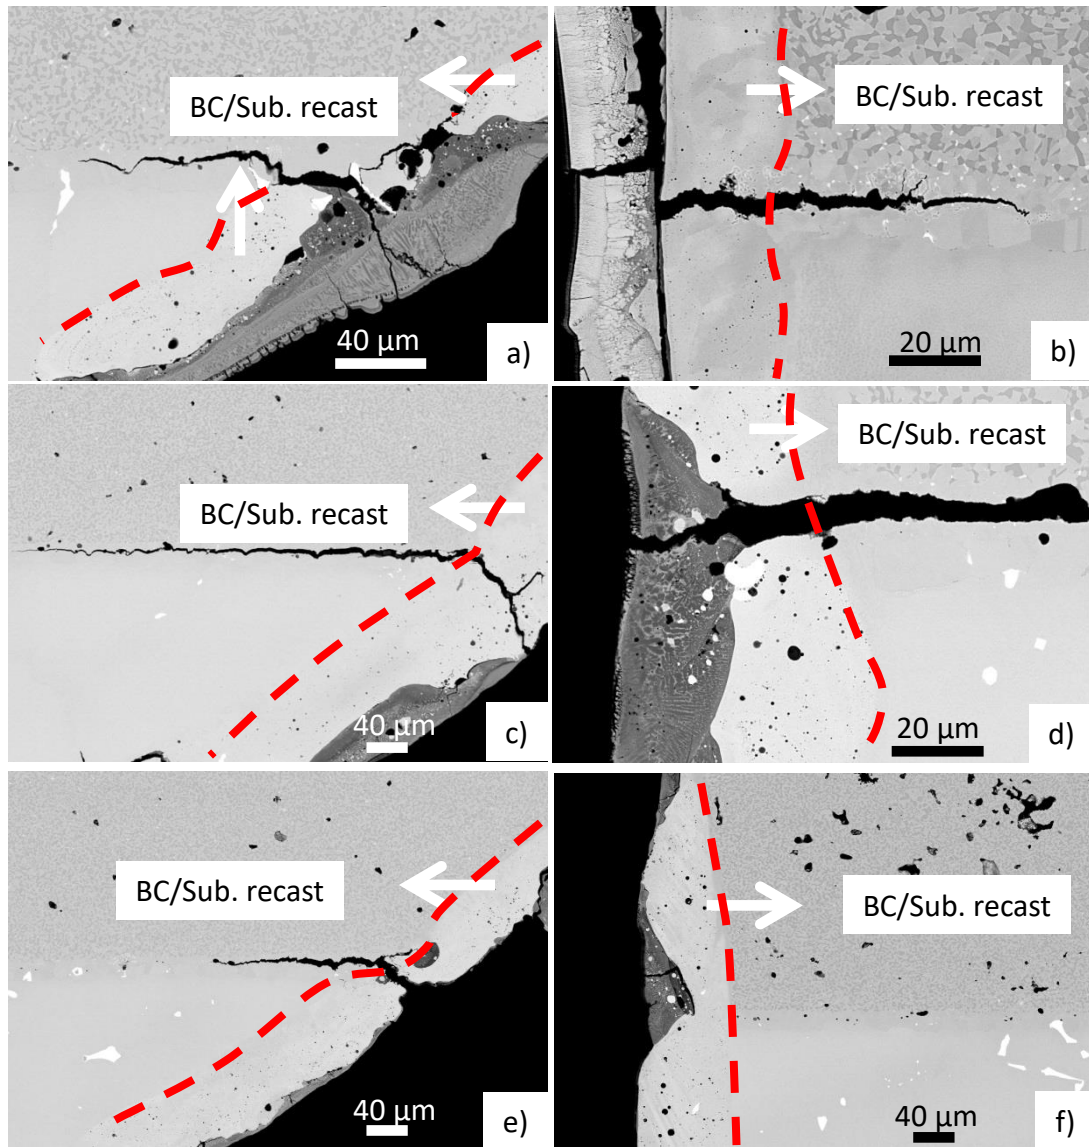
Figure 9 shows SEM images of the BC/substrate interface for specimens drilled with different laser methods. One can obtain a better understanding of the measurements of recast thickness and crack length presented in Table 5 and Table 6.

Figure 9 Comparison of BC/Sub. recast thickness and crack length for a) fiber laser, trep., 30°, b) fiber laser, trep., 90°, c) fiber laser, perc., 30°, d) fiber laser, perc., 90°, e) flash laser, perc., 30°, f) flash laser, perc., 90°.

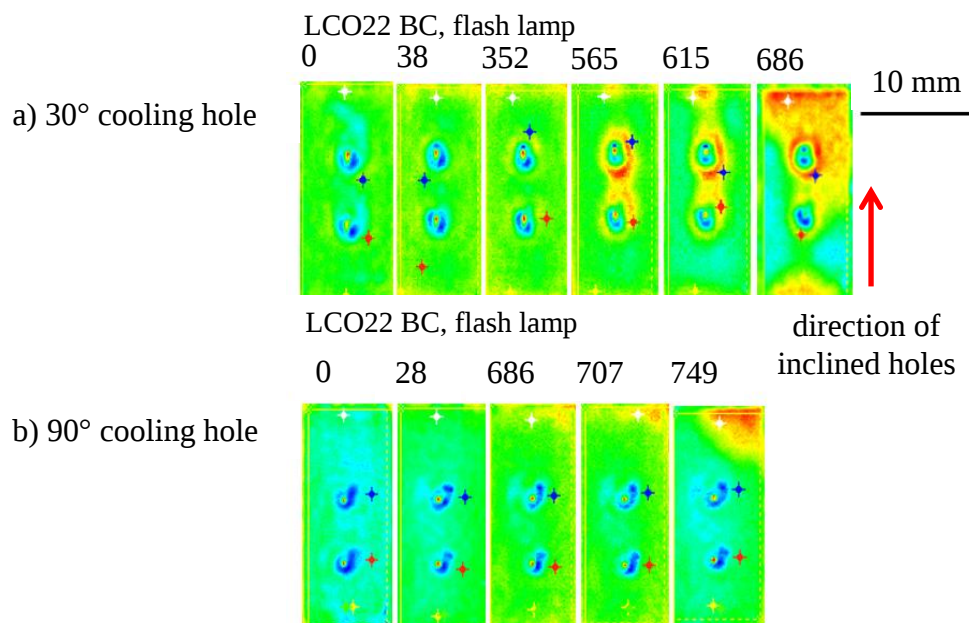
It has been illustrated in literature [28, 29] that thermography is a useful method to examine the delamination of TBCs. Thermography experiments performed for specimens after different number of thermal cycles, from the beginning to failure, are shown and discussed in the following. In Figure 10, for instance, the formation and propagation of delaminations for two specimens (BC type: aluminized LCO22), for vertical and inclined holes drilled with flash lamp laser using percussion mode, are compared. It can be concluded from these images that the delamination cracks are more pronounced at the holes for inclined holes than for vertical holes. Although not shown in details, the thermography images of the remaining tested specimens, drilled with fiber laser using trepanation and percussion mode as well as the ones with PWA286 BC revealed rather similar trends.

Figure 10 The development of delamination for specimens during cyclic oxidation test, drilled by flash lamp laser, with a) 30° and b) 90° cooling holes.

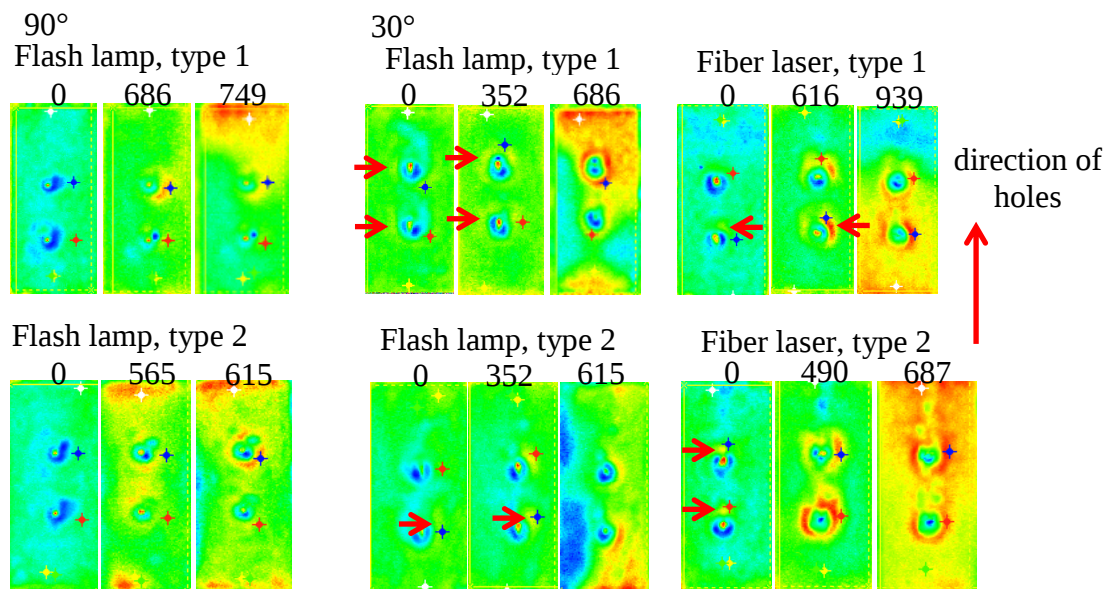
In Figure 11, the thermography measurements after laser drilling of inclined and vertical holes, before and after cycling, are shown. Contrary to 90° holes, delaminated regions at the 30° holes can be already recognized after drilling, indicated with red arrows.

Figure 11 The development of delamination for the laser drilled specimen due to cyclic oxidation. Type 1: specimens with aluminized LCO22 as BC, and type 2: specimens with PWA286 BC.

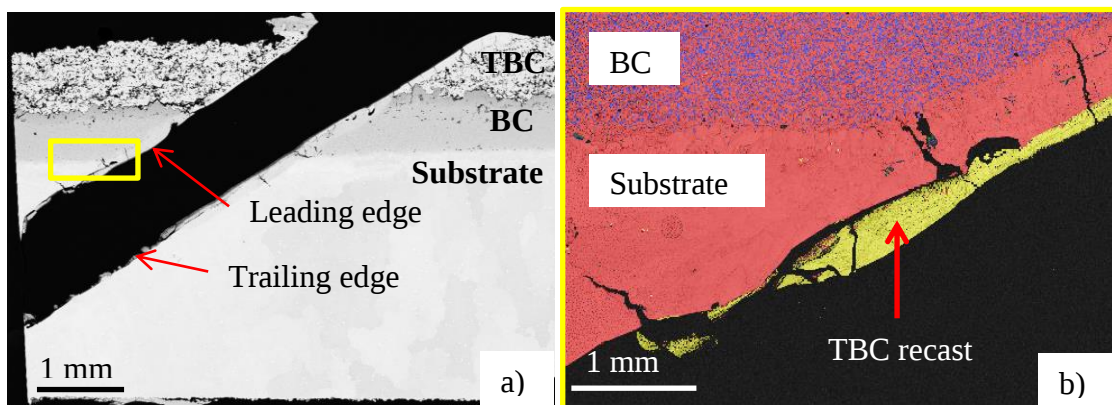
Microstructural images of the as-drilled specimen for the location near the hole are given in Figure 14. A large delamination crack can be observed at the leading edge after laser drilling. Several cracks formed that at the hole can be observed as well. Such cracks are formed mostly within recast layer at interfaces or substrate's grain boundary. Cyclic oxidation of the specimen can lead to further propagation and oxidation of these cracks in the BC and substrate, therefore, they must be avoided. The BC/substrate recast layer is composed of mainly  $\gamma$  (red) phase and has on average finer grains in comparison with the substrate grain size (see Figure 15). Since the grains of this layer are finer, its creep resistance at higher temperature decreases more than that of the substrate. The zirconia recast layer, shown in yellow in Figure 14b, is induced by TBC melting during laser drilling. There can be also an oxide layer on the hole wall which develops as a result of the high temperature exposure of the BC/substrate recast layer.

Figure 14 As-drilled specimen (BC type: aluminized LCO22), drilled by fiber laser, trepanation mode. (a) SEM image of cross-section and (b) EBSD phase map of the marked area in (a), yellow:  $\text{ZrO}_2$ , red: Ni-fcc, blue: beta-NiAl.

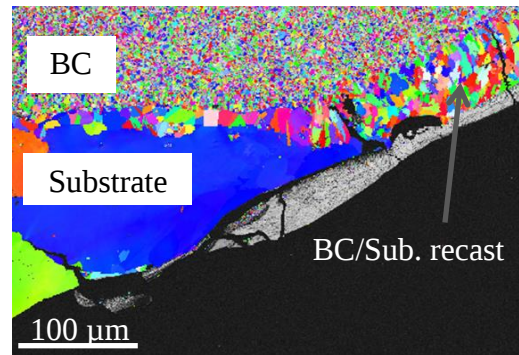
EBSD orientation mapping of the section in Figure 14b on the leading edge after laser drilling is shown in Figure 15. Grains in the BC/substrate recast layer are oriented mainly in the perpendicular direction to the hole wall, which makes this layer prone to crack initiation in the direction parallel to hole edge.

Figure 15 EBSD orientation map for specimen drilled with fiber laser, trepanation mode, at the BC/substrate interface on the leading edge, shown in Figure 14b.

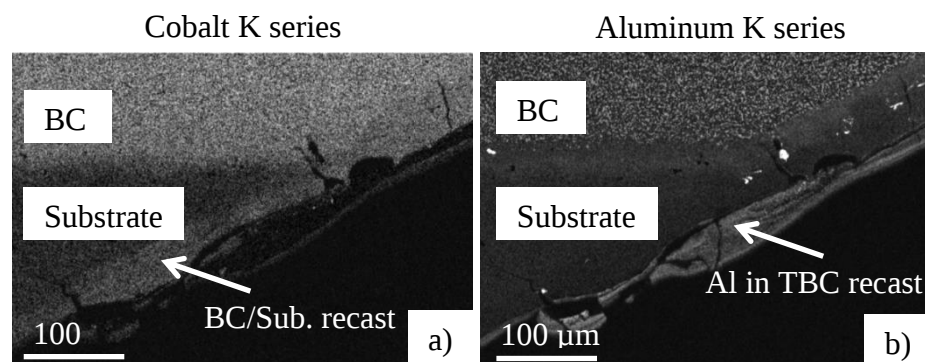
In the EDS mapping of the leading edge, a larger concentration of Co can be observed in the BC/substrate recast layer, see Figure 16a, supposedly as a result of mixture of molten BC, with much larger Co content, and substrate during laser drilling, where the molten recast layer flows usually downward in the final steps of the trepanation drilling [6]. Aluminum can also be found in the TBC recast layer, see Figure 16b, which originates most likely from both BC and substrate. Based on the EDS mapping, the TBC recast consisted of mainly Zr, O, Al, Cr, Co, Ni, Ti, and Mo.

Figure 16 EDS mapping of cross-section shown in Figure 14b for a) cobalt and b) aluminum.

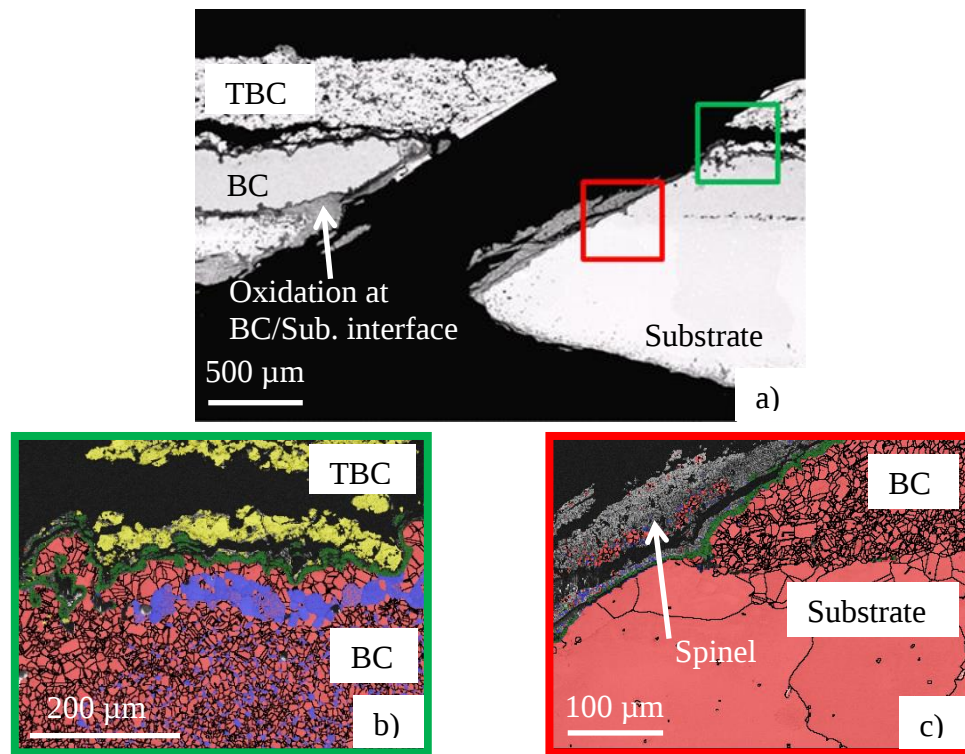
Microstructural analysis results of the failed specimen after cyclic oxidation, drilled with fiber laser using trepanation mode, are shown in Figure 17. It can be concluded that the delamination of TBC coating occurs mainly at the TBC/BC interface (Figure 17b), where a mixture of black and white failure can be found. Strong oxidation of BC and substrate is observed as well. TGO formation was observed at TBC/BC interface where the delamination crack has propagated through TGO and TBC, shown in green in Figure 17b. Oxidation and formation of TGO at TBC/BC interface has been reported extensively in literature to be critical for TBC life [30, 31]. Moreover, TGO (alumina) and spinel type oxide were also observed at BC/substrate on the leading edge near the hole as well as on the hole wall, as it is shown in green in Figure 17a and c, which has likely led to the shorter life time of laser-drilled TBC systems compared with the undrilled specimen. No significant difference in TGO thickness at TBC/BC interface was observed. However, a much larger depletion of  $\beta$ -NiAl phases in BC can be found at the hole, resulting in a weaker bond coating at this zone. Similarly the substrate is severely oxidized and eroded at the lower parts of the hole, see Figure 17a and c. Large amount of spinel type oxides including Cr, Co, and Al are observed on the hole wall, see Figure 18, that is due to very high temperature of the base alloy in the absence of film cooling, which is used in a gas turbine during operation to reduce the superalloy temperature. Such oxides has been reported to be detrimental for TBC life time, due to their lower mechanical strength [30]. The laser-induced cracks at the hole are critical which caused oxidation attack in BC and substrate.

Figure 17 Microstructural images of a laser drilled specimen (BC type: aluminized LCO22) drilled by fiber laser, trepanation mode, after cyclic oxidation test; a) SEM image of the hole, b) EBSD phase map at the delamination crack near TBC/BC interface, c) EBSD phase map of the trailing edge at BC/substrate, yellow:  $\text{ZrO}_2$ , green: alumina, red: Ni-fcc, blue: beta-NiAl.

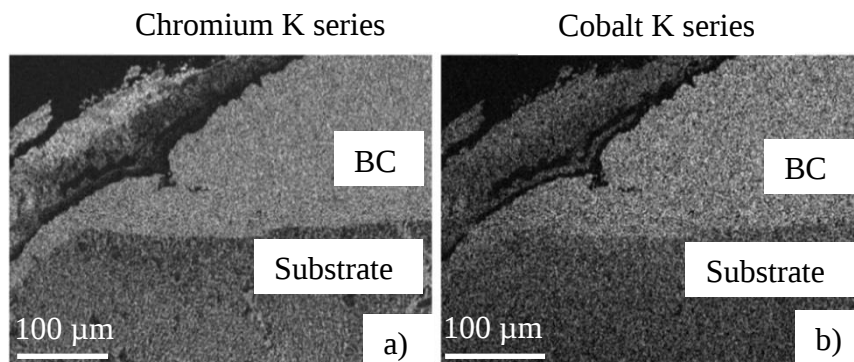
Figure 18 EDS mapping of the oxide layers on the hole wall for the cross-section shown in Figure 11c.

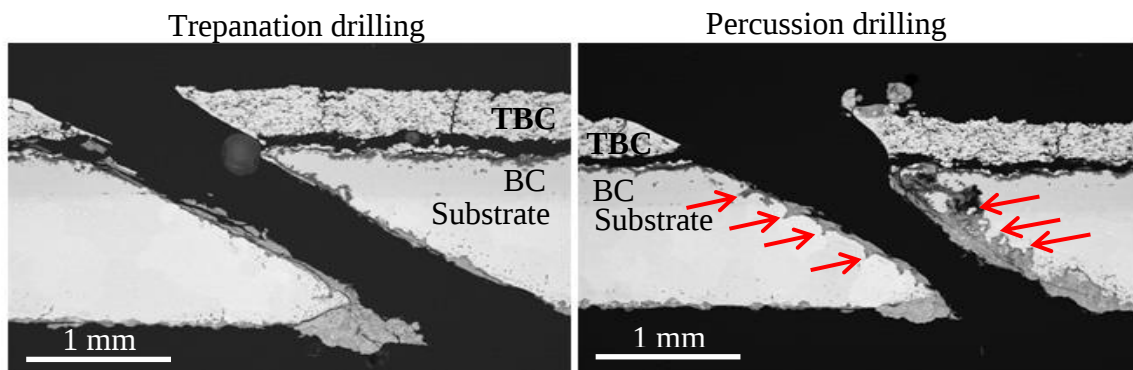
The difference between fiber laser drilling for percussion and trepanation drilling after cyclic oxidation is represented in Figure 19. The amount of oxidation attacks in BC appears to be more critical for percussion drilling, which is probably due to low quality of the drilling process, especially the laser-induced cracks.

Figure 19 Comparison of specimens with PWA286 BC drilled by fiber laser using trepanation drilling (left) and percussion drilling (right).
