Inspection of W 7-X plasma-facing components after the operation phase OP1.2b: observations and first assessments

Due to its twisted magnetic configuration, the plasma facing components of the Wendelstein 7-X stellarator are oriented in a 3D shape. The plasma facing components consist of graphite test divertor units, baffles, head shield tiles and toroidal divertor closures and stainless steel wall panels, pumping gap panels and poloidal closures. In order to document the status of these components as well as get the first foot-prints of the plasma wall interactions occurred during the plasma campaign, a detailed inspection of the whole plasma vessel after the plasma campaign is of vital importance. Such an inspection was carried out after the operation phase OP1.2b completed in October 2018. A number of observations were made, such as, molten stainless steel drops, melting of a long term probe, deposition on steel panels, arc traces, loosely bound particles and deposition stripes on the plasma vessel hidden behind the graphite tiles. In order to understand the possible cause, their implication and steps to avoid some of these problems for the next phase of machine operation, an a

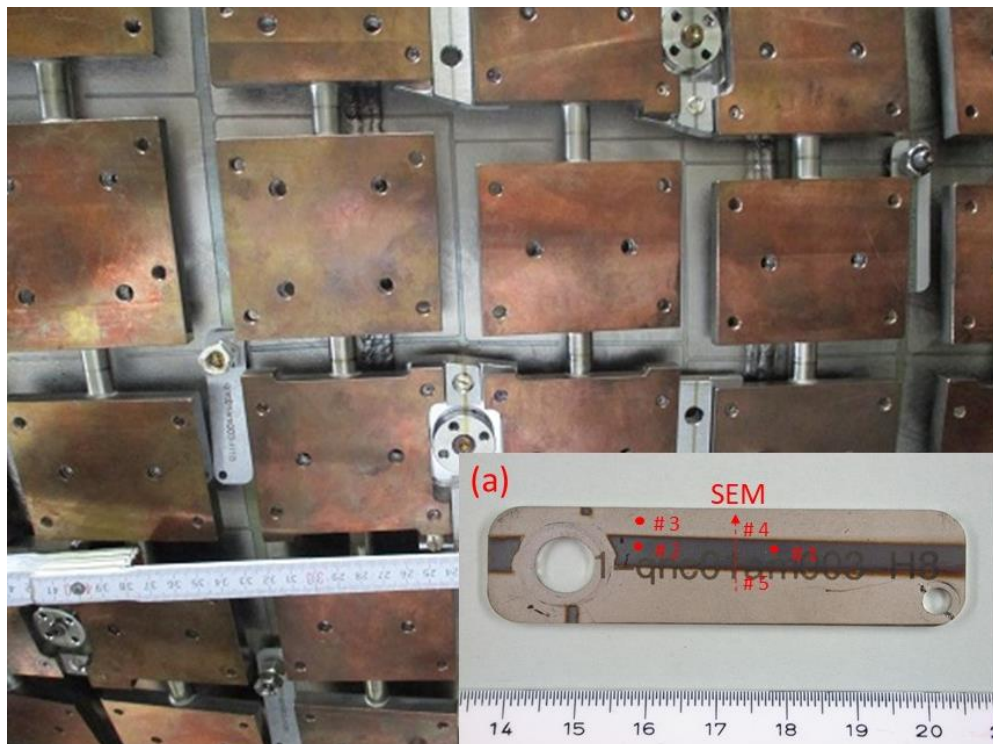
On the whole inboard side plasma vessel wall behind the graphite tiles, sharp deposition stripes were observed, located at the gaps between the tiles as shown in figure 2. These depositions appeared also on a TAG number plate (see figure 2 inset (a)) incidentally fixed at the stripe location. This was removed and analyzed with Elastic Backscattering Spectrometry (EBS) with 2.5 MeV incident protons at the IPP tandem accelerator facility Bombardino using the BesTec manipulator [4]. The measured atomic concentrations are shown in table 1. The deposited material was found to be mainly consist of C with small amount of O and traces of B (H is not measured by the technique used). At the line crossing the deposition stripe (see figure 2 inset (a)), Scanning Electron Microscopy (SEM) and Energy-Dispersive X-ray spectroscopy (EDX) measurements were done (see figure 3) confirming the EBS results. With the values of stripe width and distance between the neighboring stripes, an array was generated for the whole inboard side of plasma vessel and the fraction of deposited area (3.23 m^2) compared to the total area (89.9 m^2) was estimated. Further, with the measured thickness, the total amount of deposited C ($1.39 \times 10^{22} \text{ atm.}$) was estimated to be 0.3 g. Deposition is also expected on the sides of the tiles forming the gap through which C travelled up to the vessel wall. These tile are presently being investigated.

Figure 2. View of the inboard side plasma vessel showing the Cu-Cr-Zr support plates after removing the graphite tiles installed on these plates. The deposition stripes on the vessel wall are visible behind the support plates, inset (a) shows a TAG number plate installed on the vessel on which the stripes were also deposited.

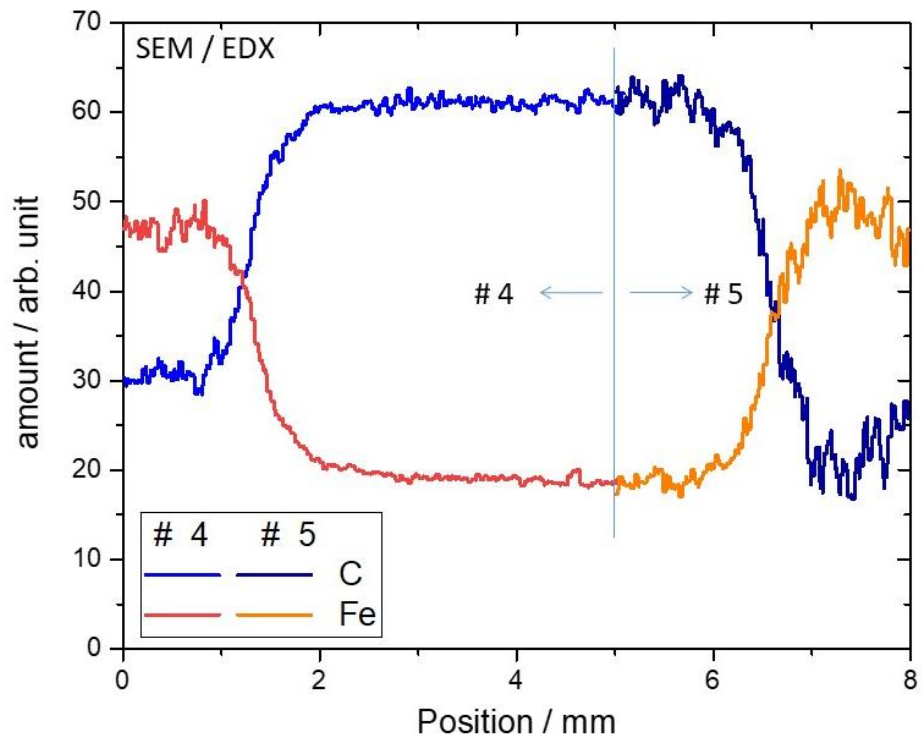
Table 1. Atomic concentration of C, O and B atoms measured by EBS, here positions # 1 and # 2 are at the deposited stripe and # 3 at the base material, see figure 2a. Statistical uncertainties are + 5%.

Position	C ($\times 10^{15} \text{at./cm}^2$)	O ($\times 10^{15} \text{at./cm}^2$)	B ($\times 10^{15} \text{at./cm}^2$)
# 1	457.9 ± 52.2	98.1 ± 40.9	75.5 ± 25.2
# 2	406.5 ± 51.0	131.4 ± 41.1	76.4 ± 25.1
# 3	80.2 ± 47.1	61.0 ± 41.2	< 20

Figure 3. SEM/EDX measurements on the TAG number plate at the line crossing the deposition stripe at the locations # 4 and # 5 shown in figure 2.

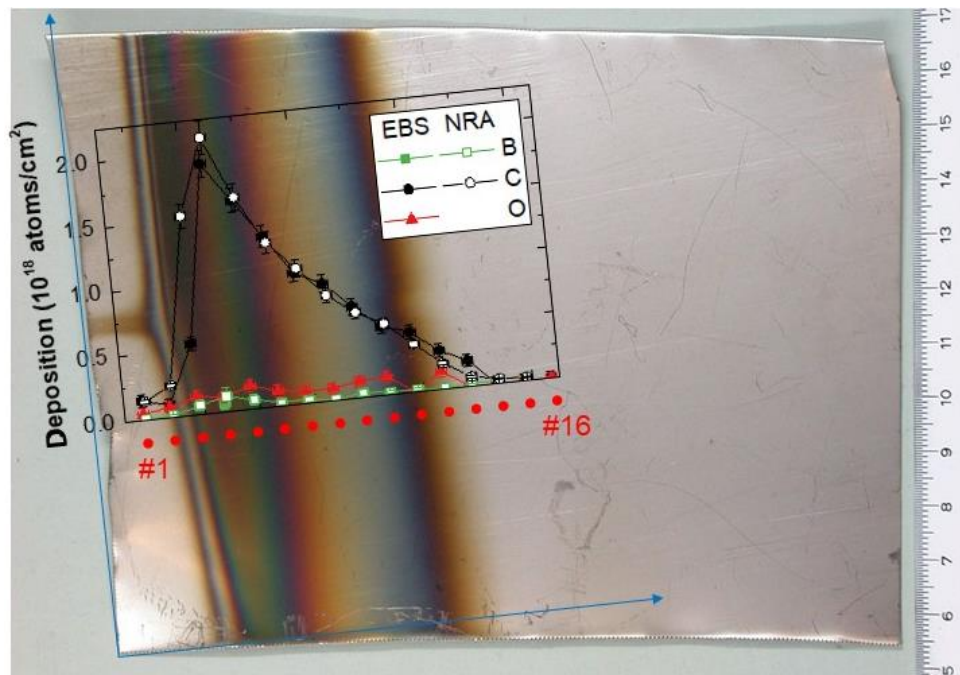
The space behind the test divertor units were closed using 0.5 mm thin stainless steel plates named as inner divertor closures. When the TDUs were removed for installing the water cooled high heat flux divertors, depositions were seen on these closures. These depositions were analyzed using EBS as described above and Nuclear Reaction Analysis (NRA) with incident 2.5 MeV ^3He ions using the $^{12}\text{C}(^3\text{He}, p_0)^{14}\text{N}$ and $^{10}\text{B}(^3\text{He}, p_1)^{12}\text{C}$ reactions. A gradient of deposition was observed with the peak values of about $2 \times 10^{18} \text{ atoms/cm}^2$ for C (see figure 4), the amounts of O and B were relatively small. These deposits were probably created during some of the plasma configurations during OP1.2a mimicking the scraper configurations, when the strike lines were moved close to the pumping gap panels and some of the convective loads could reach to the closures. For OP1.2b, however these were blocked by modified graphite baffle tiles (L-shaped tiles) in this region, further analysis would be carried out to find the deposition took place during OP1.2b. For the next phase of operations, together with the new divertor these closures will be also exchanged.

Figure 4. Inner divertor closure plate removed after OP1.2b from the lower TDU in module-2. Deposition layers are visible on the left side of the plate. The plot of EBS/NRA measurements

superimposed at the 16 measuring positions on the plate, shows variation of deposited layer thicknesses.

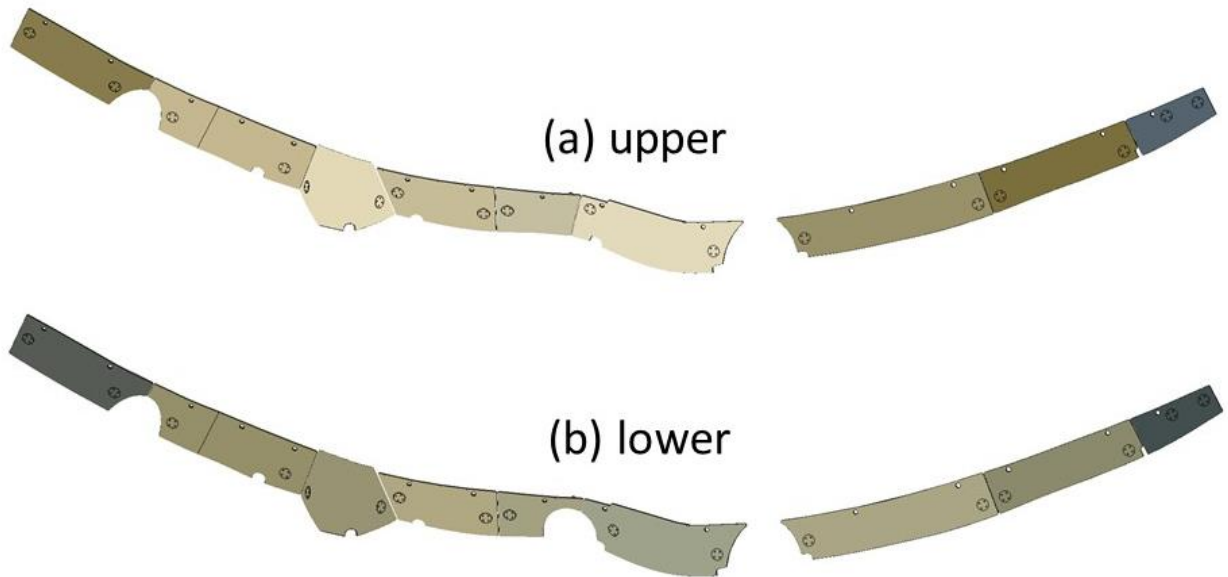
optical reflection measurement technique was employed for the in-situ measurements. In this technique the intensities of reflected Red, Green and Blue (RGB) lights from the measurement spot are measured and together with ellipsometric measurements, the deposited layer thickness is estimated [5]. All the panels around the torus were measured, the thickness profile on the wall panels shows a definitive pattern with the thickest deposition around the interface between the modules and the thinnest in the middle of a module [6]. Depositions were seen only on certain areas of pumping gap panels as well. Interesting deposition patterns were observed on the poloidal closures (see figure 5) with different depositions on upper and lower closures of one module indicating up-down asymmetry. Such asymmetry was observed in all the five modules.

Figure 5. Views of the upper (a) and lower (b) poloidal closures from module-4, the difference in colors of both these indicate the up down asymmetry of the depositions.

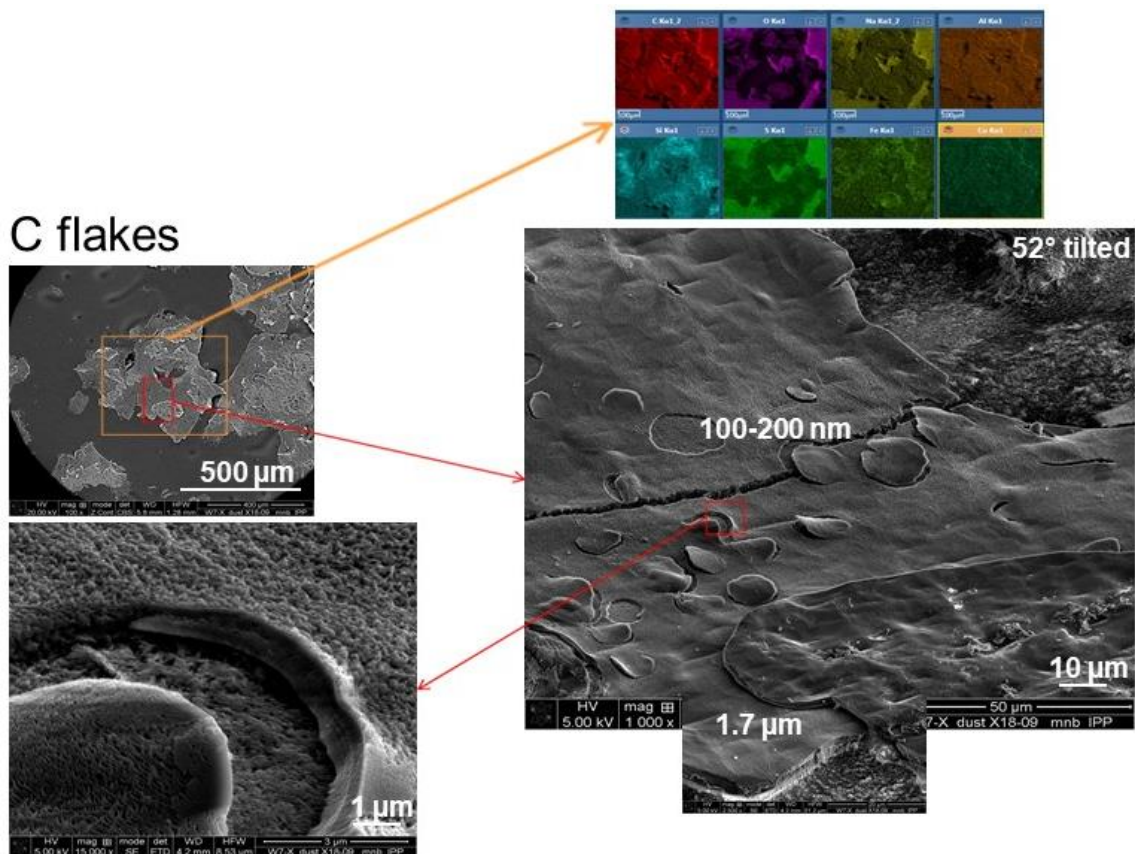
The samples were analyzed using SEM/EDX. Figure 6 shows the observed view of a C-flake. From the measurements, the observed particles could be classified in three categories: C-dominated flakes, Fe particles with Cr, Ni and Mn traces and Al-Cu particles. C originates mainly from the erosion of test divertor units and Fe, Cr, Ni and Mn from the stainless steel panels and structures. Cu is present in the Cu-Cr-Zr support structure of graphite tiles for the baffles, heat shields and toroidal closures. For Al the possible sources could be ceramic feedthroughs made from Al_2O_3 or glass windows. Since three boronizations were carried out for reducing the C and O impurities, it was explored if this was present in these samples, however these were found to be below the measurable levels.

Figure 6. SEM/EDX image of a C flake sample collected from a tile.

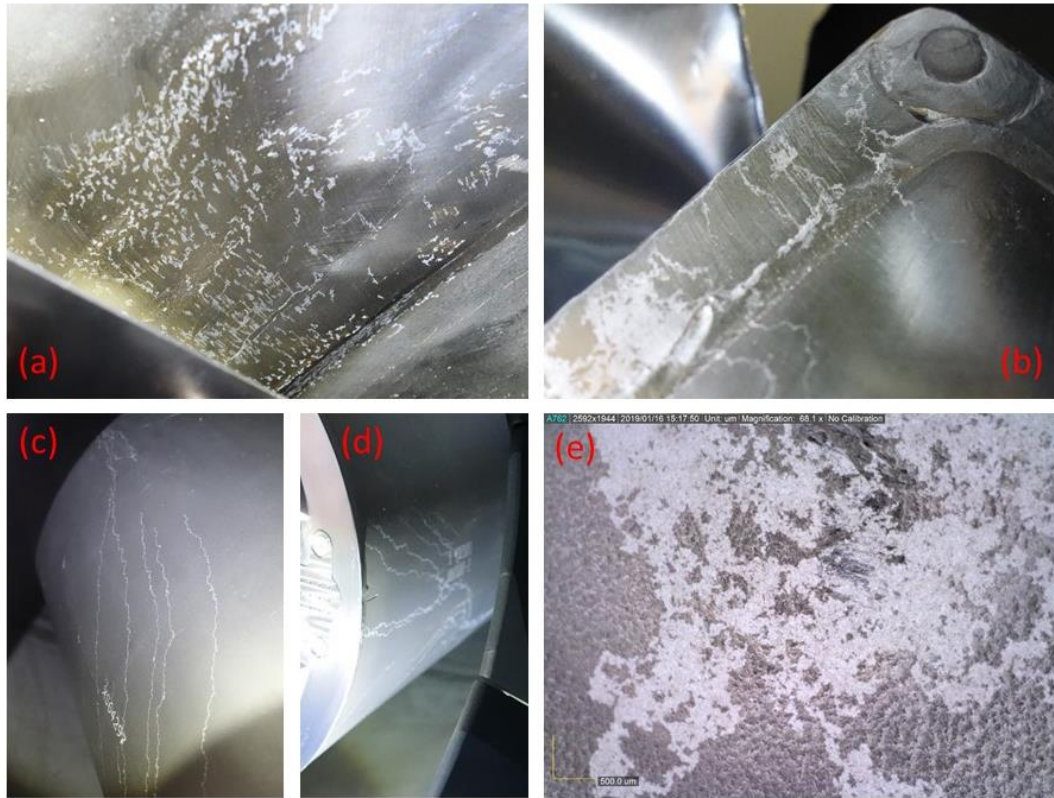
The whole plasma vessel including its components and the ports were checked for arc traces using a Dino-Lite digital microscope. Altogether only 212 arc traces have been found on the panels, ports, plasma vessel and the tile supports, out of these 158 were observed on the plasma facing side and the rest on the back side (see figure 7). The length of these traces varies from 1-2 cm up to about 0.5 m. Only a small fraction i.e. <10% of these have been found to follow $-J \times B$ direction due the magnetic field generated by the main superconducting coils. The majority of the tracks are oriented in random directions. Besides, about 25% of these arcs even occurred on non-plasma facing sides, indicating the origin of the arcs to be due to the glow discharge cleaning. The depth of these traces appears to be very small and no observable material erosion was seen.

Figure 7. Arc traces observed on the front side (a) and backside (b) of a panel, ports (c) & (d) and an enlarged view of a random arc trace with microscope (e).

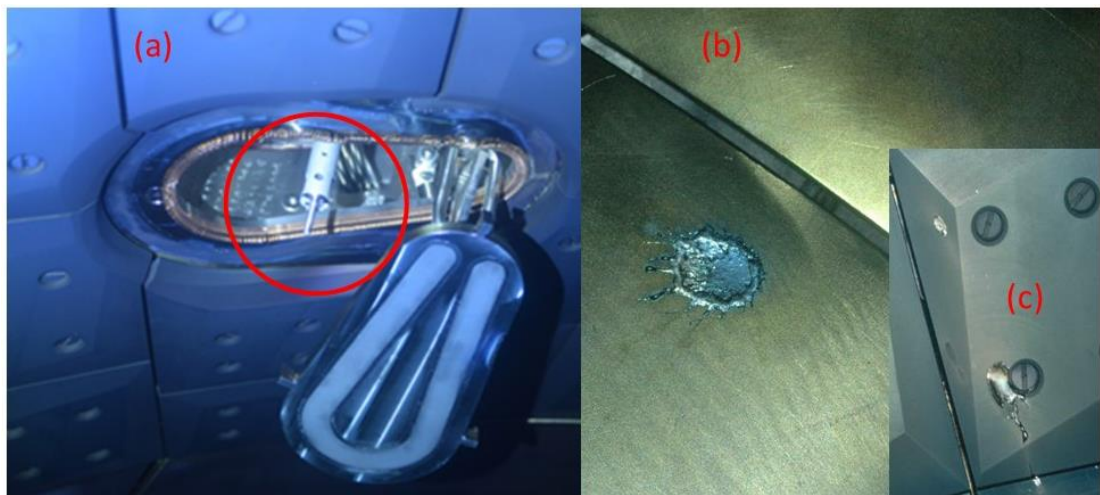
One of the probes installed in the plasma vessel in module 1 for the 3D magnetic flux surface mapping [1] was retracted into the port during the whole OP1.2b. Despite of this port remaining closed with a shutter, part of a 3.0×0.5 mm SS probe tube was molten and flowing out of the sealed flange and drops were falling down as well as spread on the neighboring tiles (see figure 8). The problems probably have occurred due to an inappropriate setting of polarization for the Electron Cyclotron Resonance Heating (ECRH) remote launcher that makes use of the shutter as a reflector. For the future operations this will be corrected by introducing an interlock in the ECRH control software. Furthermore, the shutter and frontend will be water-cooled in the future.

Figure 8. View of the magnetic flux surface measurement probe installed on the upper side in module-1, (a) shows the probe with shutter opened, the melted steel drops are on the panel below (b) and neighboring graphite tile (c).

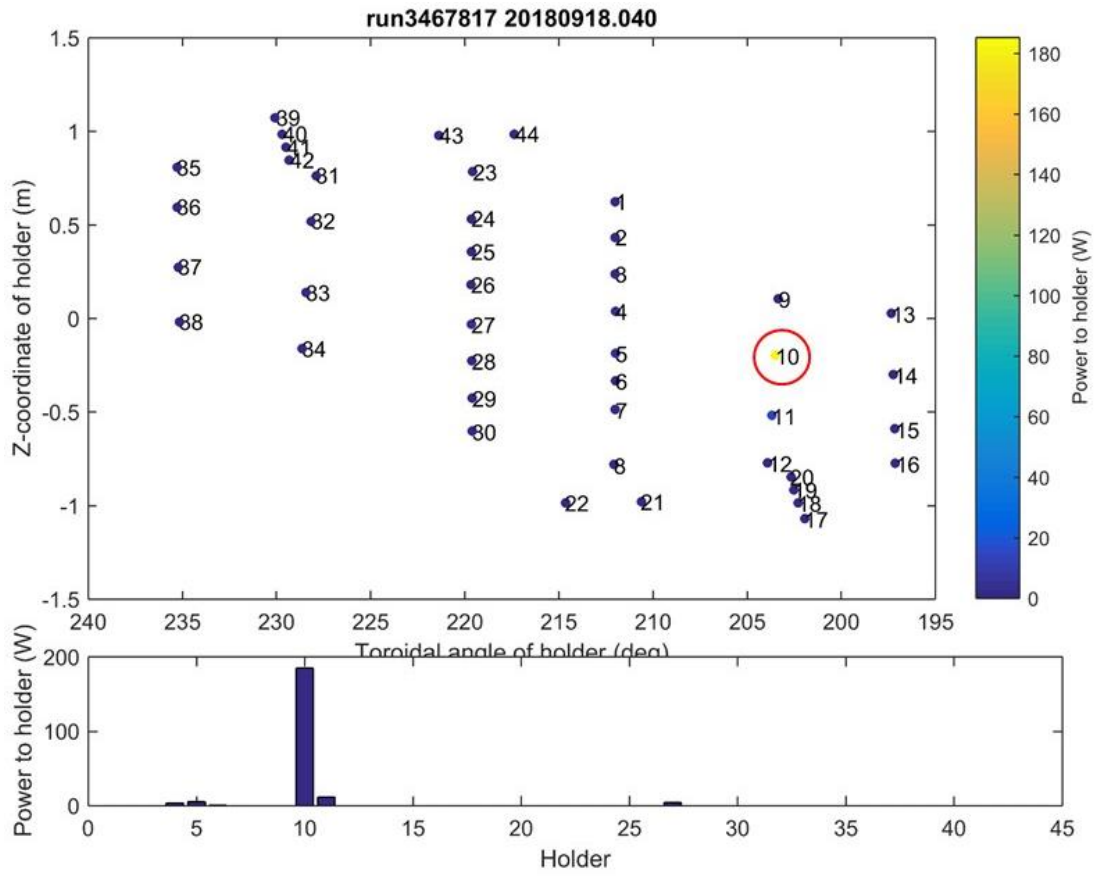
44 pieces of long term deposition probes of three different types, i.e. Si-wafer, directional material and cavity probes [8, 9] were installed at the outboard wall as well as at the pumping gap panels in module 4 (see figure 1) for monitoring depositions on these low loaded components. One of the edges of a SS probe holding the Si-wafer installed around the mid-plane was found to be molten. All the other probes were intact, despite some of these located on the pumping gap panels, being closer to the plasma. According to the mass of the molten SS, about 100 J for a second could melt the edge. Resulting from simulations with the ASCOT code [10], the melt event had occurred due to neutral beam injected fast ion orbit losses (see figure 9). The estimated fast ion heat load at this probe location is about 180 W which is sufficient for the observed melting. For future operations, no probe will be installed at this location, besides, in order to account for the plasma operations with reversed magnetic field, another probe at the mirror opposite location will be removed as well.

Figure 9. Estimations from the ASCOT code showing the heat loads due to the fast ions around the locations in module-4 where the Si-wafer was installed. The molten Si-wafer probe at location 10 (marked with a circle) received maximum loads above 180 W.
