Early degradation of silicon heterojunction PV modules installed on horizontal single-axis trackers in desert climate

A.A. Abdallah^{a,*}, M. Kivambe^a, M. Abdelrahim^a, M. Elgaili^a, A. Ahmed^a, K. Mroue^a, O. Stroyuk^b, O. Mashkov^b, I.M. Peters^b, C. Buerhop-Lutz^b

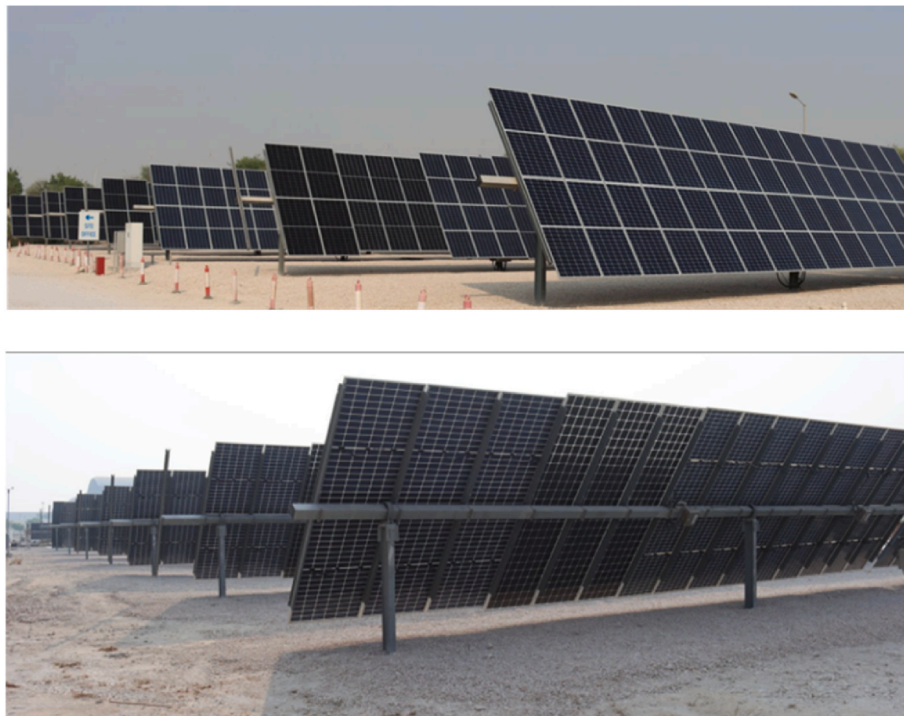
Fig. 1. Photographs of the front (top) and rear (bottom) of the Horizontal Single Axis (HSAT) testbed installed at the outdoor test facility (Doha, Qatar). Trackers 2, 4, and 6, each consisting of eight strings, will be the focus of this study.

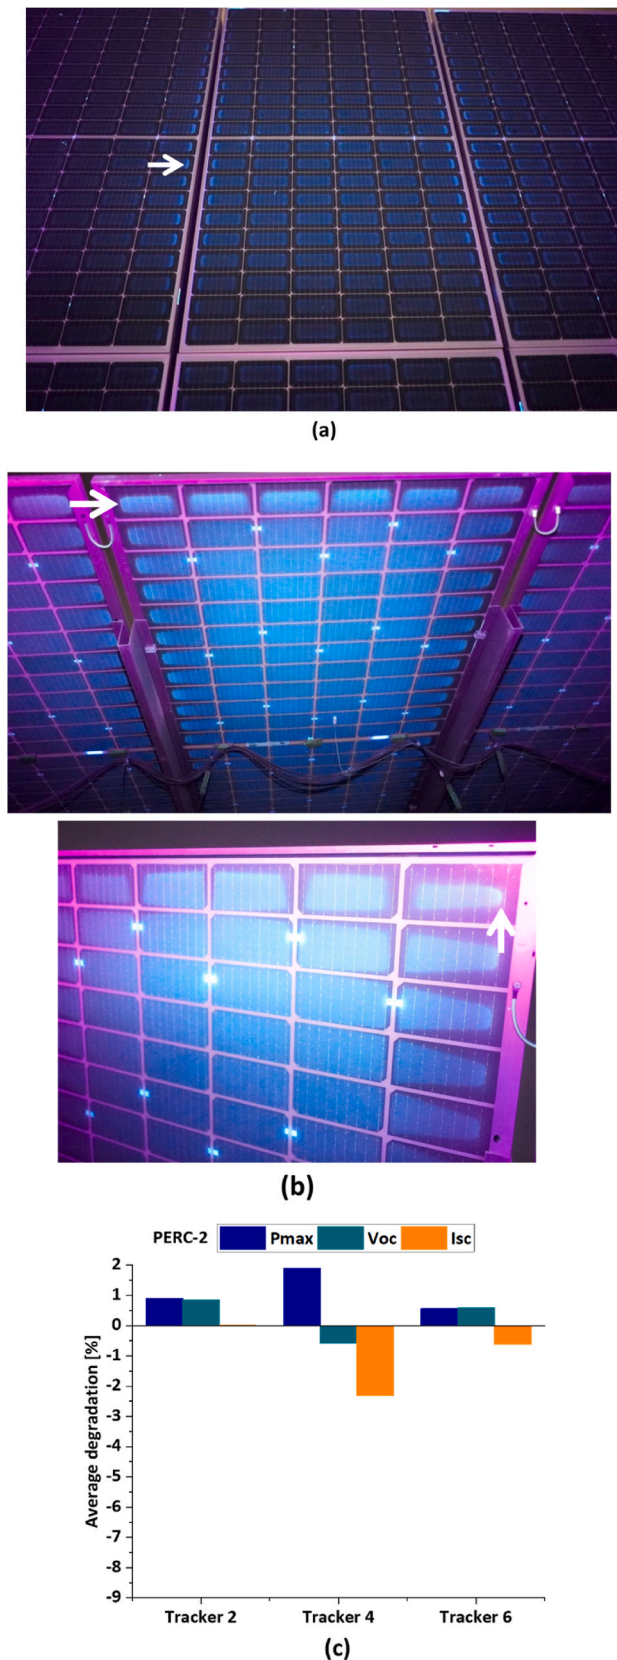
Fig. 4. Early degradation in bifacial PERC-2 PV modules with framed glass/glass configuration installed on trackers 2, 4, and 6: (a) UVF degradation pattern of the front side indicated by an arrow, (b) UVF pattern on the rear side indicated by an arrow, and (c) variations in the average measured electrical parameters P_{max} , I_{sc} , and V_{oc} .

The early aging of PV modules on trackers 2, 4, and 6 was detected by UVF imaging. Fig. 4a and b shows exemplary UVF degradation patterns observed at the front and rear sides of the framed glass/glass bifacial PERC technology. The UVF patterns at the front differ from those at the rear. The fluorescence intensity at the rear increases gradually towards the module edge. The appearance of gradients in the UVF patterns at the module edges (increase in fluorescence intensity toward the edge) most probably indicates the path of water and oxygen ingress. At that, the indoor EL images of these PV modules (not shown here) do not show any sign of degradation.

The bar plot in Fig. 4c shows the results of the indoor STC-measured

electrical parameters P_{max} , I_{sc} , and V_{oc} normalized to the datasheet values. The average change in the electrical parameters is within the measurement uncertainty of the Sun simulator $\pm 2\%$. Therefore, while the first changes of the encapsulant material are visible by UVF, no change in the PV module P_{max} is detected.

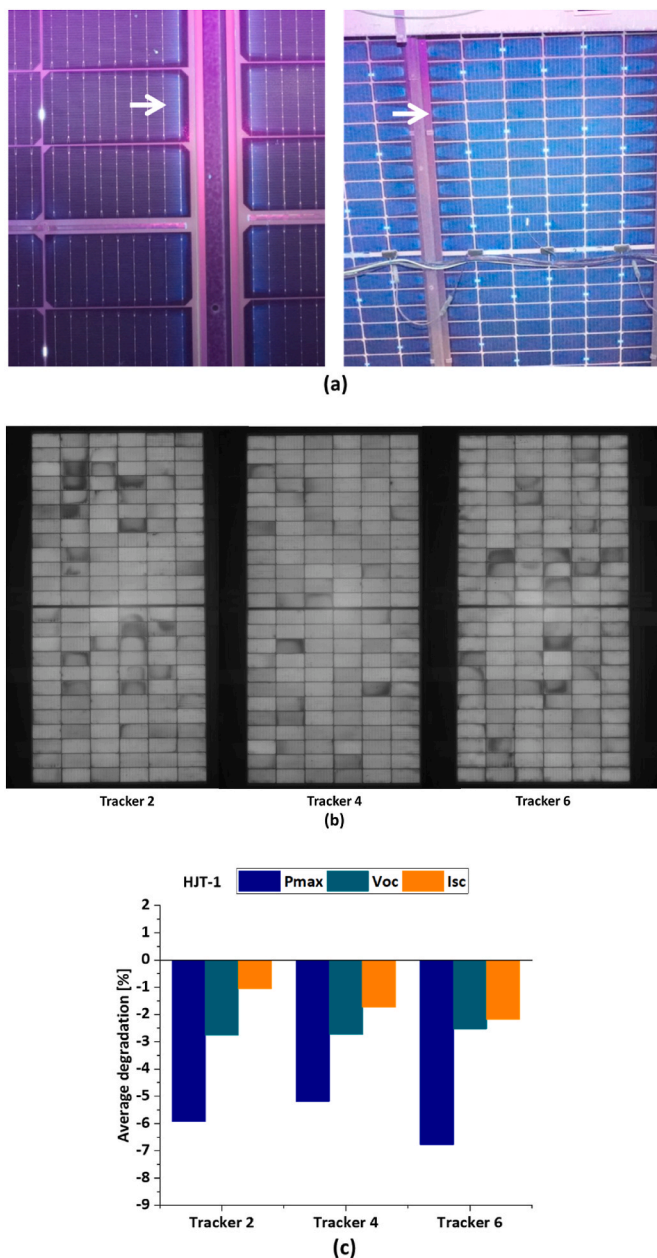
Fig. 6. Characteristics of bifacial framed glass/glass PV modules with the HJT-1 cell technology installed on trackers 2, 4, and 6: (a) UVF degradation pattern at the front (left) and at the rear (right) indicated by an arrow, (b) EL images of the modules from tracker 2, 4, and 6, (c) the average variation of P_{max} , I_{sc} , and V_{oc} normalized to the datasheet values.

Fig. 6 shows exemplary UVF patterns of the bifacial framed glass/glass module with HJT-1 cell technology. While the front side (Fig. 6a (left)) shows a weak UVF pattern at the edge, the rear side (Fig. 6a (right)) shows a strong UVF pattern with a gradual increase of the UVF intensity towards the edge. This non-uniform aging pattern indicates that the encapsulant has degraded more strongly at the module edges potentially due to the ingress of moisture and oxygen from the module edge accelerating the chemical and physical aging of the polymer encapsulant.

The EL images on Fig. 6b show cell mismatch (dark inactive cell areas). Fig. 6c shows a strong power loss, the P_{max} of the module from tracker 2, 4, and 6 drops by average -5.9% , which is associated with a drop on the V_{oc} . Therefore, we can conclude that both polymer and cell degradation are responsible for the power drop of the HJT-1 on tracker 2, 4 and 6.

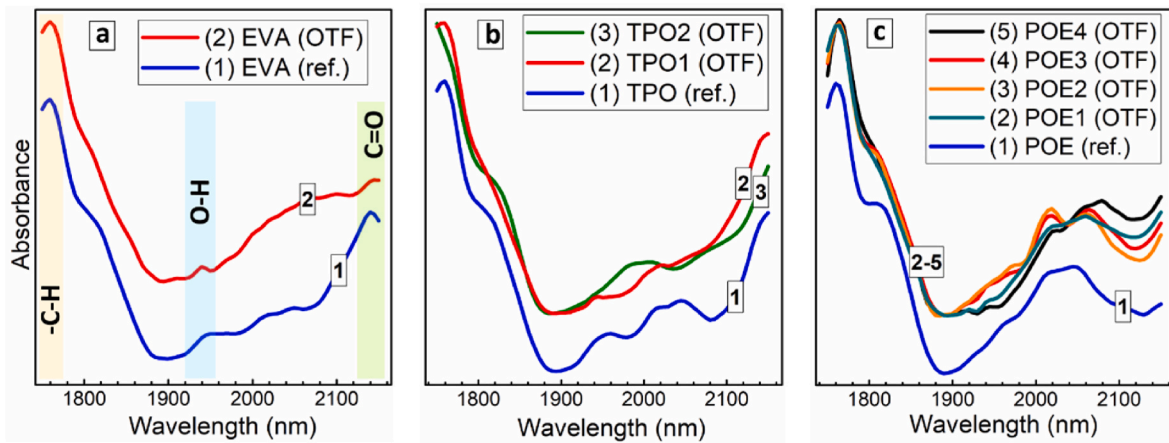
Fig. 8. Exemplary spectra of reference and field-registered (at the OTF) NIRA spectra of EVA, TPO, and POE encapsulants. Reference spectra are artificially shifted along the Y-axis.

Fig. 8a shows reference and field spectra of EVA encapsulants revealing characteristic vibrational bands of -C-H in aliphatic polyolefin backbone, O-H in adsorbed water, and carbonyl C=O in the acetate group, the latter unambiguously indicating that both spectra belong to the EVA encapsulant. Minor differences in the shape of the reference (Hanwha HEP-02T, 0.41 mm) and field spectra can be assigned to the effect of cross-linking in the case of the field sample.

Fig. 8b shows exemplary spectra of two types of TPO encapsulant (abbreviated as TPO1 and TPO2) identified based on the general similarity of the spectra to the reference TPO sample (Bettertrial TPO, 0.50 mm). While both TPO1 and TPO2 are similar to the reference, they show distinct differences in the fine structure of the spectra in the range of 1900–2050 nm. While the exact assignment of these bands comes beyond the scope of the present work, the differences can tentatively be related to variations in additive composition. The identification of these additives would require destructive sampling of polymers from a sacrificial module, which cannot be done for the present OTF still being
