# **Damage Detection in High-Pressure Storage Cylinders**

18th World Hydrogen Energy Conference 2010 - WHEC 2010

**Michael Sulatisky**, Dan Mourre, SRC, Saskatoon, Canada

**D. Robert Hay**, TISEC Inc., Montreal, Canada

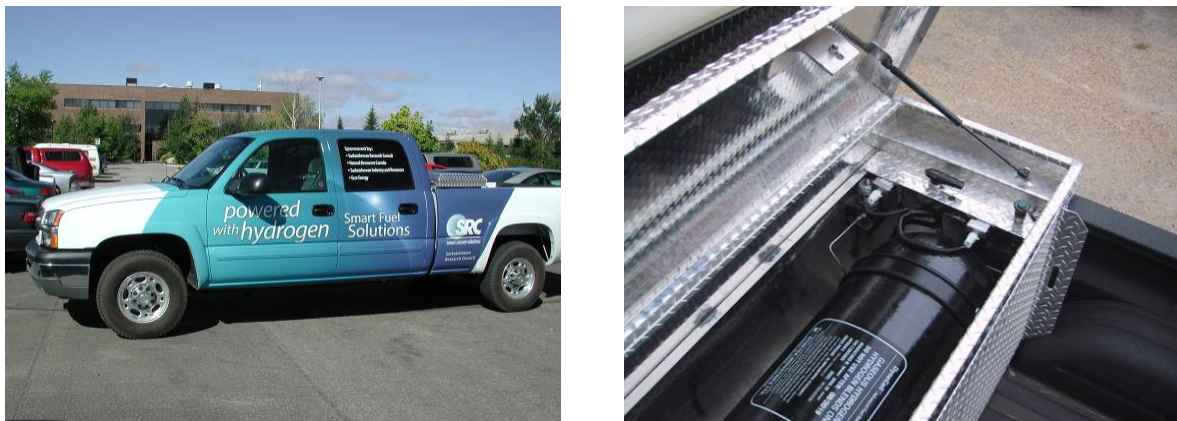
**Figure 1: Dual-fuel hydrogen-gasoline truck and storage tank installation.**

Gaseous fuels stored at pressures up to 700 bar (10,000 psig) have created a need for an on-line damage detection system similar to the on-board diagnostic system for detecting faults in automotive components [1, 2, 3, 4]. The goal was to develop a low-cost system for detecting cuts, holes, and delamination in tanks as shown in Figure 1.

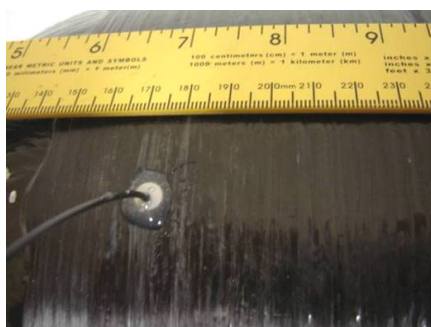
A piezoceramic disk sensor installation is shown in Figure 4, along with a sample waveform demonstrating an excellent signal-to-noise (SNR) ratio.

**Figure 4: Piezoceramic disk mounted on cylinder and signal-to-noise ratio.**

Wave-speed and attenuation characteristics were determined to identify a suitable sensor to generate and receive ultrasound efficiently while mounted on the surface of the tank. It was

found that the optimum long-range ultrasound frequency modes were 190 kHz and 322 kHz for axial and circumferential inspection, respectively. Damage detection tests evaluated the sensitivity of these frequency modes to parallel cuts, perpendicular cuts, small diameter holes, and mechanical impact damage. None of the damage introduced resulted in leakage from the tank.

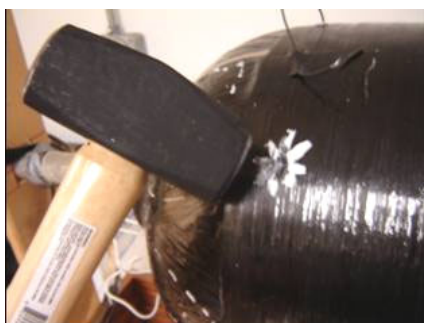
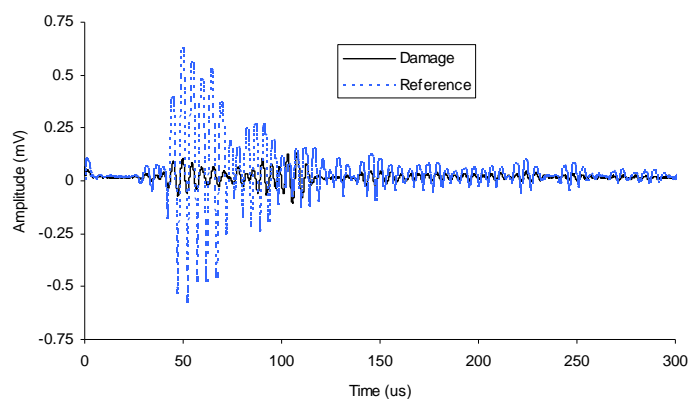
The damage detection result for impact using a hammer is shown in Figures 5. In this figure the reference waveform acquired before impact is shown as a blue dashed line, and the data acquired after damage is shown as a solid black line which is greatly attenuated. The test setup demonstrates that it is possible to detect damage located midway in the cylinder using sensors on opposite ends of the cylinder.

**Figure 5: Inflicting impact damage and pre/post wave form.**

Transverse cuts and axial notches, 3-mm diameter drilled holes, and impact damage via steel mallet were introduced into a cylinder at various locations. A 1.5-mm thick grinding wheel was used to cut the notches, and a 3-mm diameter drill bit was used to cut a hole 5-mm deep into the carbon-fiber composite material without cutting through.
