Development of corrosion protection layers for current collectors

G. Teucher, M. Krott, T. Van Gestel, S. Uhlenbruck, R.-A. Eichel, H.P. Buchkremer Forschungszentrum Jülich GmbH, Institut für Energie- und Klimaforschung IEK-1, Jülich, Germany

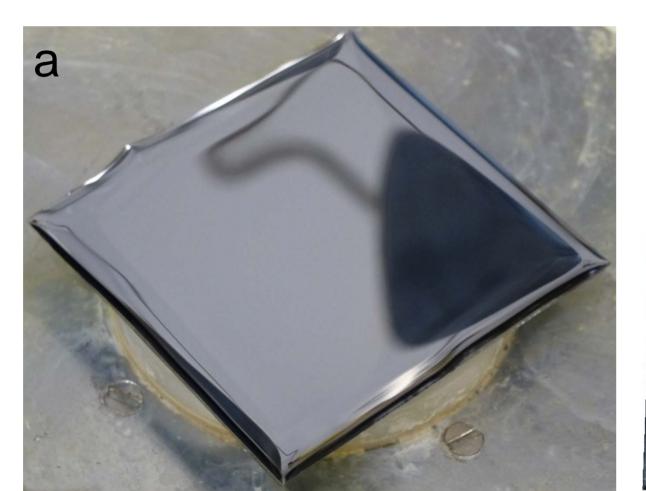
Figure 2 a: Sol wetted silicon wafer (5x5 cm²) using 0.15 M ethanolic solution of stabilized particles (sizes 0.7...7 nm).

Figure 2 b: Photo after 2x spin-coating and heat treatment at 500 °C (10 min).
