## Direct comparative test of single crystal and polycrystalline diagnostic mirrors exposed in TEXTOR in erosion conditions

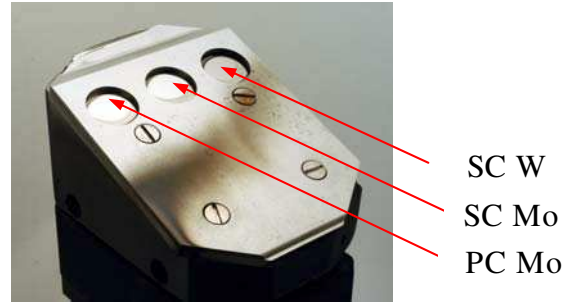
Fig. 1. The limiter with mirrors after exposure in the SOL of TEXTOR

For the exposure all three mirrors were placed in a row on the specially instrumented limiter. The limiter with mirrors was exposed in the SOL plasma of TEXTOR under erosion-dominated conditions in the same plasma environment. 36 NBI-heated plasma discharges were carried out with total duration of 210 seconds. Optical pyrometers were used to monitor the temperature of mirrors. The temperature of the limiter was measured with thermocouples and was varying between 200°C and 270°C degrees during the exposure. Electron density and temperature were measured with He beam diagnostic. The energy of D<sup>+</sup> ions impinging the surface of mirrors was in the range of 200 - 250 eV. Ion flux density was  $2.4 \cdot 10^{18}$  ion/(cm<sup>2</sup>\*sec) which is approximately 25000 times larger than expected for flux of CX neutrals on the first wall in ITER [5]. Total fluence averaged over mirror surface was  $1.7 \cdot 10^{20}$  ion/cm<sup>2</sup>, which corresponds to more than 1000 ITER discharges. The limiter with mirrors after the exposure is shown on Fig. 1.

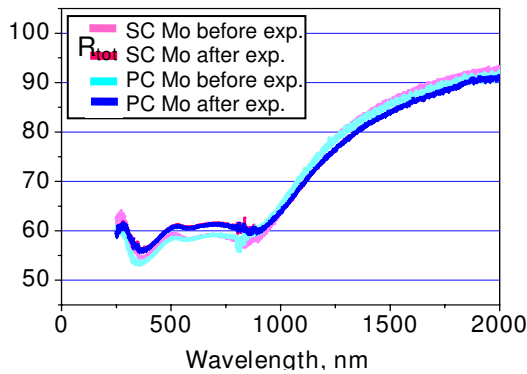
Fig.2. Total reflectivity of molybdenum mirrors before and after exposure

The total reflectivity of mirrors was measured after exposure on the same locations as before it. The results are shown in Fig. 2. The total reflectivity of both mirrors didn't change much under erosion conditions. In turn, the effect of erosion on diffuse reflectivity was dramatic. The dependence of diffuse reflectivity on wavelength is plotted on Fig. 3. For the

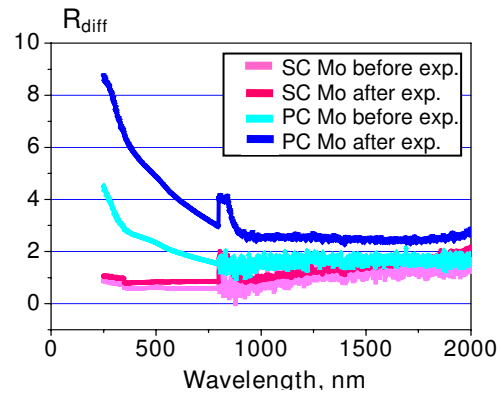
Fig. 3. Diffuse reflectivity of molybdenum mirrors before and after exposure

polycrystalline Mo mirror there is a drastic increase of diffuse reflectivity, especially pronounced in the region 250-1000 nm. For the SC mirror the diffuse reflectivity remains unchanged.

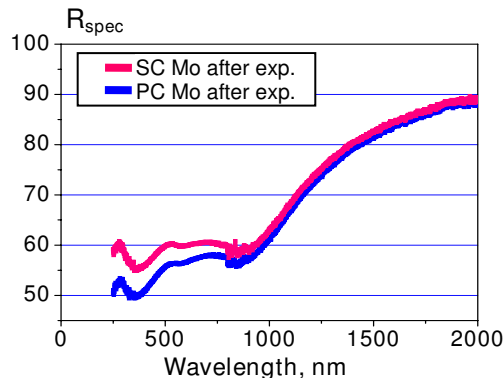
Fig.4. Specular reflectivity of molybdenum mirrors after exposure

Specular reflectivity plots  $R_{spec} = R_{tot} - R_{diff}$  are shown in Fig.4. In fact, the specular reflectivity is one of the most important characteristics of a diagnostic mirror for ITER, since it sets the amplitude of signal transmitted from plasma radiation towards the detecting hardware. As it can be inferred from the Fig. 4, the SC Mo mirror keeps its specular reflectivity while the reflectivity of polycrystalline molybdenum mirror is significantly deteriorated after exposure. The reason for this deterioration is an increase of diffuse reflectivity, likely caused by the surface relief of polycrystalline mirrors. Indeed, Scanning Electron Microscope (SEM) photos showed the presence of so-called “step-structure” [6] on the polycrystalline mirror, while single crystal remained plain after erosion.

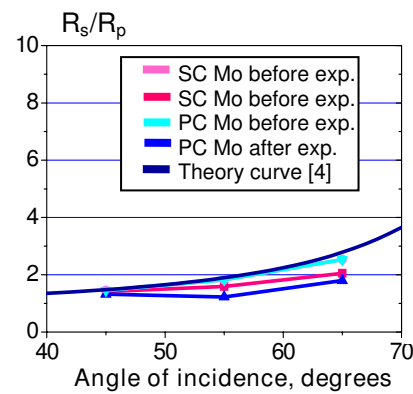
Fig.5. Polarization at different angles of incidence.  $R_p$  and  $R_s$  are parallel and perpendicular components of light vector respectively.

Polarization measurements were made for the parallel  $R_p$  and perpendicular  $R_s$  components of the light vector in dependence on wavelength and on the angle of incidence. In both cases, measurements revealed little or no effect of erosion on polarization characteristics. Some results are plotted in Fig. 5 as an example. As it can be observed from the Fig. 5, the measured values are in good agreement with theory predictions [5].
