The purpose of this study was to employ suspension plasma spraying (SPS) to produce various coatings with columnar microstructure and to assess the possibility of increasing the efficiency of diesel engines with this type of coatings. Both coatings with a sealing layer and without a sealing layer were investigated in this study. The targeted industrial application of the coatings investigated in this study was diesel engines for heavy-duty vehicles, but the results can be applied to other engines.

## 2. Material and methods

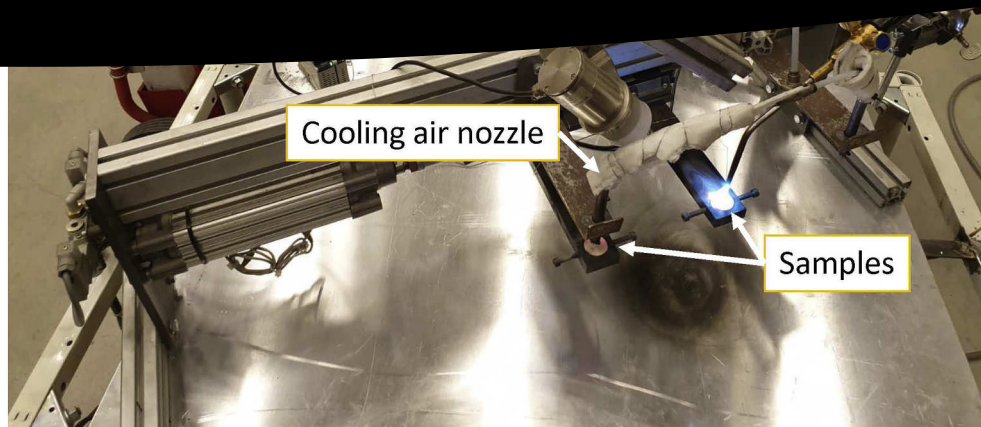
Fig. 3. Flame rig test.

To complement the TCF tests, a flame rig test, Fig. 3, was designed and performed in collaboration with Jönköping University, Sweden. For this test, two samples from each set of the coatings were used.

The equipment consists of two sample holders mounted on a frame that can move transversally, an oxy-acetylene flame torch that is used for heating the samples from the top side, and two cooling nozzles symmetrically distributed to the flame torch for cooling the samples with compressed air, as shown in Fig. 3. To perform the test, the two samples are placed in the sample holders and cyclically moved from the flame torch to one of the cooling nozzles, depending on which side of the torch the sample is, and keeping the same cooling/heating time for all tested samples. Therefore, while one sample is heated for 6 s from the top using an oxyacetylene flame up to a temperature of approximately 700 °C, the second sample is cooled with compressed air to a temperature of approximately 600 °C. In the next step, the sample that was heated up moves to the cooling nozzle (situated on the other side of the torch) while the sample that was cooled moves to the torch for heating, completing thus a heating-cooling cycle [18].

The temperature change of the coating was measured using a K-type thermocouple installed on the side of the sample and logged every 100 ms using a Keyence NR-H7W instrument. The oxy-acetylene torch nozzle used for this test was operated at a gas flow of 315 L/h. Monitoring the “cleanness” of the torch was essential because the oxyacetylene burning process can form soot on the tip of the torch, which in turn affects the shape of the flame and hence the heat distribution on the surface of the sample. Cleaning of the torch was performed after every 500 cycles with pressurized air.

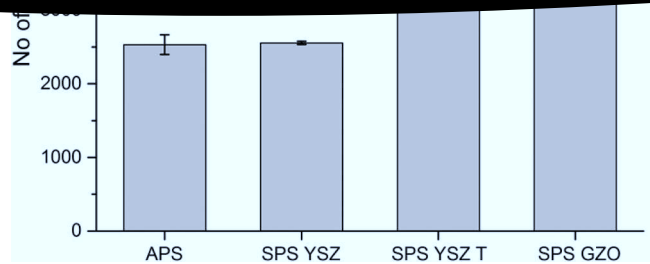
**Fig. 16.** Number of cycles for first and second architecture of top coat samples flame rig test.

The flame rig test results of the samples with first and second architecture are shown in Fig. 16. The longest lifetime in this test was obtained by the SPS YSZ T sample, which showed no failure signs after 6000 cycles. The second-highest lifetime was observed for the SPS GZO sample followed by the thin SPS YSZ, while the APS sample exhibited the shortest lifetime.
