TESTING AND EVALUATION OF THERMAL BARRIER COATINGS

Robert Vaßen¹, Yutaka Kagawa², Ramesh Subramanian³, Paul Zombo³, Dongming Zhu⁴

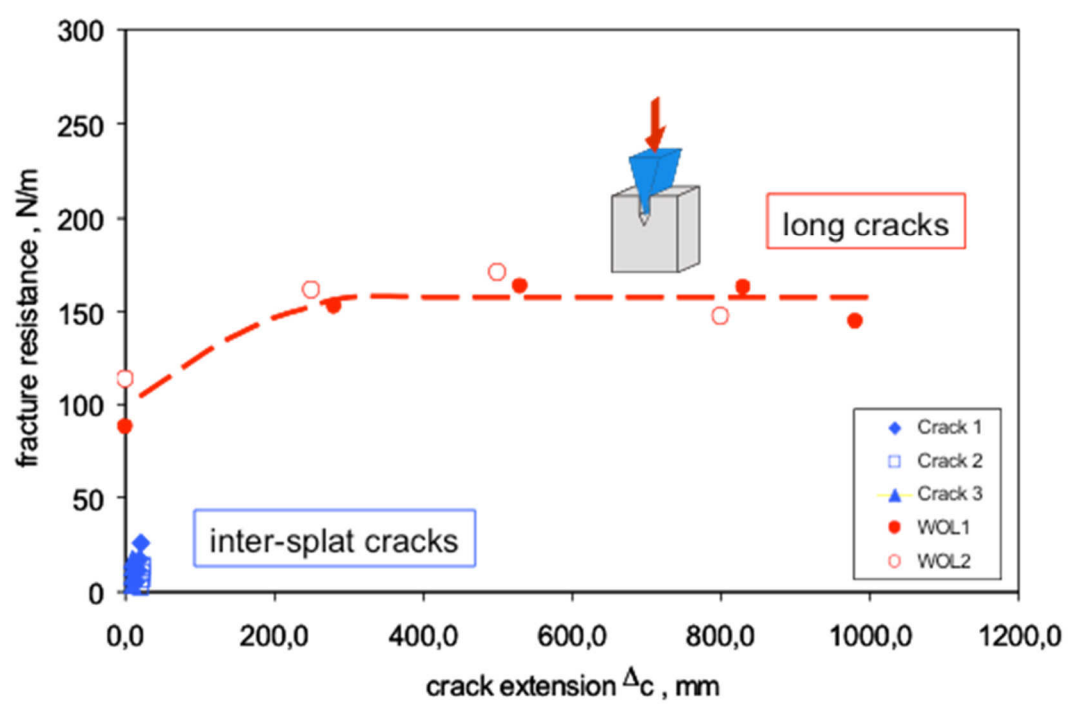
1. Crack resistance of inter-splat cracks and R-curve from extension of long delamination cracks in WOL (wedge opening loading).
2. Photograph of the Julich gas burner rig heating a disk-shaped TBC sample with back-side compressed air cooling. In the central part of the flame a solution of CMAS is injected to spray it onto the hot-surface.
3. Laser heat flux thermal gradient cyclic test results of a 127 μm thick, precracked TBC specimen subject to 20 min heating and 4 min cooling thermal cycling. The initial circular crack was 2 mm

is unusually high for an oxide and has recently been attributed to ferroelastic domain switching [8]. Understanding the toughening processes in YSZ also provides guidance for the selection and design of new TBC materials with enhanced toughness levels. One of the surprising results of recent measurements has been that fracture toughness for long cracks in TBCs, for instance those associated with coating delamination, is three to four times higher than the intrinsic toughness, as illustrated in Fig. 1. While it has always been recognized that microstructure must play a role in the fracture of TBCs the magnitude of the toughening enhancement, of the order of 150 N/m [9] and extent of the R-curve (rising toughness) is considerably larger than anticipated. The origin of the R-curve in plasma-sprayed and electron-beam physical vapor deposited (EB-PVD) TBCs is now known to differ in detail but is essentially due to local crack deflections resulting in a tortuous crack path forming microstructural heterogeneities whose relative motion during crack propagation results in friction. Details on crack path and toughening mechanisms are discussed in Refs. [9, 10].

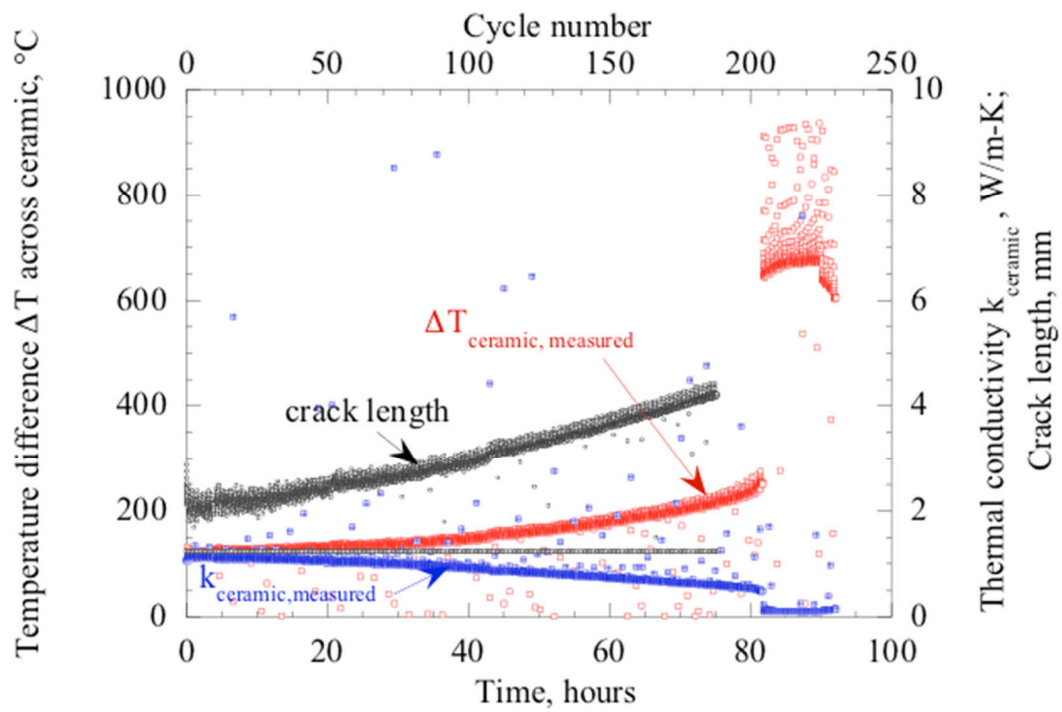
in diameter. The effective thermal conductivity clearly correlates with the crack propagation until the coating spalled after 200 cycles.

Since the initial development of the steady-state CO₂ laser (wavelength 10.6 μm) test facility at NASA and its application to measuring the sintering of coatings and thermal conductivity, for instance [14, 15, 16], its capabilities have subsequently been extended. Amongst the most recent is evaluating interface crack propagation under extreme heat flux, cyclic loading conditions [17] such as might occur during repeated aircraft take-off. Figure 3 shows the test results of a 127 μm thick, precracked TBC specimen. The initial ceramic surface temperature was set at approximately 1287°C and 20-min heating/cooling cycles and 60 to 100 W/cm² heat flux. The coating surface temperature increased continuously as the crack propagates, whereas the metal backside temperature remained relatively constant. The apparent coating thermal conductivity, calculated from the known laser heat flux, decreases as the delamination crack grew until the test was interrupted by spallation of the coating after about 200 cycles. The crack propagation process has also been monitored independently by a high sensitivity video camera, for calibrating the crack propagation with cycles. From these data, the crack propagation rate (da/dN) and the laser thermal transient stress associated stress intensity factor amplitude (ΔK) for a plasma sprayed 7-8YSZ were also determined [17]. The results show slower thermal fatigue crack propagation rates compared to monolithic ceramics indicative of additional R-curve toughening effects due to the roughness and plasticity at or near the ceramic/metal interface.

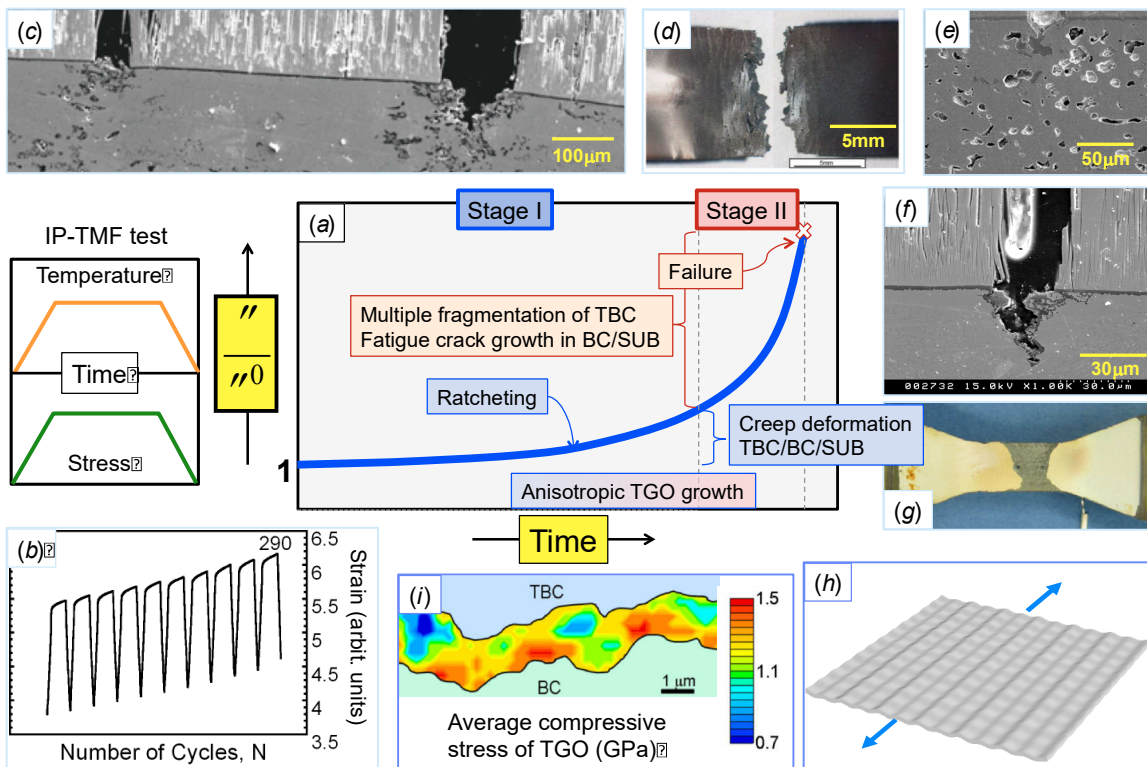
4. Examples of typical behavior and damages in a EB-PVD TBC system during in-phase TMF testing mode: (a) creep curve, (b) ratcheting behavior, (c) TBC layer cracking (polished section, parallel to loading axis), (d) multiple fragmentation of TBC layer, (e) void formation in BC layer, (f) fatigue crack growth and new TGO formation in BC layer, (g) delamination of TBC layer, (h) illustration of anisotropic TGO morphology (arrow, loading direction), (i) example of stress distribution in TGO layer.

only now being addressed. Even so there have been surprises. One is that contrary to initial expectation, compressive deformation is the major form of damage in strain-controlled in-phase and stress-controlled out-of-phase modes [22]. Another is that cracks can nucleate in the bond-coat at high-temperatures and propagate into the superalloy. Figure 4 illustrates several of the loading configurations and characteristic damage accumulation behavior in EB-PVD TBC systems under in-phase stress-controlled TMF test mode [23, 24]. Stress/strain-time, and numbers of loading cycles, under in-phase TMF test conditions are consistent with the creep behavior of superalloys, as reported elsewhere (Fig. 4a). Ratcheting behavior superimposes on the creep behavior as illustrated in Fig. 4b. This behavior is consistent with most of the applied load being supported by the superalloy. However, the creep behavior of the EB-PVD TBC layer is interesting: at 1150 °C the layer can deform up to about 8% tensile strain without evidence of visible cracking [25]. With increasing tensile creep strain, cracking of the TBC layer initiates, and ultimately, multiple fragmentation behavior occurs, as seen in Figs. 4c and 4d. It is found that the cracks in the TBC layer do not propagate through the entire thickness and the spacing (Fig. 4d) is much smaller than that predicted using continuum mechanics [26]. In addition, TMF tests on samples with a center-hole clearly demonstrate that cracking is related to tensile stress/strain concentrations [24]. Following cracking of the TBC layer, void formation in the bond coat below the cracks can occur and new oxide forms in the exposed alloy. The width of the cracks in the TBC layer typically has a wide distribution and the cracks below the cracked TBC layer propagate to different depths (Figs. 4c and 4f). The evidence suggests that there is a sequence of cracking in the TBC oxide. After cracking of the TBC, the life is similar to that of the bare superalloy. Another form of damage is the large area delamination where the bond-coat and superalloy are locally exposed to higher temperatures (Fig. 4g).

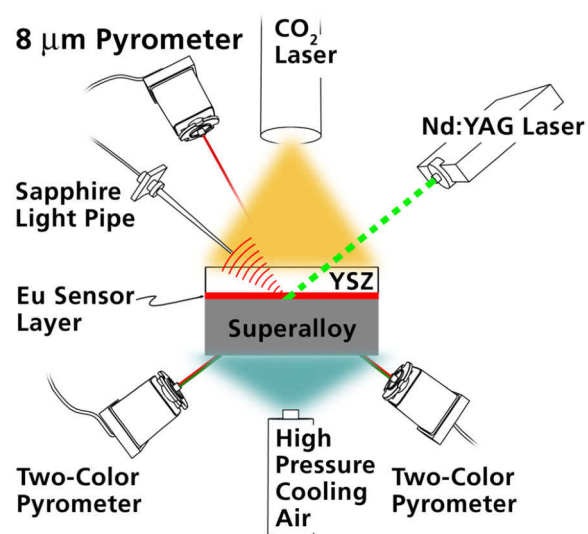
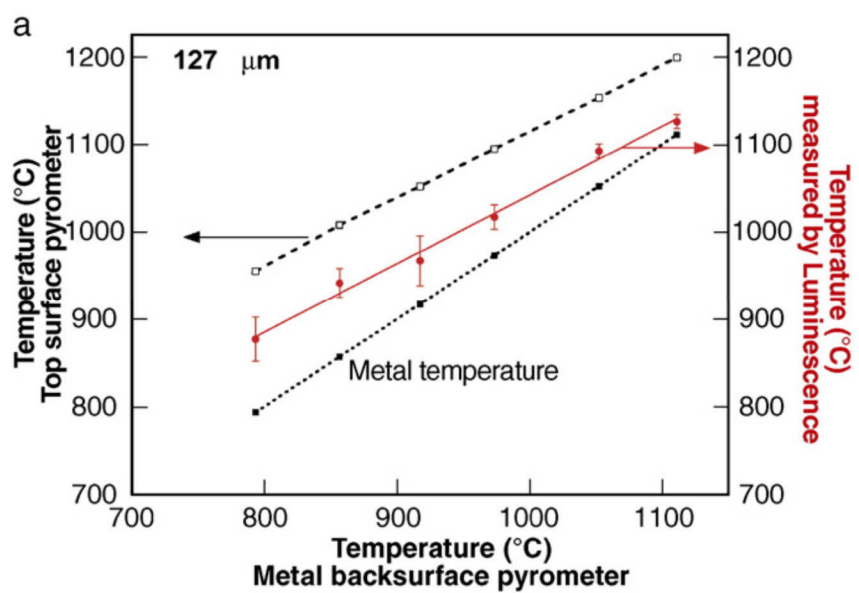
5. (a) Experimental setup for measuring the thermal barrier coating/metal interface temperature through the TBC by luminescence under laser high heat flux thermal gradient tests [27]. (b) TBC interface temperature measured as function of TBC surface and metal back surface temperatures with various heat fluxes, for two EB-PVD coating thicknesses. A good correlation of the sensor measurements with the heat flux measurements have been observed with the embedded Eu-YSZ sensor at high temperature [27, 31].

temperature [27, 28, 29, 30]. It deals with using luminescence to monitor delamination. In this method, luminescent rare-earth ions are incorporated into the crystal structure of the YSZ coating during deposition of the coating so that they are localized, for instance, at the ceramic top-coat/TGO interface and then again at the top-coat surface. Then, at temperature their luminescence is stimulated by a pulsed laser and the excited luminescence collected and its luminescence decay monitored. In addition to being a non-contact method, the rare-earth dopant can also be localized to a smaller depth than the optical penetration depth in optical pyrometry giving superior depth resolution. This temperature sensing methodology has recently been demonstrated using an EB-PVD 7YSZ TBCs [27, 30, 31]. The experiment setup is illustrated in Fig. 5A. A solid-state frequency doubled YAG:Nd laser emitting at 532 nm illuminates the center of the coating surface, while the main high heat flux CO₂ laser was used for heating the specimens under large thermal gradients. A sapphire light pipe was positioned to collect the excited luminescence signal during the testing. Figure 5B shows the luminescence sensor measured real-time interface temperature under various heat flux conditions, demonstrating the ability to collect luminescence from a thin embedded sensor layer in a thermal barrier coating systems under high temperature thermal gradients.

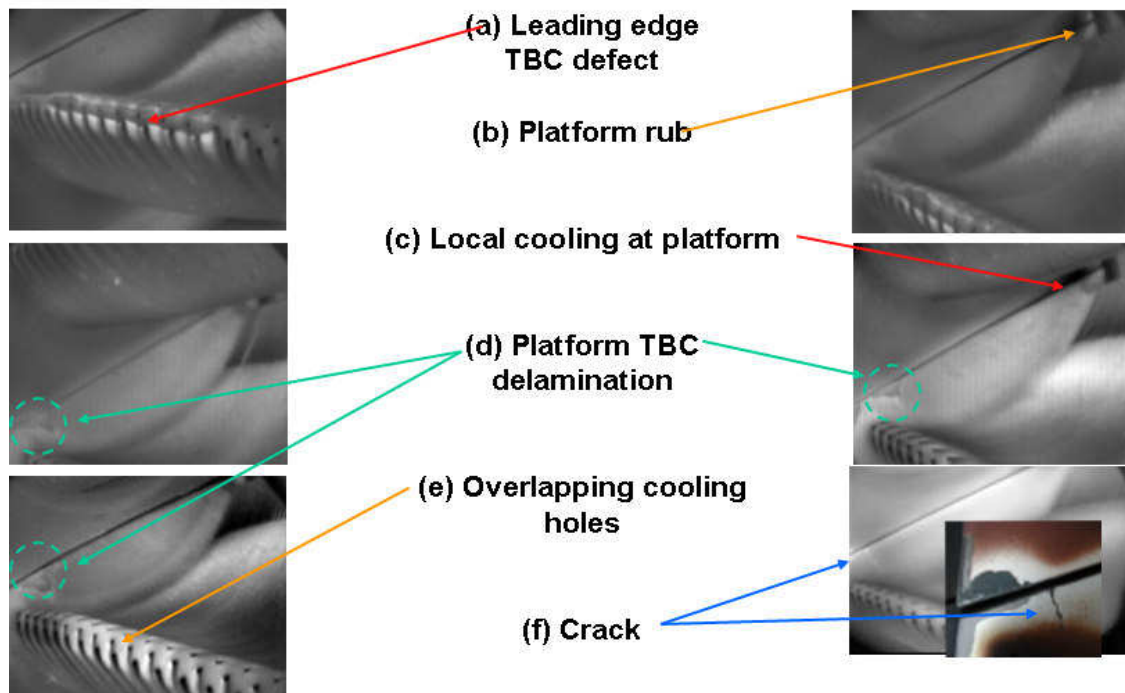
6. Example of possible features observed by an IR camera, during engine operation, at 3600 rpm with gas path temperatures higher than 1200 °C. Pictures are “still” frames of rotating blades.

Radiation reaching the detector includes contributions from three sources: 1) radiation emitted from the surface of the turbine component being imaged, 2) reflected radiation included from particulates in the gas stream as well as, 3) radiation emitted from hot gases and particles in the field of view. A methodology was developed to overcome these hurdles and finally perform the surface temperature measurements. Figure 6 illustrates features that can be seen during the engine operation using state-of-the-art focal plane arrays with advanced software imaging. These include (a) TBC spallation on the leading edge of the blade as seen by dark edge of TBC, (b) local heating due to platform rub – bright feature near rub, (c) local cooling at platform – dark due to cooling air leakage (d) Platform TBC delamination, observed as bright/dark line corresponding to a buckled TBC, (e) overlapping cooling holes, with the dark cooling streams are not giving good coverage and (f) Platform TBC crack observed as a faint bright line, verified by visual picture shown in the inset in Fig. 6.
