TESTING AND EVALUATION OF THERMAL BARRIER COATINGS

Abstract

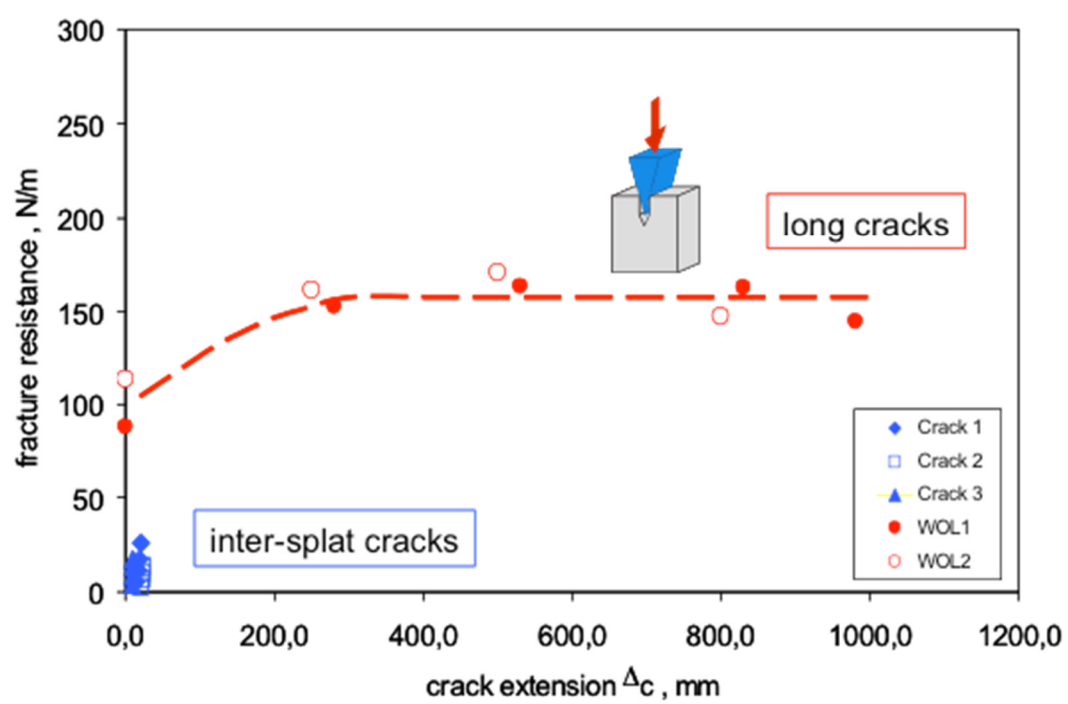
1. Crack resistance of inter-splat cracks and R-curve from extension of long delamination cracks in WOL (wedge opening loading).
2. Photograph of the Julich gas burner rig heating a disk-shaped TBC sample with back-side compressed air cooling. In the central part of the flame a solution of CMAS is injected to spray it onto the hot-surface.
3. Laser heat flux thermal gradient cyclic test results of a 127 μm thick, precracked TBC specimen subject to 20 min heating and 4 min cooling thermal cycling. The initial circular crack was 2 mm

is unusually high for an oxide and has recently been attributed to ferroelastic domain switching [8]. Understanding the toughening processes in YSZ also provides guidance for the selection and design of new TBC materials with enhanced toughness levels. One of the surprising results of recent measurements has been that fracture toughness for long cracks in TBCs, for instance those associated with coating delamination, is three to four times higher than the intrinsic toughness, as illustrated in Fig. 1. While it has always been recognized that microstructure must play a role in the fracture of TBCs the magnitude of the toughening enhancement, of the order of 150 N/m [9] and extent of the R-curve (rising toughness) is considerably larger than anticipated. The origin of the R-curve in plasma-sprayed and electron-beam physical vapor deposited (EB-PVD) TBCs is now known to differ in detail but is essentially due to local crack deflections resulting in a tortuous crack path forming microstructural heterogeneities whose relative motion during crack propagation results in friction. Details on crack path and toughening mechanisms are discussed in Refs. [9, 10].

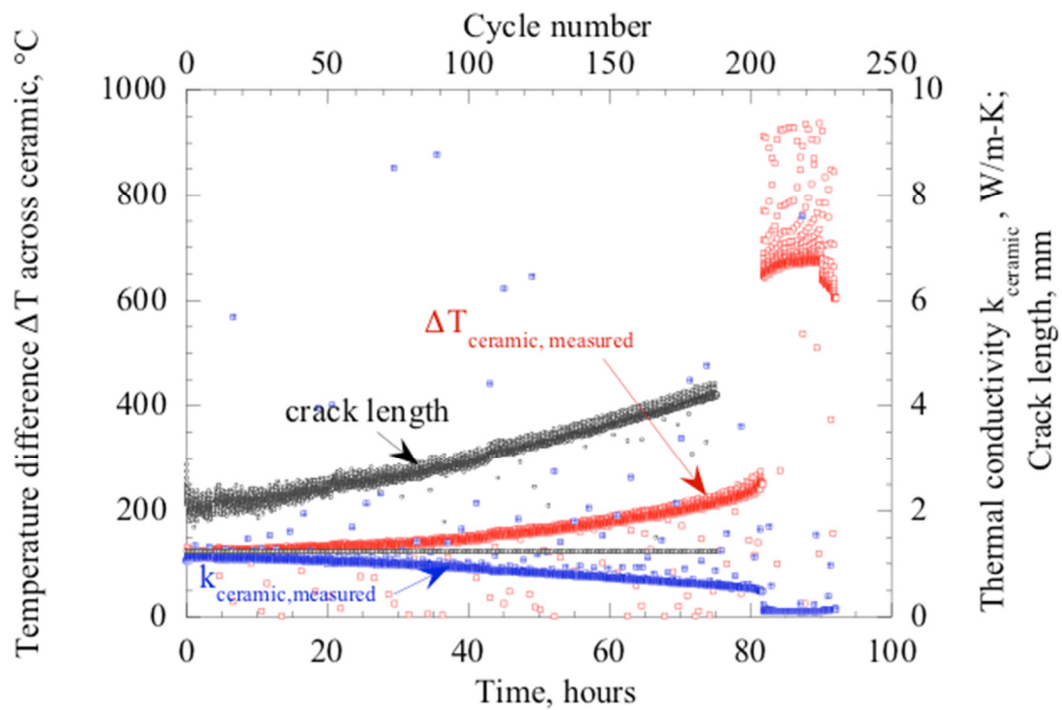
in diameter. The effective thermal conductivity clearly correlates with the crack propagation until the coating spalled after 200 cycles.

Since the initial development of the steady-state CO₂ laser (wavelength 10.6 μm) test facility at NASA and its application to measuring the sintering of coatings and thermal conductivity, for instance [14, 15, 16], its capabilities have subsequently been extended. Amongst the most recent is evaluating interface crack propagation under extreme heat flux, cyclic loading conditions [17] such as might occur during repeated aircraft take-off. Figure 3 shows the test results of a 127 μm thick, precracked TBC specimen. The initial ceramic surface temperature was set at approximately 1287°C and 20-min heating/cooling cycles and 60 to 100 W/cm² heat flux. The coating surface temperature increased continuously as the crack propagates, whereas the metal backside temperature remained relatively constant. The apparent coating thermal conductivity, calculated from the known laser heat flux, decreases as the delamination crack grew until the test was interrupted by spallation of the coating after about 200 cycles. The crack propagation process has also been monitored independently by a high sensitivity video camera, for calibrating the crack propagation with cycles. From these data, the crack propagation rate (da/dN) and the laser thermal transient stress associated stress intensity factor amplitude (ΔK) for a plasma sprayed 7-8YSZ were also determined [17]. The results show slower thermal fatigue crack propagation rates compared to monolithic ceramics indicative of additional R-curve toughening effects due to the roughness and plasticity at or near the ceramic/metal interface.

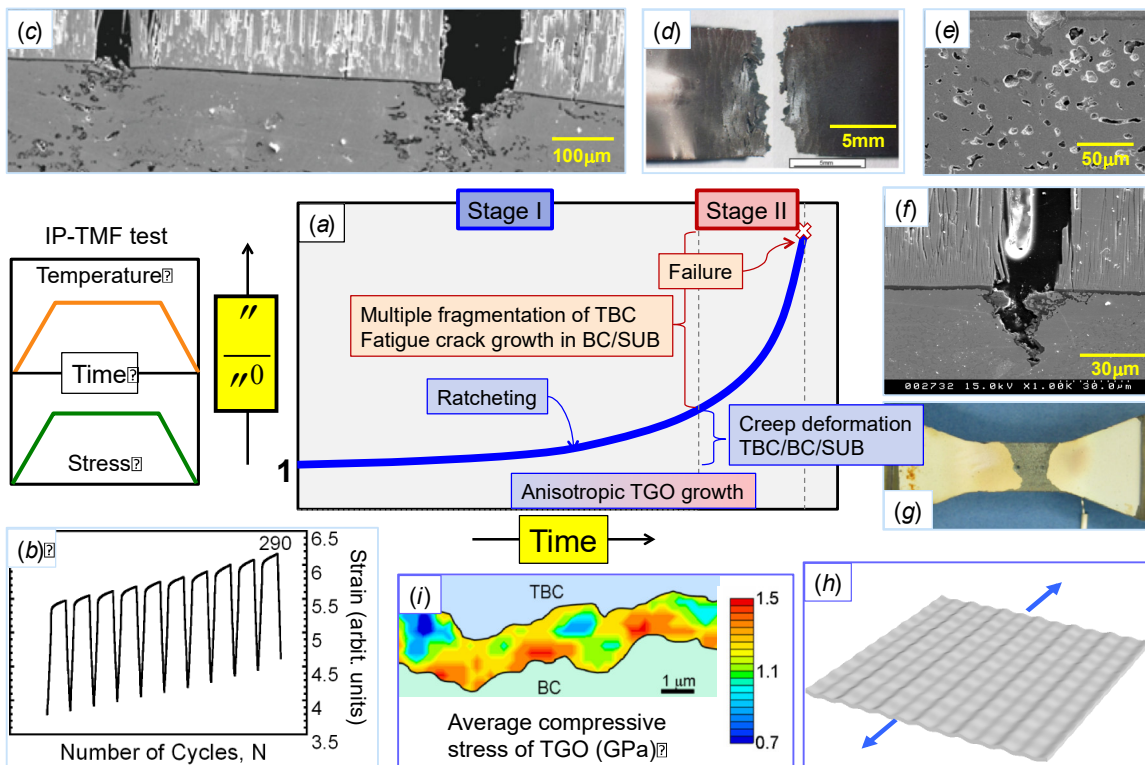
4. Examples of typical behavior and damages in a EB-PVD TBC system during in-phase TMF testing mode: (a) creep curve, (b) ratcheting behavior, (c) TBC layer cracking (polished section, parallel to loading axis), (d) multiple fragmentation of TBC layer, (e) void formation in BC layer, (f) fatigue crack growth and new TGO formation in BC layer, (g) delamination of TBC layer, (h) illustration of anisotropic TGO morphology (arrow, loading direction), (i) example of stress distribution in TGO layer.

only now being addressed. Even so there have been surprises. One is that contrary to initial expectation, compressive deformation is the major form of damage in strain-controlled in-phase and stress-controlled out-of-phase modes [22]. Another is that cracks can nucleate in the bond-coat at high-temperatures and propagate into the superalloy. Figure 4 illustrates several of the loading configurations and characteristic damage accumulation behavior in EB-PVD TBC systems under in-phase stress-controlled TMF test mode [23, 24]. Stress/strain-time, and numbers of loading cycles, under in-phase TMF test conditions are consistent with the creep behavior of superalloys, as reported elsewhere (Fig. 4a). Ratcheting behavior superimposes on the creep behavior as illustrated in Fig. 4b. This behavior is consistent with most of the applied load being supported by the superalloy. However, the creep behavior of the EB-PVD TBC layer is interesting: at 1150 °C the layer can deform up to about 8% tensile strain without evidence of visible cracking [25]. With increasing tensile creep strain, cracking of the TBC layer initiates, and ultimately, multiple fragmentation behavior occurs, as seen in Figs. 4c and 4d. It is found that the cracks in the TBC layer do not propagate through the entire thickness and the spacing (Fig. 4d) is much smaller than that predicted using continuum mechanics [26]. In addition, TMF tests on samples with a center-hole clearly demonstrate that cracking is related to tensile stress/strain concentrations [24]. Following cracking of the TBC layer, void formation in the bond coat below the cracks can occur and new oxide forms in the exposed alloy. The width of the cracks in the TBC layer typically has a wide distribution and the cracks below the cracked TBC layer propagate to different depths (Figs. 4c and 4f). The evidence suggests that there is a sequence of cracking in the TBC oxide. After cracking of the TBC, the life is similar to that of the bare superalloy. Another form of damage is the large area delamination where the bond-coat and superalloy are locally exposed to higher temperatures (Fig. 4g).

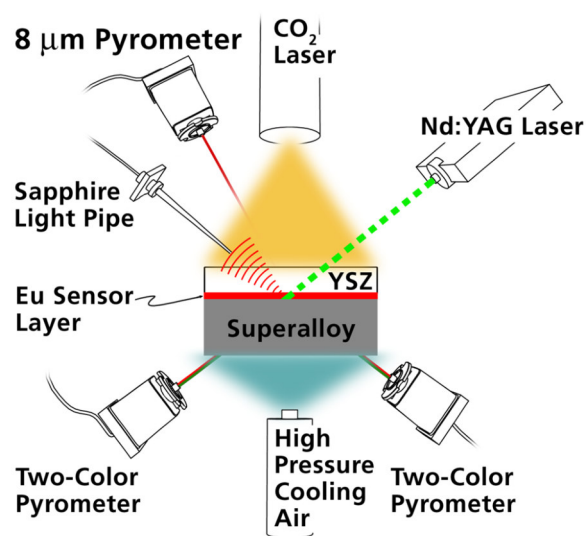
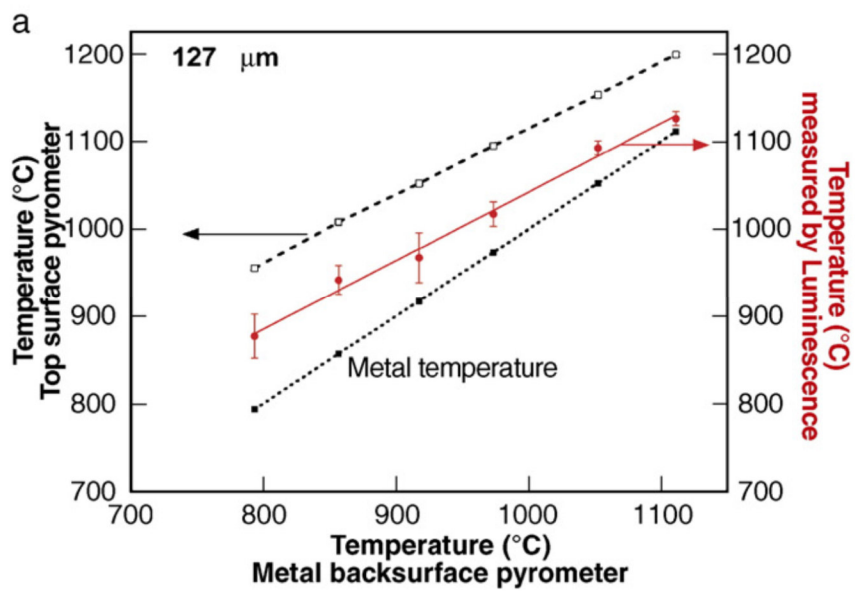
5. (a) Experimental setup for measuring the thermal barrier coating/metal interface temperature through the TBC by luminescence under laser high heat flux thermal gradient tests [27]. (b) TBC interface temperature measured as function of TBC surface and metal back surface temperatures with various heat fluxes, for two EB-PVD coating thicknesses. A good correlation of the sensor measurements with the heat flux measurements have been observed with the embedded Eu-YSZ sensor at high temperature [27, 31].

temperature [27, 28, 29, 30]. It deals with using luminescence to monitor delamination. In this method, luminescent rare-earth ions are incorporated into the crystal structure of the YSZ coating during deposition of the coating so that they are localized, for instance, at the ceramic top-coat/TGO interface and then again at the top-coat surface. Then, at temperature their luminescence is stimulated by a pulsed laser and the excited luminescence collected and its luminescence decay monitored. In addition to being a non-contact method, the rare-earth dopant can also be localized to a smaller depth than the optical penetration depth in optical pyrometry giving superior depth resolution. This temperature sensing methodology has recently been demonstrated using an EB-PVD 7YSZ TBCs [27, 30, 31]. The experiment setup is illustrated in Fig. 5A. A solid-state frequency doubled YAG:Nd laser emitting at 532 nm illuminates the center of the coating surface, while the main high heat flux CO₂ laser was used for heating the specimens under large thermal gradients. A sapphire light pipe was positioned to collect the excited luminescence signal during the testing. Figure 5B shows the luminescence sensor measured real-time interface temperature under various heat flux conditions, demonstrating the ability to collect luminescence from a thin embedded sensor layer in a thermal barrier coating systems under high temperature thermal gradients.

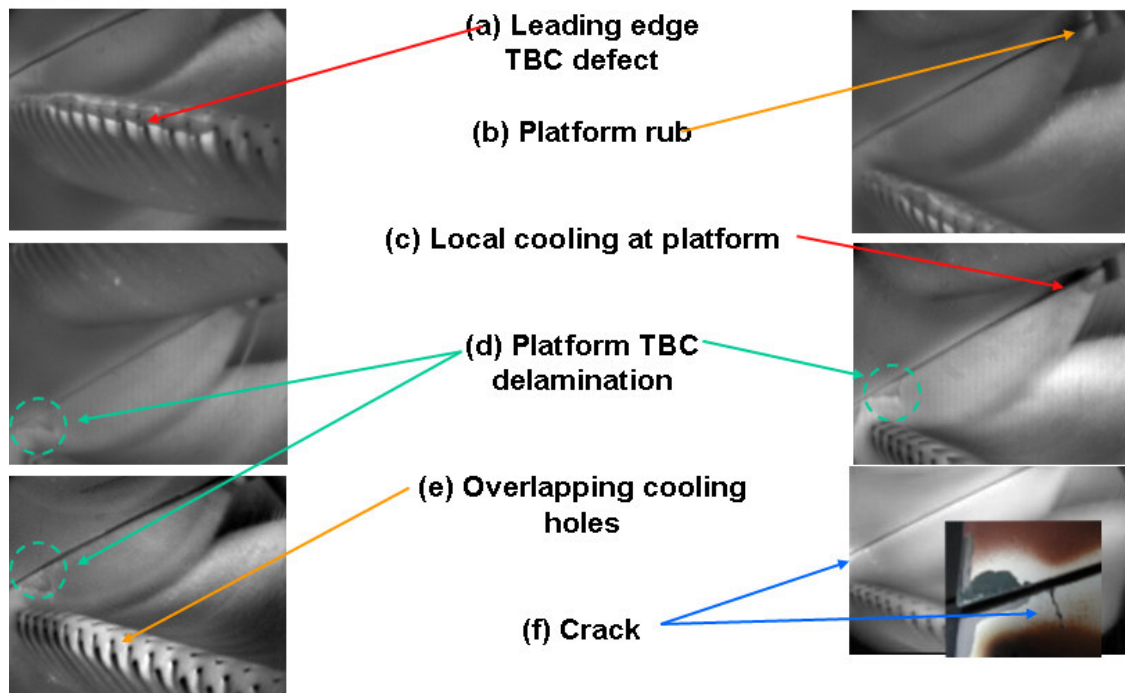
6. Example of possible features observed by an IR camera, during engine operation, at 3600 rpm with gas path temperatures higher than 1200 °C. Pictures are “still” frames of rotating blades.

Radiation reaching the detector includes contributions from three sources: 1) radiation emitted from the surface of the turbine component being imaged, 2) reflected radiation included from particulates in the gas stream as well as, 3) radiation emitted from hot gases and particles in the field of view. A methodology was developed to overcome these hurdles and finally perform the surface temperature measurements. Figure 6 illustrates features that can be seen during the engine operation using state-of-the-art focal plane arrays with advanced software imaging. These include (a) TBC spallation on the leading edge of the blade as seen by dark edge of TBC, (b) local heating due to platform rub – bright feature near rub, (c) local cooling at platform – dark due to cooling air leakage (d) Platform TBC delamination, observed as bright/dark line corresponding to a buckled TBC, (e) overlapping cooling holes, with the dark cooling streams are not giving good coverage and (f) Platform TBC crack observed as a faint bright line, verified by visual picture shown in the inset in Fig. 6.
