Erosion of tungsten marker layers in W7-X

To cite this article: M Mayer *et al* 2021 *Phys. Scr.* **96** 124070

Keywords: W7-X, erosion/deposition, tungsten, test divertor unit (TDU), inner heat shield, scraper

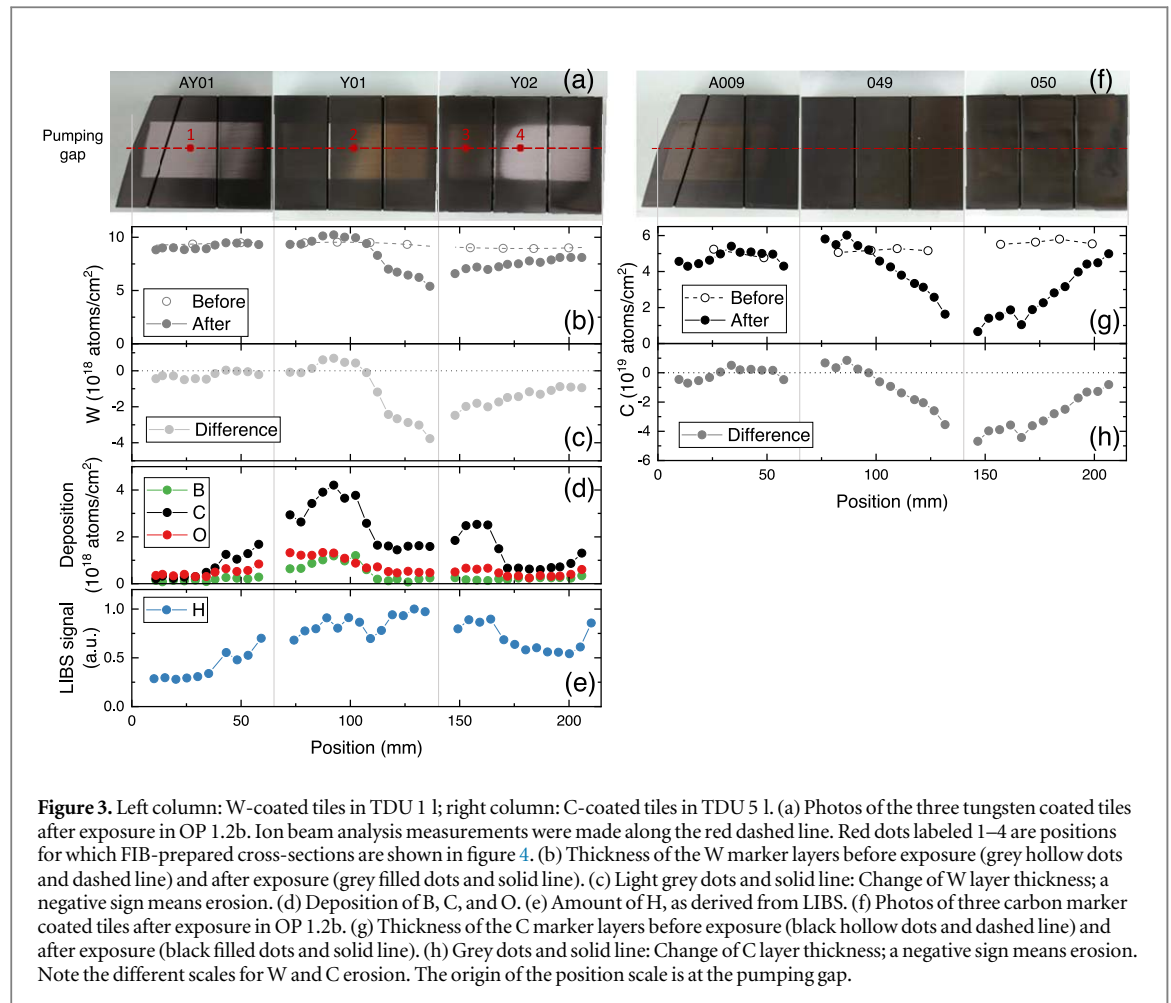
The W layer thickness and the difference of W layer thickness before and after exposure, as determined by EBS, are shown in figures 3(b) and (c). The accuracy for the determination of the amount of W is about 5%. Erosion of W is clearly seen at positions between 110 and 205 mm, the maximum erosion of about 4×10^{18} atoms/cm² (about 630 nm) is observed around 135 mm. Between 10 and 110 mm the amount of tungsten after exposure is identical within the achieved experimental accuracy to the amount of W before exposure, i.e., here erosion is not observed. Deposition of W is not expected due to the very small amounts of W present in the machine. Taking the maximum observed net tungsten erosion and the total discharge time in Standard configuration during OP 1.2b yields the maximum tungsten erosion rate during Standard configuration discharges of about 8.3×10^{14} atoms/cm²s (about 0.13 nm s⁻¹). As discussed in section 2.1 different plasma configurations as ‘Standard’ have their strike lines on different areas of the TDU. The probability for prompt redeposition of eroded W depends on position and plasma conditions and reaches maximum values of about 60% [33], section 9.3.3]. Prompt redeposition takes place typically within a few mm from the point of origin of the sputtered W atom, i.e., W atoms eroded from the W marker stripe and redeposited by prompt redeposition

The deposition of B, C and O, as determined by EBS, is shown in figure 3(d). The black stripes visible at around 90 mm and around 160 mm are not caused by erosion, but are due to redeposited layers with mean thickness up to about 6×10^{18} atoms/cm² (about 600 nm) B + C + O. These layers consist mostly of carbon, but contain about 15–20 at% B and about the same amount of O. Small traces of medium-Z elements (Fe, Cr, Ni) could be sometimes identified in EBS and EDX spectra, but not quantified.

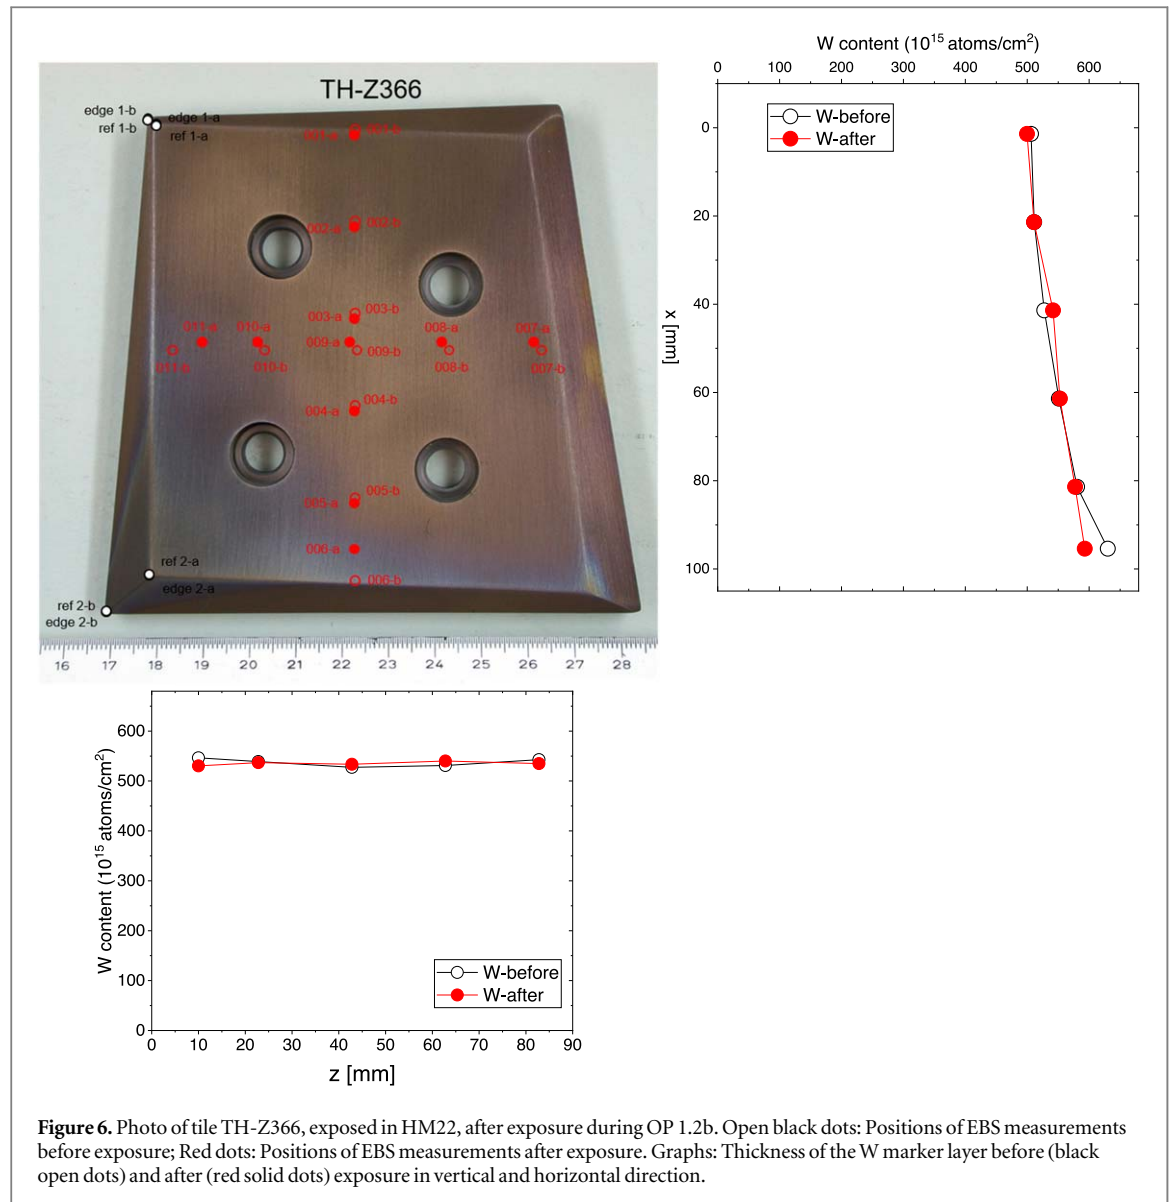
Figure 6. Photo of tile TH-Z366, exposed in HM22, after exposure during OP 1.2b. Open black dots: Positions of EBS measurements before exposure; Red dots: Positions of EBS measurements after exposure. Graphs: Thickness of the W marker layer before (black open dots) and after (red solid dots) exposure in vertical and horizontal direction.

A typical result for the thickness distribution of the W marker layer is shown in figure 6: the thickness of the W marker layer before and after exposure is identical within the experimental uncertainty of about 5%. On all 21 tiles the net W erosion was below the detection limit of $2.5\text{--}5 \times 10^{16}$ W-atoms/cm² (about 4–8 nm)—the detection limit depends on the initial W layer thickness and is smaller for initially thinner layers. Arc traces or other signs of localized erosion were not observed on the 21 tiles.

After exposure the tiles were relatively homogeneously covered with a thin film consisting mainly of B, C and O—the brownish color of the tile shown in figure 6 is due to this film. The thickness of the deposits depended on the position inside the machine and was in the range of 2×10^{17} – 10^{18} B + C atoms/cm². The films typically contained more B than C with B:C ratios in the range 2–5 and were most probably deposited during boronizations.

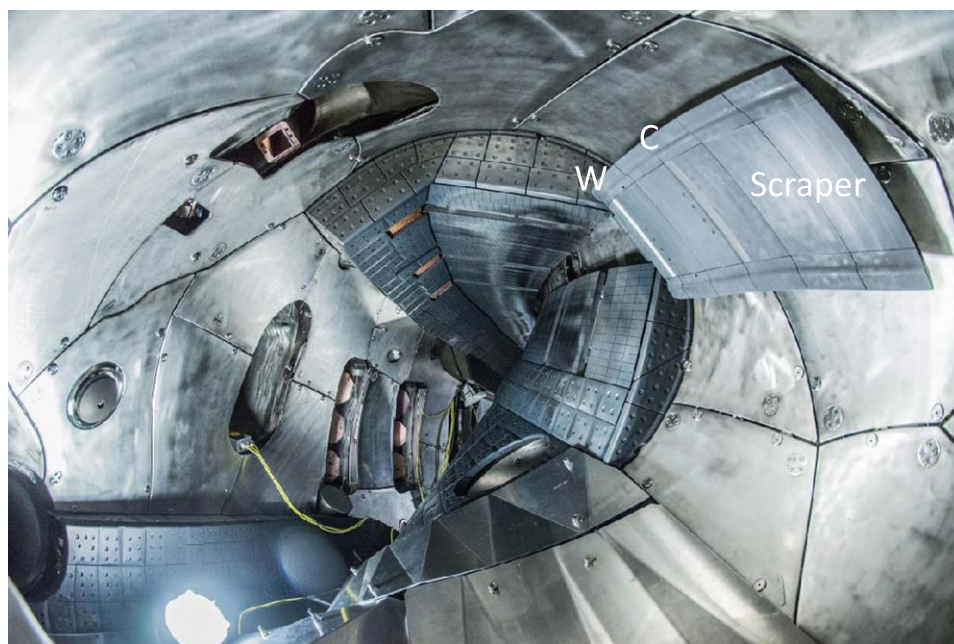
Figure 7. View of a scraper element inside W7-X. The scraper has a W and a Mo/C marker layer close to the Langmuir probe arrays.

Two scraper elements were coated with Mo/C and W marker layers, see figure 7. The initial thickness of the W marker layers was about 1.3 μm . The scrapers were mounted close to TDU 3 l and 5 u and were exposed to 50
