Nuclear Materials and Energy 12 (2017) 200–204

Self-castellation of tungsten monoblock under high heat flux loading and impact of material properties

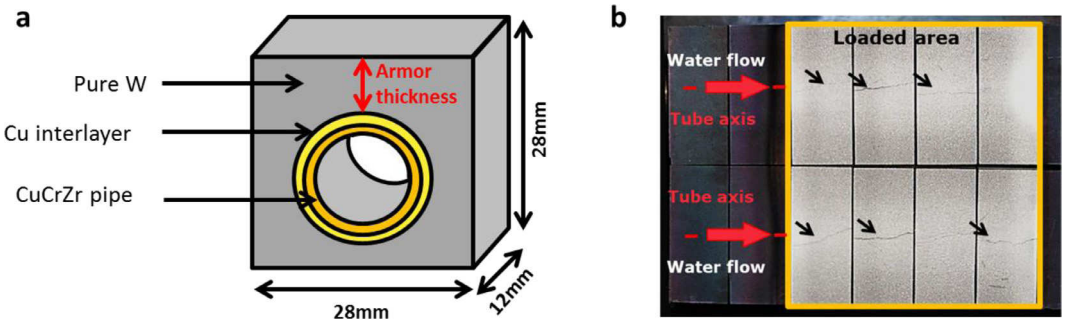
Small-scale mock-ups, made of 5 or 7 monoblocks, and full scale prototype PFUs were tested under high heat fluxes in two electron beam facilities: FE200 in France [8] and IDTF in Russia [9]. In these tests, 5000 cycles at 10 MW/m^2 followed by 300 cycles at 20MW/m^2 were applied on the actively cooled monoblocks and full-scale prototype PFUs [10]. Each cycle had a duration of 20 s, including 10 s of heating followed by a 10 s dwell time. At least 280 monoblocks were successfully tested [3,5,11,12]. Interestingly, in average 30% of them showed macro-cracks. These macro-cracks were not observed after the cycling at 10 MW/m^2 and they were observed on a fraction of the monoblocks after a few tens up to a few hundreds of cycles at 20 MW/m^2 [3]. The cracks all exhibit the same features: initiated at the loaded surface (yz plane; see Fig. 1(a)), oriented along the cooling tube axis, and propagating

Fig. 1. (a) monoblock geometry, made of a rectangular tungsten armour, a copper interlayer (typically OD/ID = 17/15) and a CuCrZr tube (OD/ID = 15/12). (b) top view of the loaded area of 2 tested mock-ups showing 6 self-castellations marked by black arrows after 5000 cycles at 10 MW/m^2 followed by 300 cycles at 20MW/m^2[16].

into the tungsten armour perpendicular to the y-direction, in the x-direction (see Fig. 1(b)).

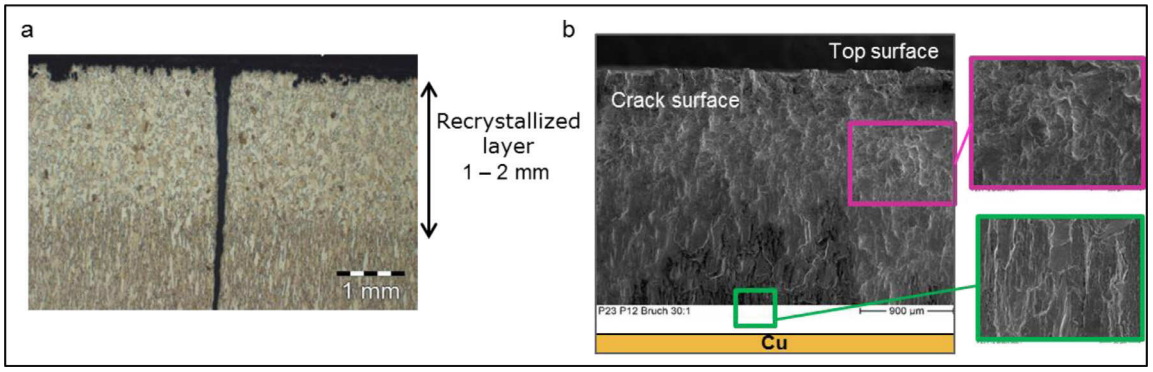
Fig. 2. Micrographs of macro-cracks appeared in cracked tungsten monoblocks after HHF tests at 5000 cycles at 10 MW/m^2 and 300 cycles at 20 MW/m^2. (a) cross-section at the vicinity of loaded surface, (b) fracture surfaces. [6].

These results have been confirmed by experimental evidences. The loaded monoblocks, which showed macro-cracks, were examined by metallography. As described in [6], microscopic analyses showed that, in the vicinity under the loaded surface (1 to 2 mm), tungsten grains started to grow due to recrystallization, see Fig. 2(a). In addition, in the same range the top part of the cracked surface showed deformed grains and intergranular fracture while in a distance >2 mm from the loaded surface the crack surface showed brittle trans-granular fracture; see Fig. 2(b).

The deformed plastic grains observed in the recrystallized zone of the tungsten armor confirmed the results of the thermo-mechanical modeling [7] namely, the tungsten material would accumulate plastic deformation in the middle of the loaded surface of the monoblock once recrystallized. The crack would then develop when the ductility of the material exhausts.

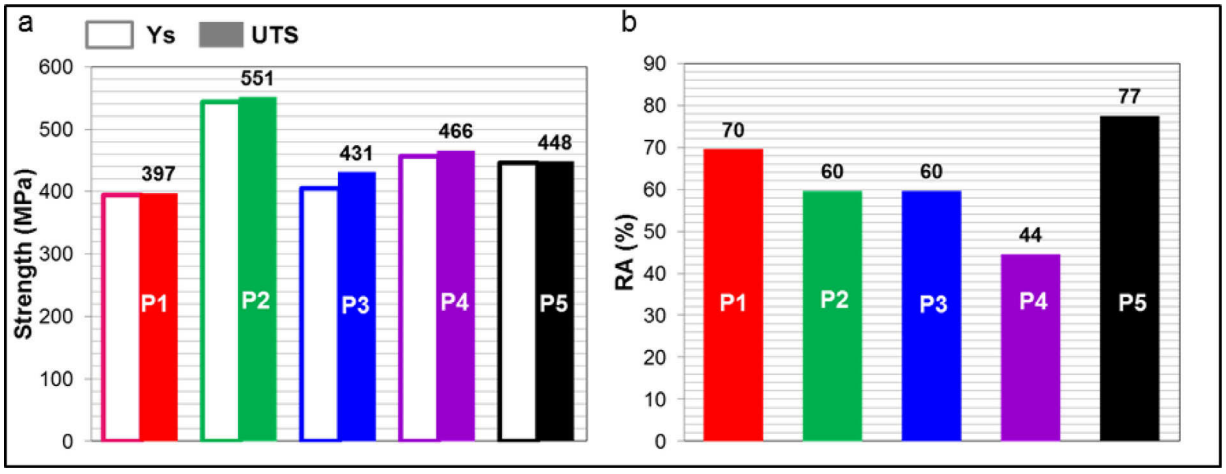
Fig. 3. (a) Ys and UTS and (b) reduction of area (in %) obtained from tensile test on as-received tungsten in y-direction at 800 °C.

The tensile test results on as-received tungsten in the y-direction at 800 °C are shown on Fig. 3. Two to three samples per product were tested. P2 had the highest yield strength (Ys) and Ultimate Tensile Strengths (UTS), while P1 had the smallest Ys and UTS (see Fig. 3(a)). Fig. 3(b) shows the reduction of area, from which ductility is defined. The results show that P5 was the most ductile material.

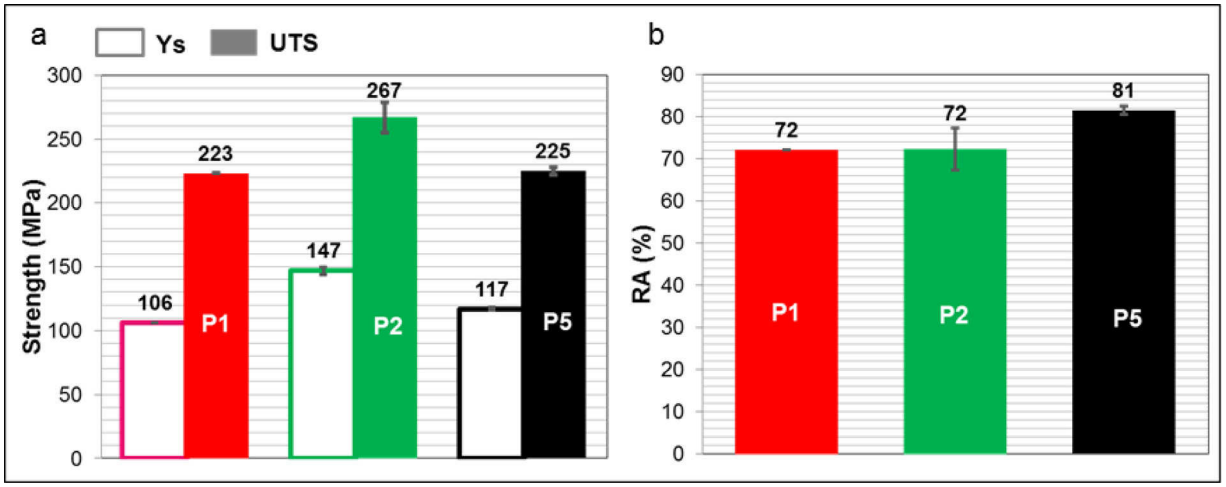
Fig. 4. (a) Ys and UTS and (b) reduction of area (in %) obtained from tensile test on recrystallized tungsten in y-direction at 800 °C.

The tensile test results on recrystallized tungsten in the y-direction at 800 °C are shown on Fig. 4. After 1 h annealing at 1800 °C, the three products P1, P2 and P5 showed softening and exhibited a decrease of Ys of about 75%. Reduction of area increased by 3%, 20% and 5% for P1, P2 and P5 respectively, after annealing at 1800 °C. The material properties of recrystallized tungsten showed less scatter between the different products. Accordingly, the effect of the production route seems to have been less noticeable as a result of recrystallization.

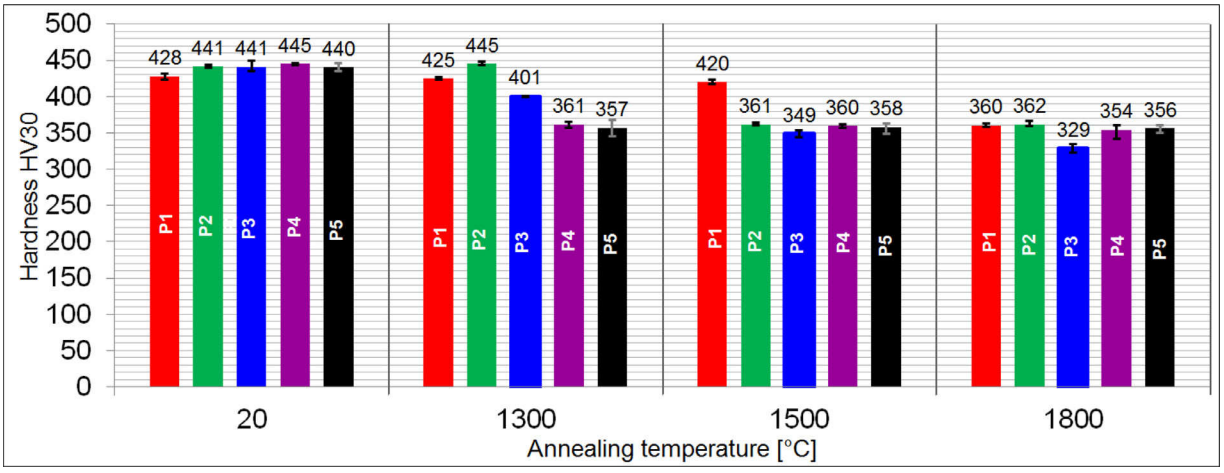
Fig. 5 shows the results of the hardness tests in the yz plane at room temperature on as-received samples, and after 1 h annealing at 1300, 1500, 1800 °C. Each product for each annealing temperature has been tested 3 to 6 times. With increasing annealing temperature, the hardness decreased from, in average, 439 HV30 for as received tungsten to 352 HV30 after annealing at 1800 °C.

As seen on Fig. 5, the sharp decrease of hardness with increasing annealing temperature varied for each tungsten product, highlighting that recrystallization occurs at a temperature specific to each tungsten product. The comparison of each product showed that the behaviour of the tungsten products varies even though they all fulfil the ITER material specification, and that some tungsten products were more resistant to recrystallization compared to others. P1 recrystallizes at the highest temperature ranging between 1500 °C and 1800 °C, P2 and P3 at a temperature ranging between 1300 °C and 1500 °C, P4 and P5 at a temperature below or equal to 1300 °C. Rolled tungsten showed a better recrystallization resistance than forged tungsten. A complete description of the experimental conditions and of the results is detailed elsewhere [21].

Fig. 5. Hardness HV30 measured on as-received tungsten and tungsten annealed at 1300 °C, 1500 °C and 1800 °C for 1 h.
