Inspection of W 7-X plasma-facing components after the operation phase OP1.2b: observations and first assessments

Due to its twisted magnetic configuration, the plasma facing components of the Wendelstein 7-X stellarator are oriented in a 3D shape. The plasma facing components consist of graphite test divertor units, baffles, head shield tiles and toroidal divertor closures and stainless steel wall panels, pumping gap panels and poloidal closures. In order to document the status of these components as well as get the first foot-prints of the plasma wall interactions occurred during the plasma campaign, a detailed inspection of the whole plasma vessel after the plasma campaign is of vital importance. Such an inspection was carried out after the operation phase OP1.2b completed in October 2018. A number of observations were made, such as, molten stainless steel drops, melting of a long term probe, deposition on steel panels, arc traces, loosely bound particles and deposition stripes on the plasma vessel hidden behind the graphite tiles. In order to understand the possible cause, their implication and steps to avoid some of these problems for the next phase of machine operation, an a

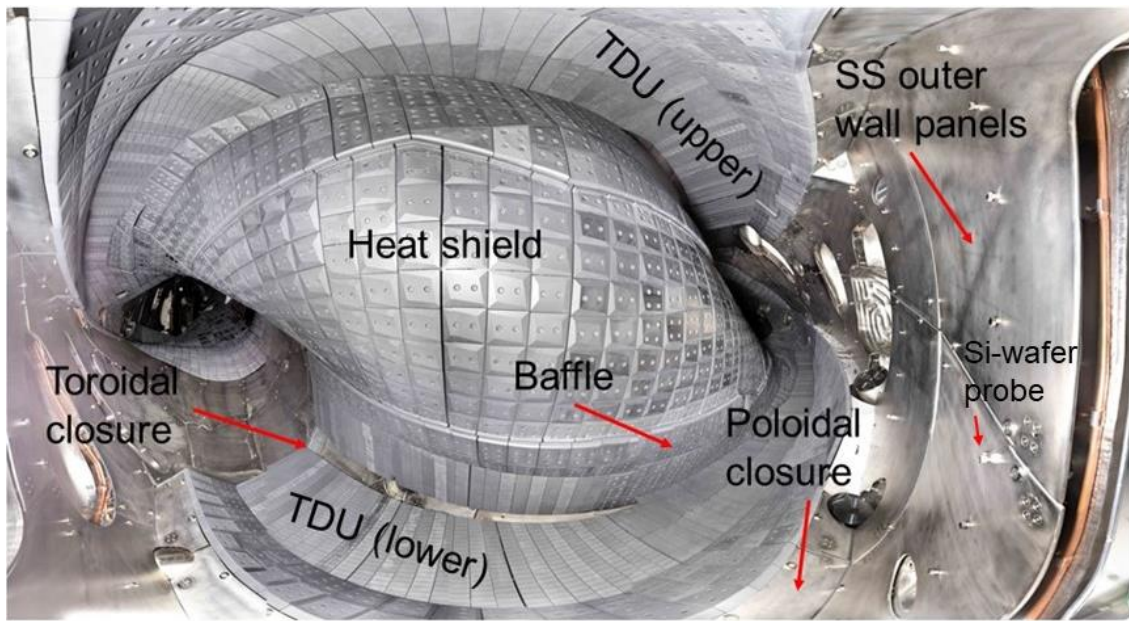
44 pieces of long term deposition probes of three different types, i.e. Si-wafer, directional material and cavity probes [8, 9] were installed at the outboard wall as well as at the pumping gap panels in module 4 (see figure 1) for monitoring depositions on these low loaded components. One of the edges of a SS probe holding the Si-wafer installed around the mid-plane was found to be molten. All the other probes were intact, despite some of these located on the pumping gap panels, being closer to the plasma. According to the mass of the molten SS, about 100 J for a second could melt the edge. Resulting from simulations with the ASCOT code [10], the melt event had occurred due to neutral beam injected fast ion orbit losses (see figure 9). The estimated fast ion heat load at this probe location is about 180 W which is sufficient for the observed melting. For future operations, no probe will be installed at this location, besides, in order to account for the plasma operations with reversed magnetic field, another probe at the mirror opposite location will be removed as well.

Figure 1. Panorama view into the W7-X plasma vessel from W7-X module 4, showing the installed plasma facing components.
