First studies of ITER diagnostic mirrors in a tokamak with all-metal interior: results of first mirror test in ASDEX Upgrade

Introduction and motivation

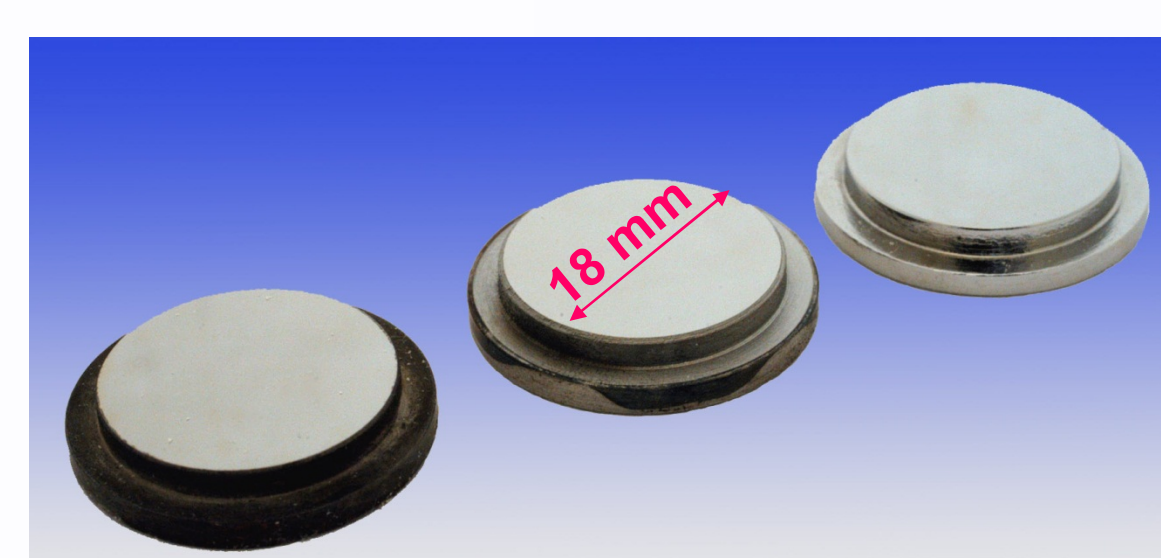
Diagnostic mirrors

- Molybdenum and copper mirrors
- Characterized before and after exposure
 - Total and diffuse reflectivity
 - Elemental composition of the mirror surface

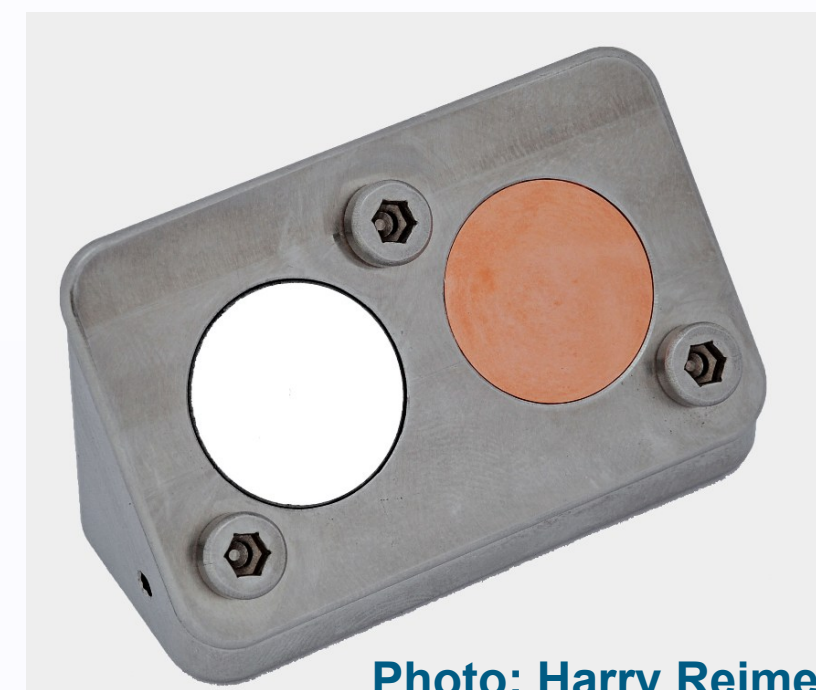
Actively heated holder with Mo and Cu mirrors

Mirror assembly

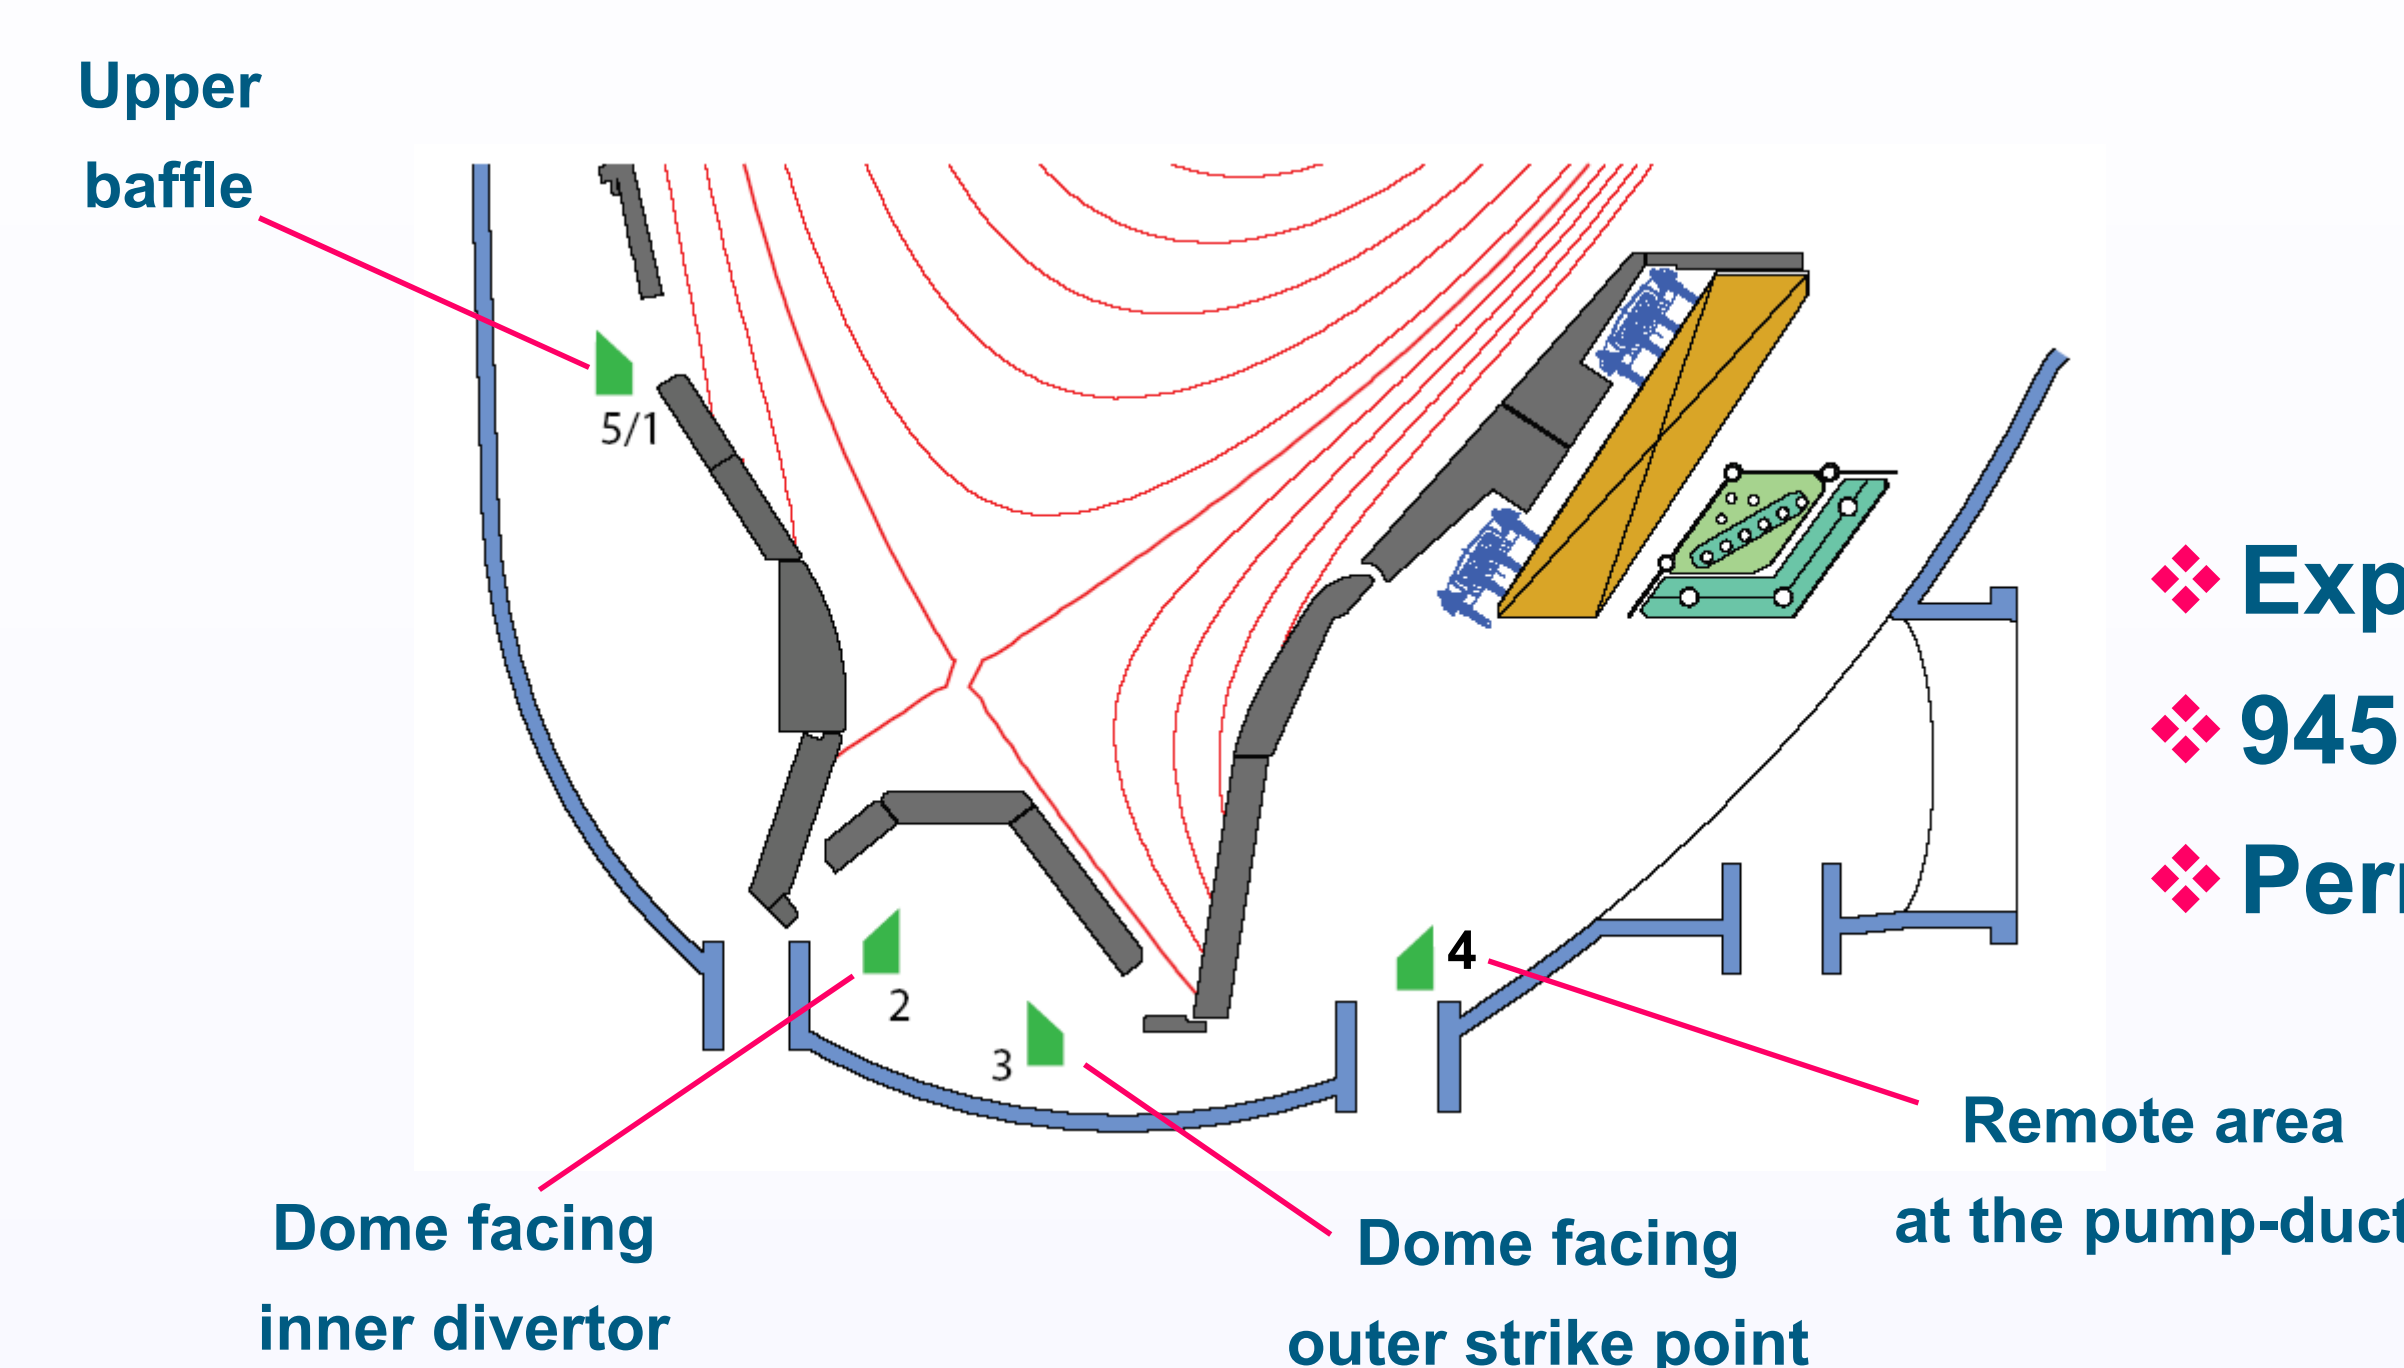
Exposure details

- Exposure from February till August 2011
- 945 discharges in divertor configuration
- Permanently heated mirrors at 145-165°C

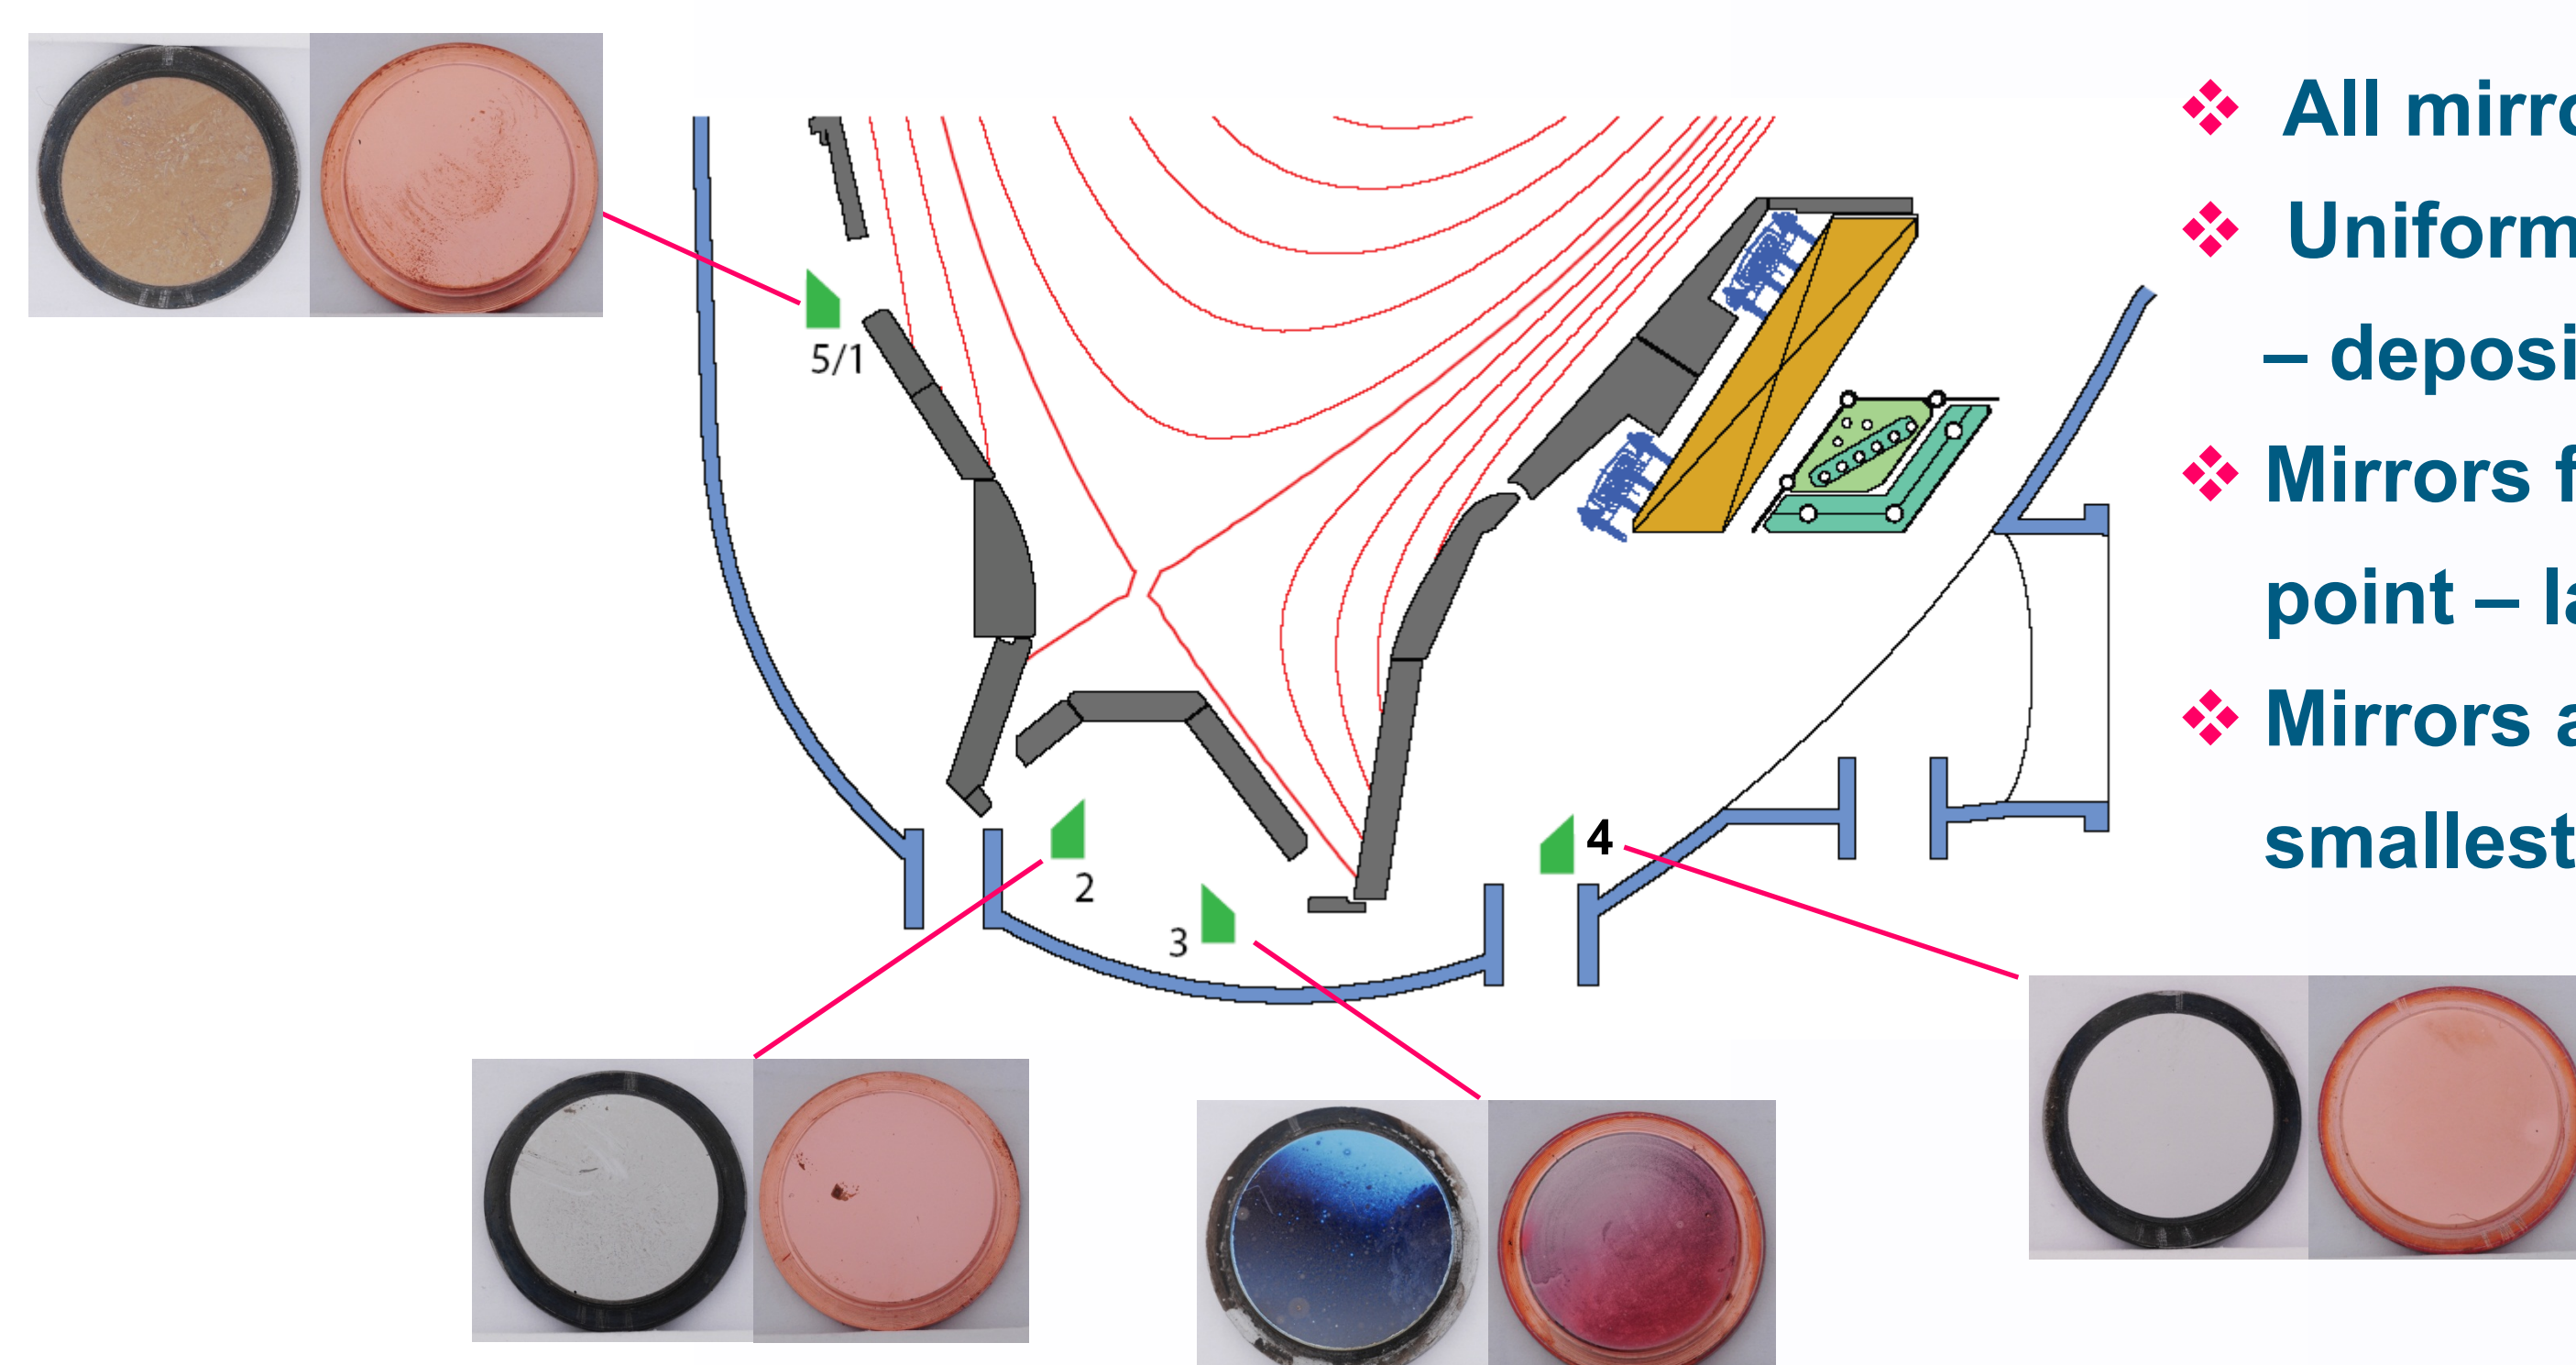
Molybdenum and copper mirrors after exposure

- All mirrors had deposition
- Uniform deposition pattern – deposition by neutrals
- Mirrors facing outer strike point – largest deposits
- Mirrors at the pump-duct – smallest ones

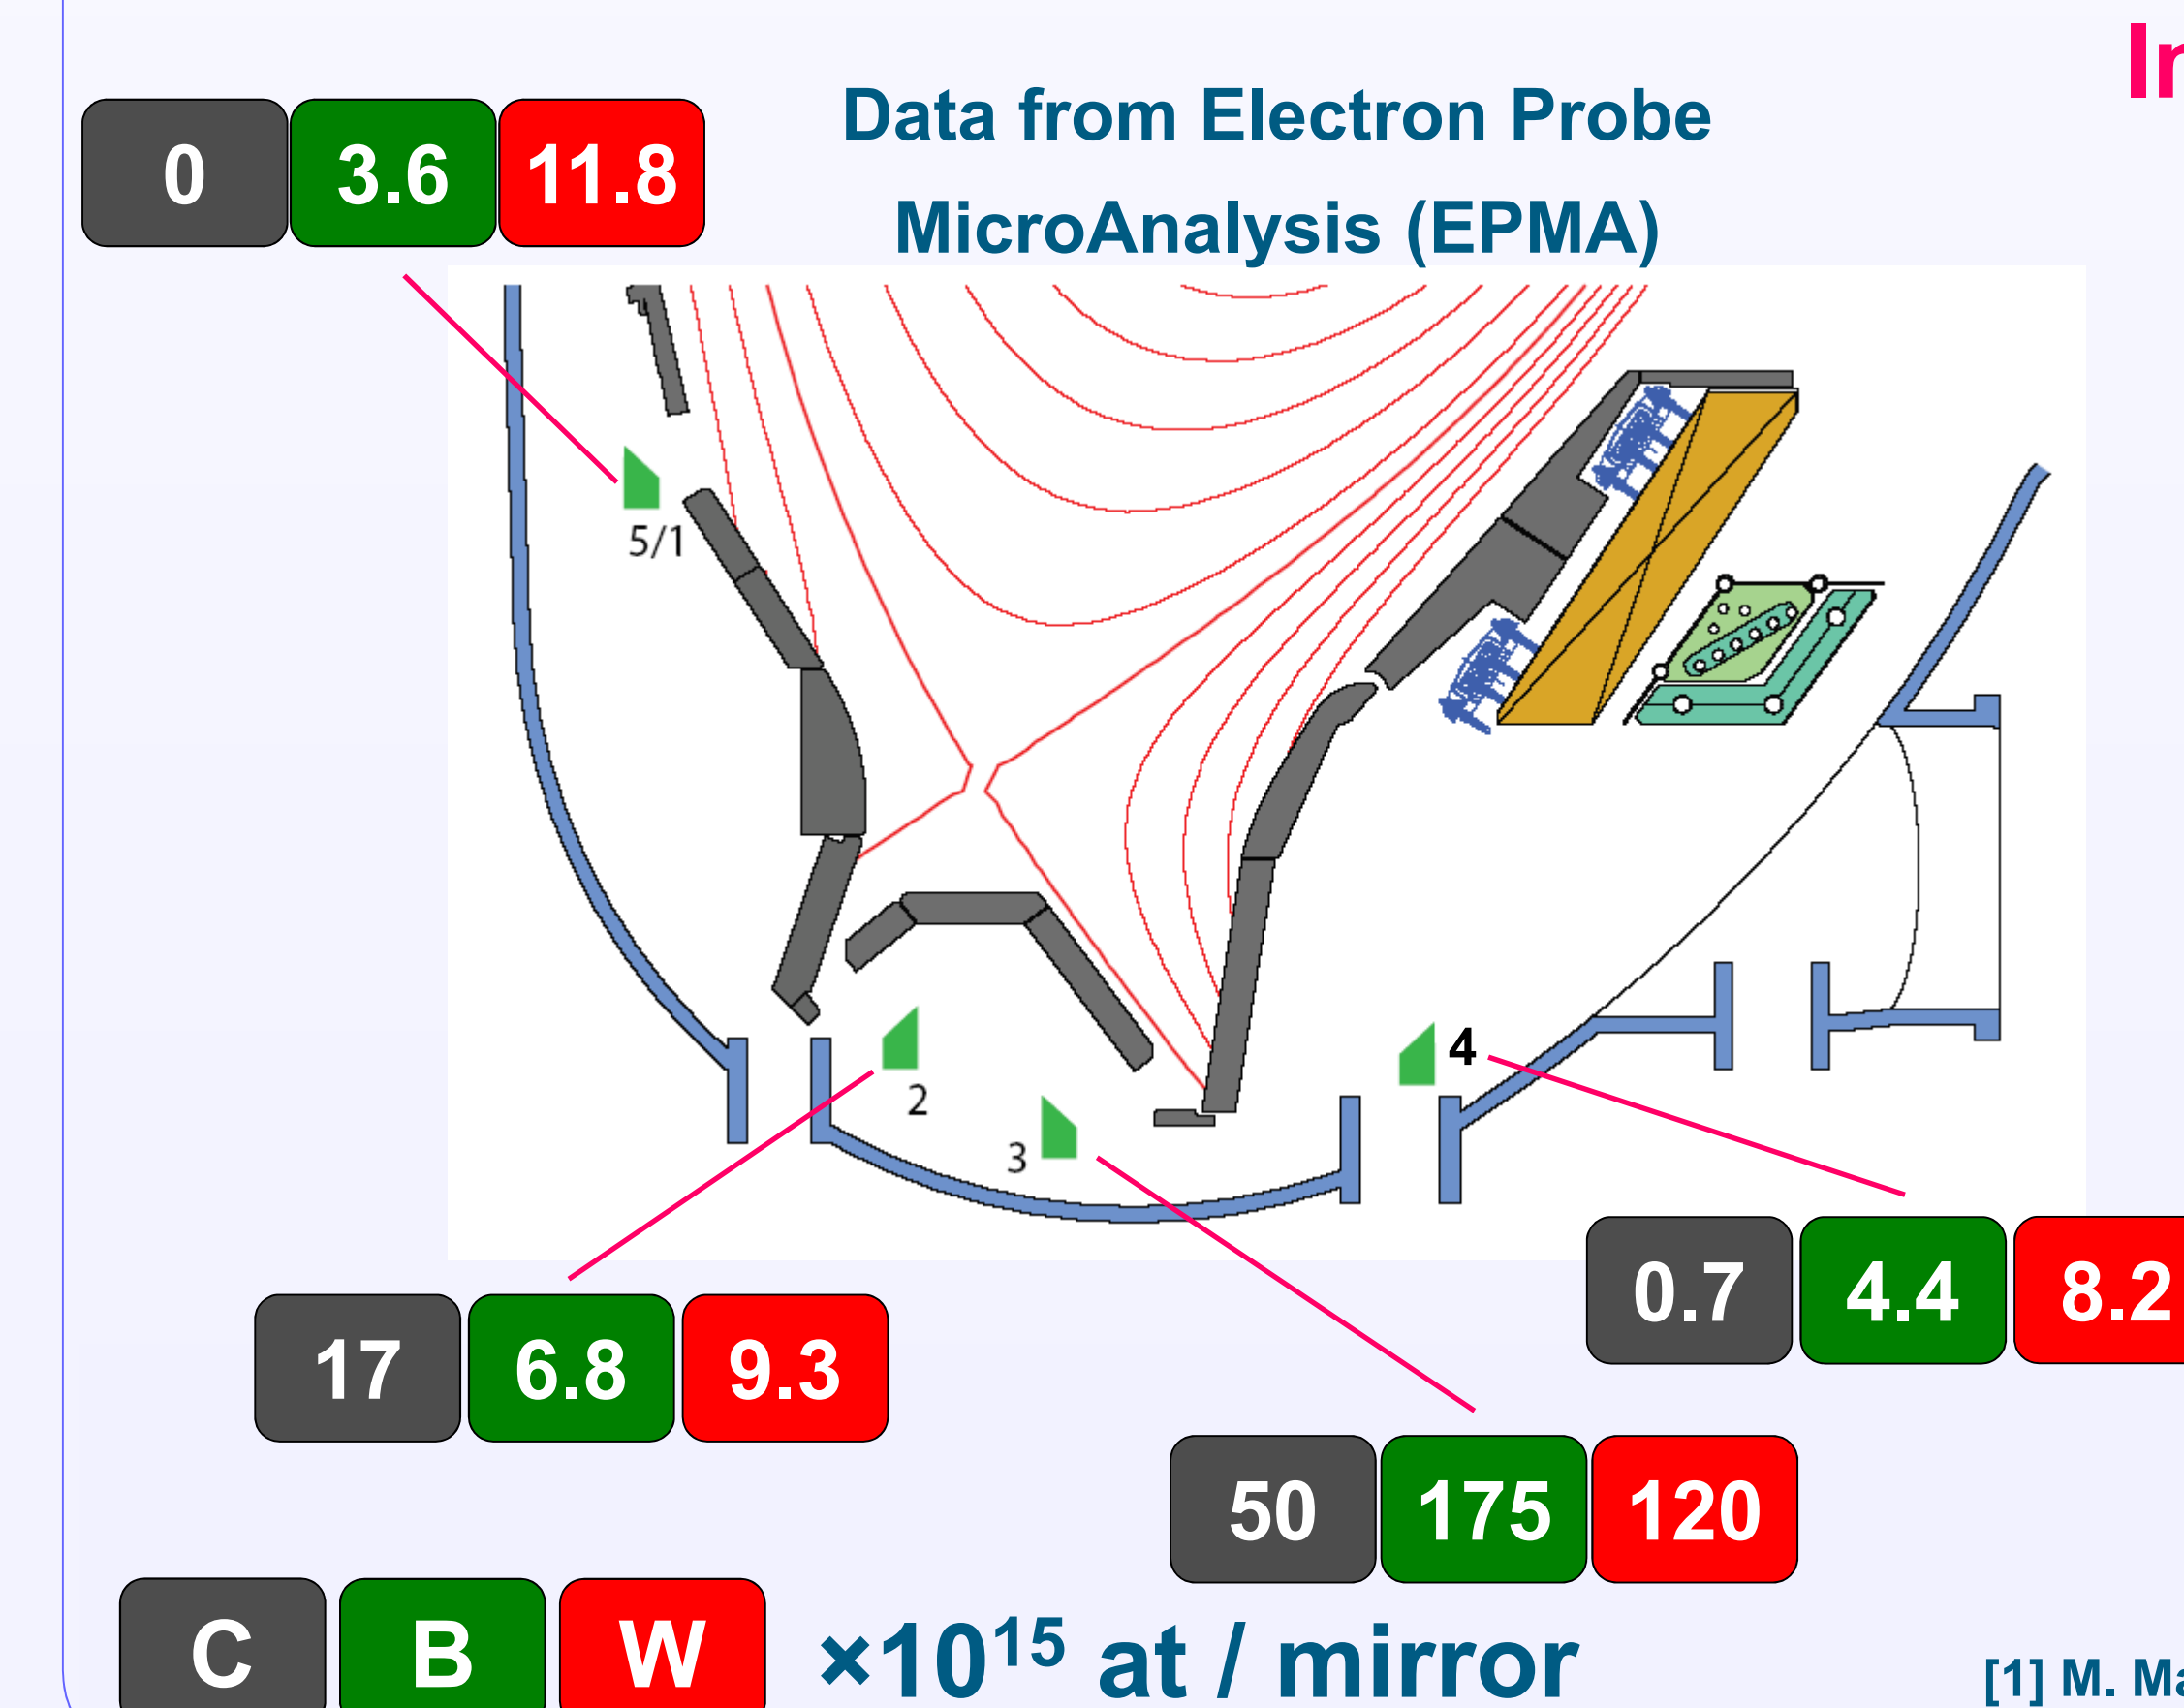
Results: deposit characterization

Impurity distribution

- Carbon found only on mirrors exposed under the dome
- 80% of entire deposition on the mirror facing outer strike point – local source [1]
- Overall deposition ~ 10 lower than with carbon PFCs [1]

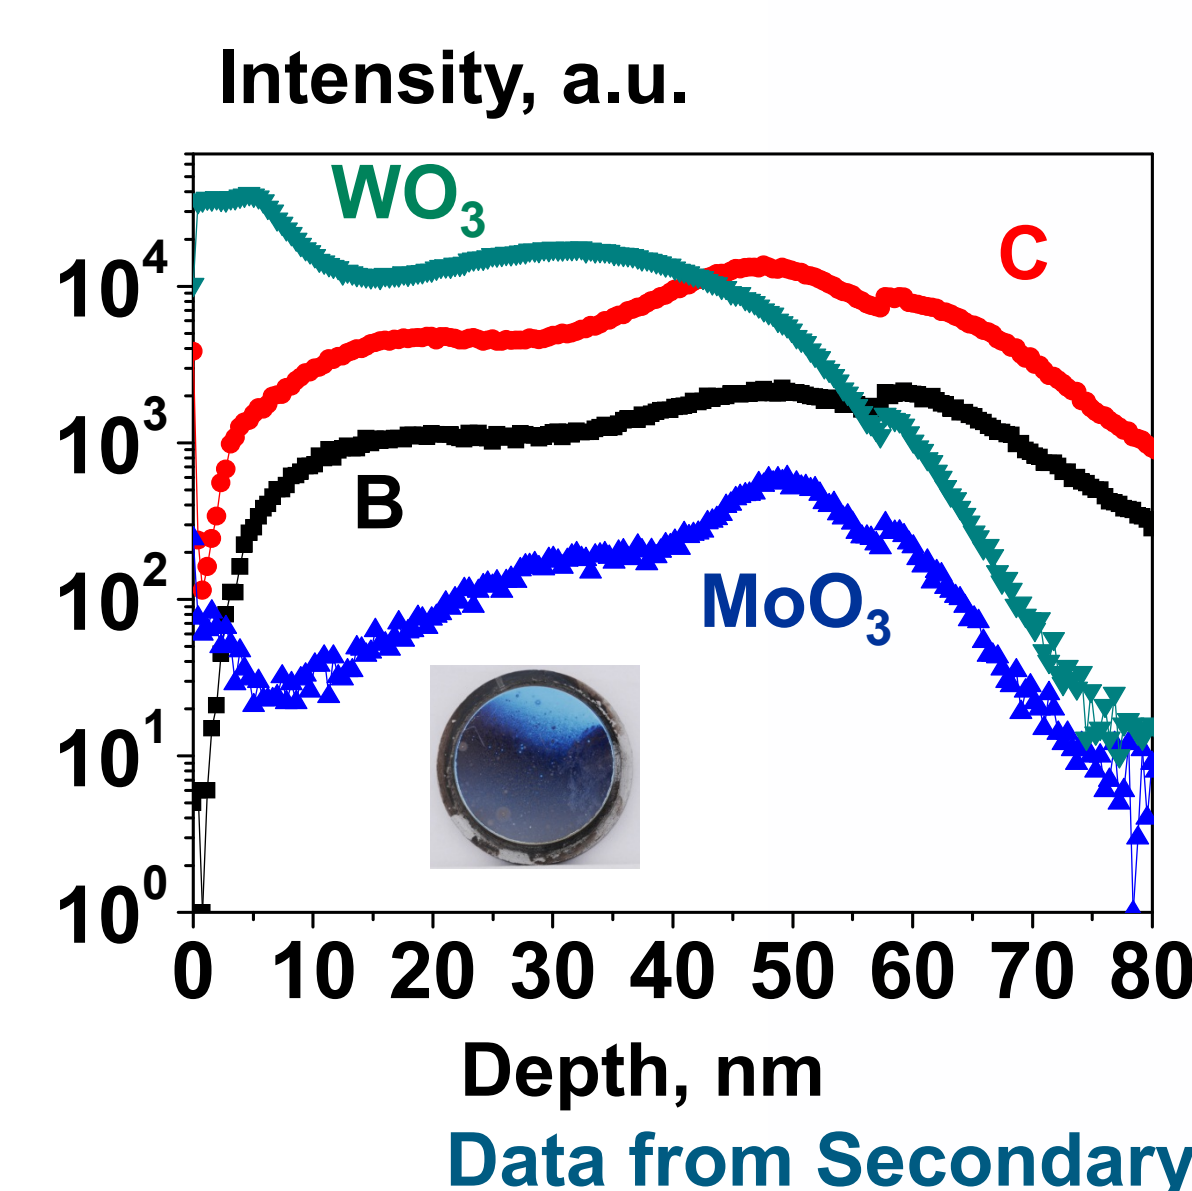
Elemental composition of deposits

- Deposits contain W oxides, B and oxygen;
- Minor fraction of carbon
- Molybdenum oxidation due to air storage prior to exposure
