# Thermal fatigue response of W-EUROFER brazed joints by the application of High Heat Flux loads

Tungsten  
Eurofer  
Brazing  
Fusion reactor  
High heat flux  
Plasma facing component

## ABSTRACT

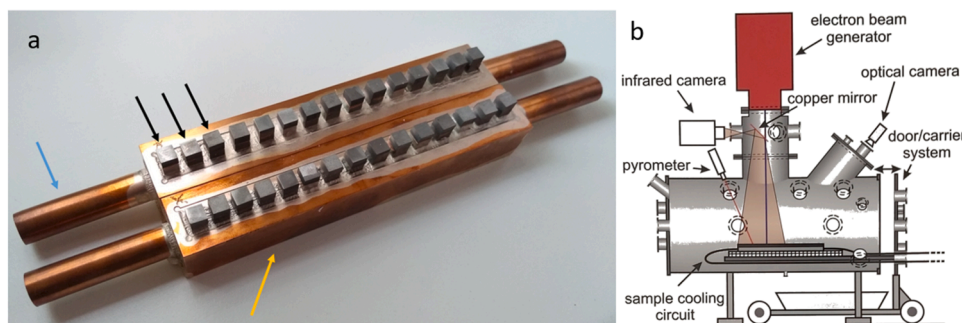
Fig. 1. General view of cooling structure with brazed samples used for HHF test with the water pipe (blue arrow), the cooling structure (yellow arrow) and the samples (black arrows). b) Schematic figure of HHF test.

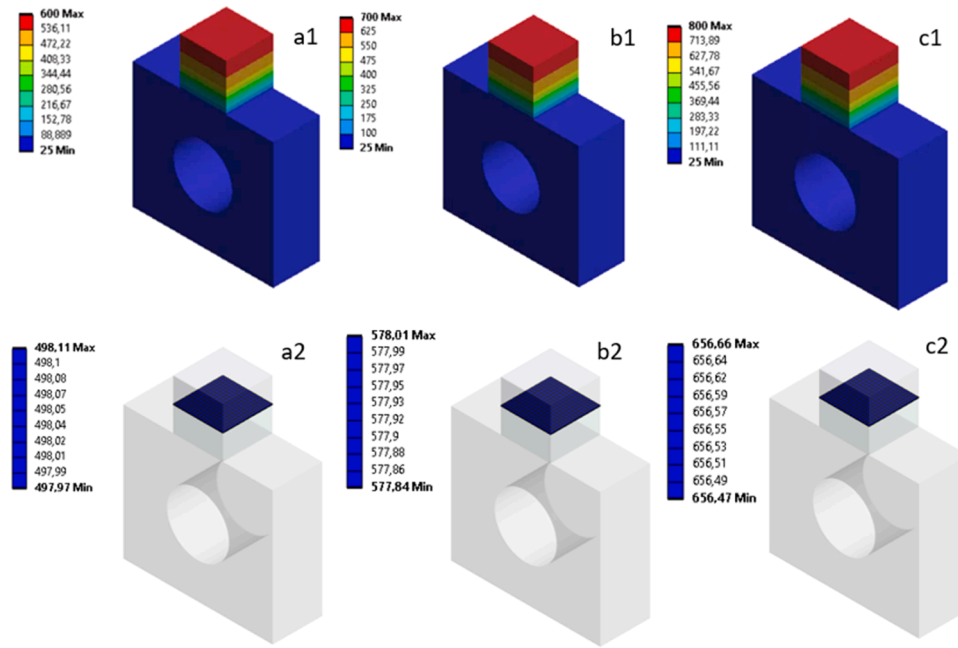
**Fig. 3.** Simulation of the temperature distribution in the component at the steady state stage at (a) 600 °C, (b) 700 °C and (c) 800 °C of W surface temperature. a2, b2 and c2 are simulation of the temperature of the filler in each condition.

Table 2 shows a summary of the HHF test results divided by batches and conditions. The tests began with a W surface temperature of 600 °C. According to the thermal simulation carried out showed in Fig. 3a 1 and 2, this surface temperature corresponds to approximately 498 °C at the braze area. In order to be more accurate when discussing the effect of the different surface temperature in the joint properties and microstructure, the following nomenclature will be used for each HHF condition: surface temperature/joint temperature/heat flux (600 °C/498 °C; 2 MW/m<sup>2</sup>, in this condition).

No anomalies during the test at 700 °C were reported neither for 100 cycles nor for 1000 cycles. The FEM simulation showed that braze area was subjected, under this condition, to approximately 578 °C (Fig. 3 b2).

The simulation of the temperature distribution in the component carried out at this condition shown in Figure 3c2 indicated that the filler reached approximately 656 °C. It has to be noted that the temperature distribution on the top of the EUROFER was in the range of 550–650 °C and according to the studies carried out by Rieth et al. (2021) EUROFER starts to soften at approximately 550 °C by stress relieving process. Although these high temperatures only affect the nearest area of the EUROFER close to the joint (1–2 mm) they should be avoided during service operation. Their effects should be addressed in future works for a

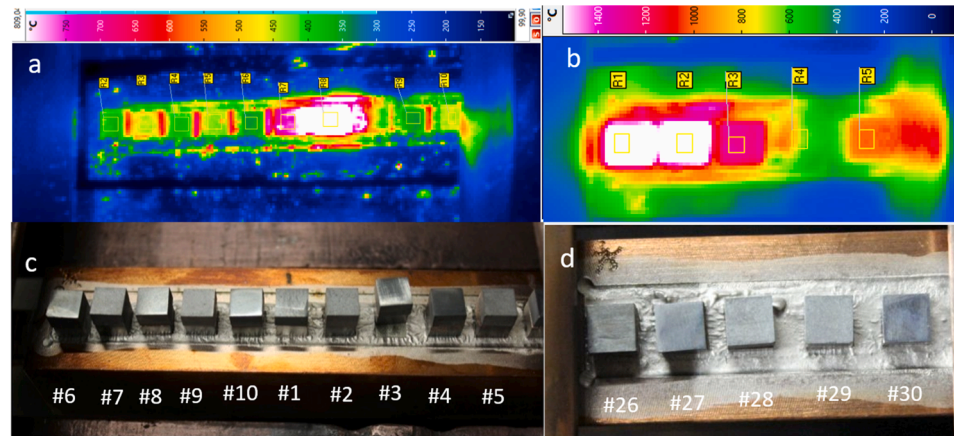
**Fig. 4.** (a) and (b) IR images showing overheating of samples in batches 1 and 6, respectively. (c) optical images after detachment of #3 (after heat fluxes of < 1 MW/m<sup>2</sup>) and (d) before the test.

Some thermal anomalies were detected during the application of this condition by the IR camera (Fig. 4a). During the calibration of the pyrometer at heat fluxes lower than 1 MW/m<sup>2</sup> sample #3 was detached and removed from the cooling structure (Fig. 4c). Sample #2 showed increasing temperature with every cycle, exceeding 800 °C around cycle 40, but the cool down behavior indicated that the sample did not detach completely from the cooling structure. Although at cycle 85 the

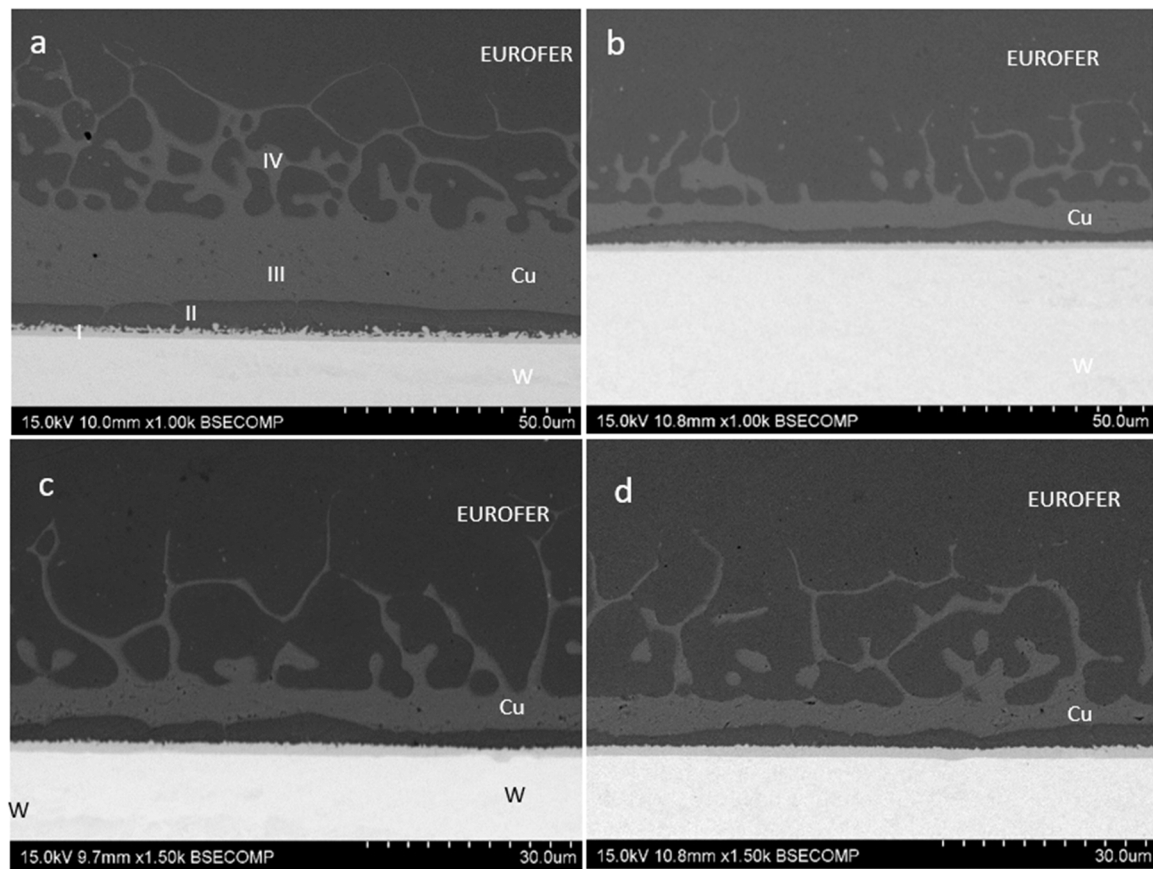
**Fig. 5.** Micrographs of samples subjected to a W surface temperature of 600 °C with the following conditions: (a) 100 cycles, (b) 100 cycles and aging treatment, (c) 1000 cycles and (d) 1000 cycles and aging treatment.

Fig. 5a-b and 5c-d show the micrograph of the samples corresponding to batch 1 and 2 subjected to a W surface temperature of 600/498 °C, 2 MW/m<sup>2</sup> for 100 and 1000 cycles, respectively. The microstructure of the joints was similar in all cases and no differences between the number of applied cycles were found (Fig. 5b and 5d subjected to 100 and 1000 cycles, respectively). Besides, reference samples (not subjected to aging treatment) did not show microstructural differences in any case (Fig. 5a and 5c for 100 and 1000 applied cycles, respectively).

The braze area was characterized by the formation of a diffusion layer at the W surface with 62W23Fe11Cu3Cr % wt. composition (I in Fig. 5a). Above this layer, the formation of a Fe-rich band has been identified (II in Fig. 5a). The formation of this Fe-rich band between W and copper braze is attributed to the partial solution of iron in the copper filler during the melting stage of this material at the brazing temperature. During the cooling stage of the process, the decrease of iron solubility in copper produces the iron-rich band solidification in contact with tungsten following a heterogeneous solidification mechanism. Copper remained in the braze forming a continuous band above the iron rich band (III in Fig. 5a). This copper band has difference thickness depending on the location in the joint being thicker in the in edges and thinner in the center of the joint (Fig. 5a and b, respectively). Braze exudation process, associated to its high wettability in the system, is the responsible of this phenomenon. During the brazing process, copper also penetrates into the prior austenitic grain boundaries of EUROFER (IV in Fig. 5a).

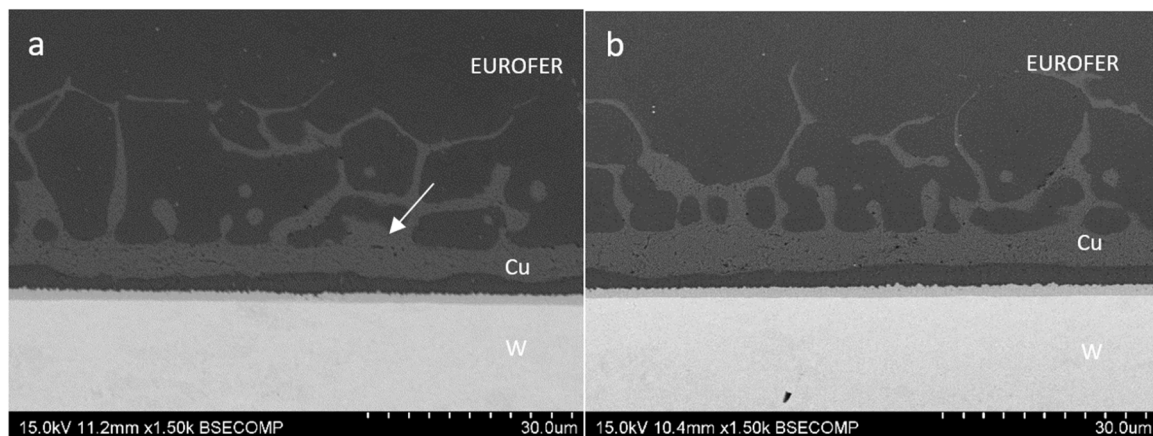
**Fig. 6.** Micrographs of samples (a) #2 and (b) #3 that showed anomalies during HHF tests.

Micrographs of the samples that showed anomalies during the tests, and were detached from the cooling structures, did not show cracks at the W-EUROFER braze area that could explain the overheating registered by the IR cameras ([Fig. 6](#)). Although isolated porosity was detected in the copper braze zone (arrowed in [Fig. 6a](#)) it was not the reason that caused the anomalies. Therefore, the overheating should be attributed to the detachment from the cooling structure.

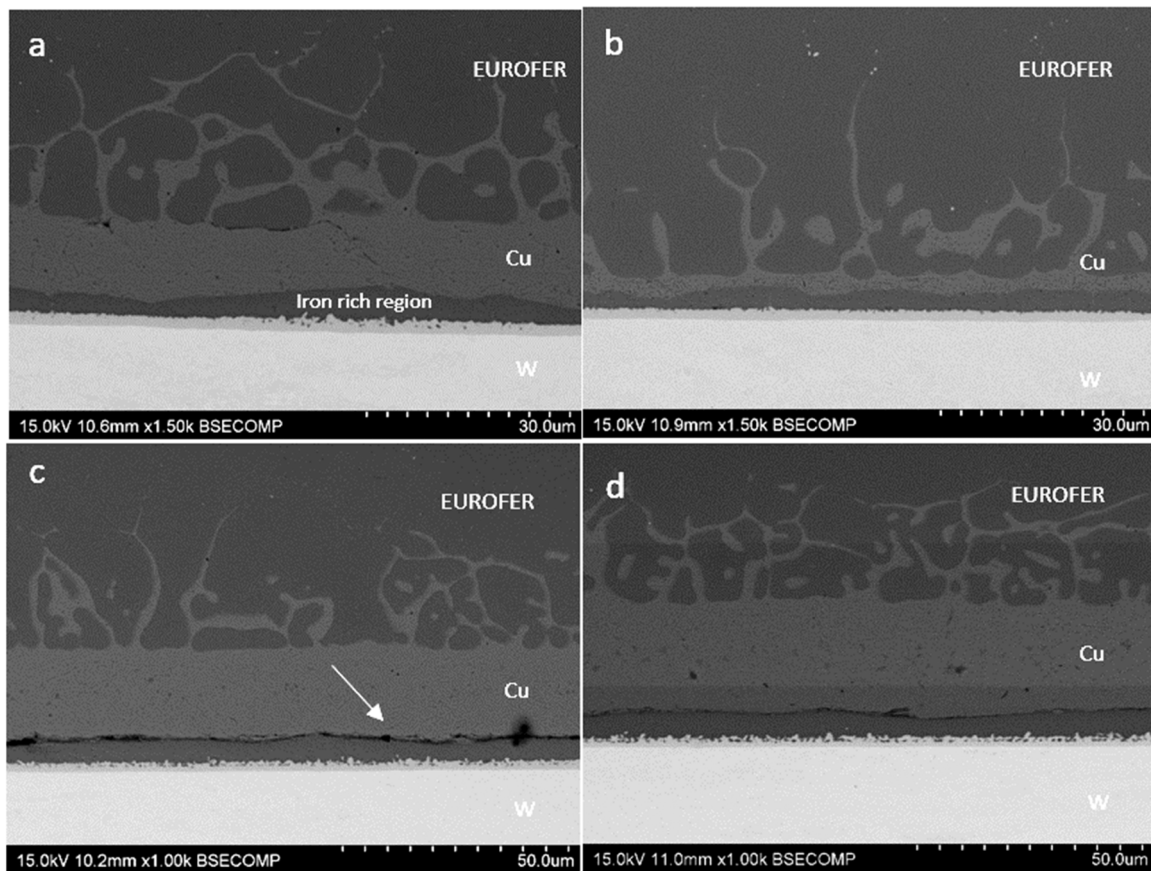
**Fig. 7.** Micrographs of samples subjected to a W surface temperature of 700 °C with the following conditions: (a) 100 cycles, (b) 100 cycles and aging treatment, (c) 1000 cycles and (d) 1000 cycles and aging treatment.

Although the application of 700/578 °C, 2.5 MW/m<sup>2</sup> at the surface temperature did not produce any overheating event during the test detected by the IR camera for any batch, the microstructural characterization of the selected samples showed the presence of cracks, only in the sample subjected to 1000 cycles ([Fig. 7c and d](#)), however the samples subjected to 100 cycles did not show any microstructural modification ([Fig. 7a and b](#)). The crack was located at the interface between the iron rich region and the copper band.

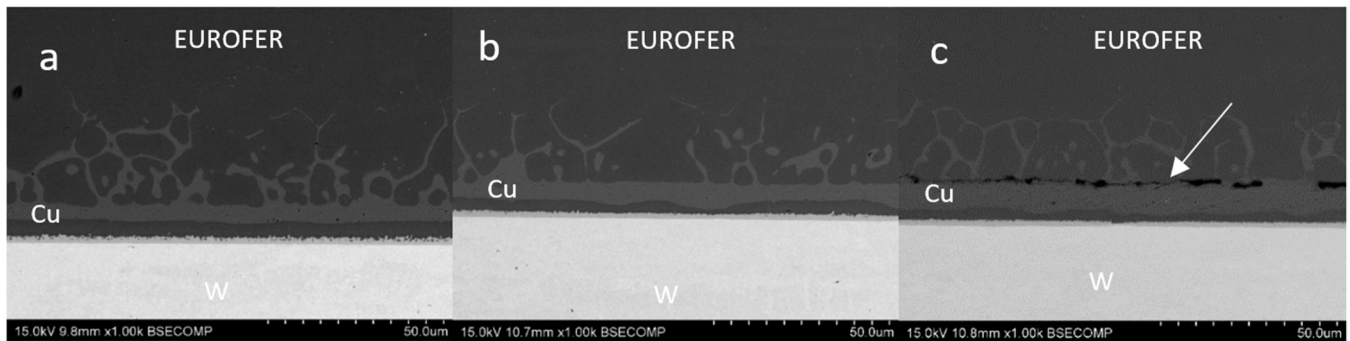
**Fig. 8.** Micrographs of samples exposed to a W surface temperature of 800 °C of for: (a) 100 cycles, (b) 100 cycles and aging treatment and (c) 182 cycles.

Microstructural characterization of samples subjected to 800/656 °C, 3 MW/m<sup>2</sup> showed different behavior depending on the exposed cycles. In the case of the samples of batch 5, subjected to 100 cycles, the microstructure did not show relevant modification ([Fig. 8a and b](#)). However, in the case of the 1000 cycles planned for the batch 6, the test was stopped due to the surface overheating after 182 cycles. The preliminary visual examination indicated the fracture of the W-EUROFER joints of two samples (#26 and #27) and the detachment of the W piece from the joint.

The microstructural examination of the exposed joints showed large cracks distributed parallel to the brazed joint at the iron rich region-copper band interface (arrowed in [Fig. 8c](#)). The formation of these cracks was associated to the high thermal stresses caused by the test as a consequence of the difference in the Coefficient of Thermal Expansion (CTE) among EUROFER (10–12 × 10<sup>-6</sup>/K) ([Mergia and Boukos, 2008](#)), tungsten (4.5 × 10<sup>-6</sup>/K) ([Zhong et al., 2010](#)) and copper (16.5 × 10<sup>-6</sup>/K) ([Ghovanlou et al., 2011](#)). Each cycle induced residual stresses in the braze area giving rise to a thermal fatigue process. The more the temperature and cycles applied the more the stress is induced, up to some point in which the joint starts to plasticize (residual stress reach the yield point of the softest material) or forming cracks. The formation of cracks parallel to the joint is the logical consequence due to the stresses are maximized at the interface of both materials. This crack did not allow transferring the heat flux from the hot area to the coolant and, therefore, the upper part of the sample overheated.

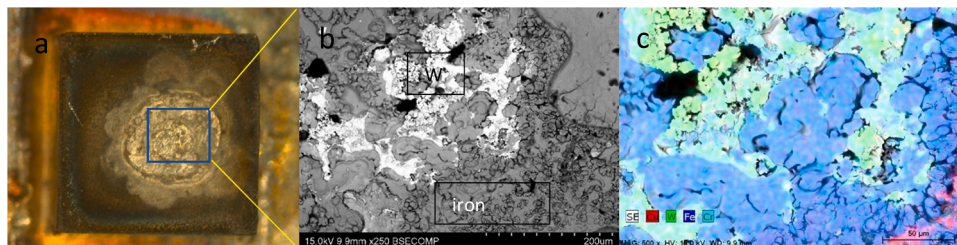
**Fig. 9.** Fractography images of EUROFER fracture surface of sample #16 obtained by: (a) stereoscopic microscope, (b) SEM and (c) elemental mapping distribution by EDS.

Fracture surface of the two samples, where tungsten was detached from the joint, (#16 and #17), were examined by SEM to analyze the failure. [Fig. 9a](#) shows the fracture surface of EUROFER base material of sample #16 analyzed by stereoscopic microscope and [Fig. 10b](#) shows a detailed inspection of the inner zone carried out by SEM. In this image, it can be distinguished particles with drop morphology compatible with a partial melting of iron caused by the temperature increase, according to the elemental mapping distribution shown in [Fig. 8c](#). The formation of discontinuities, similar of that studied in previous samples, would be responsible of the initial increase of temperature. The higher temperature resulted in higher thermal stresses until cracks propagated causing the critical failure of the joint and finally its complete fracture. The SEM analysis also shows, in [Fig. 9b/c](#), the presence of tungsten material detached from the base material during the fracture, which indicated the good adhesion properties of the brazed joint.

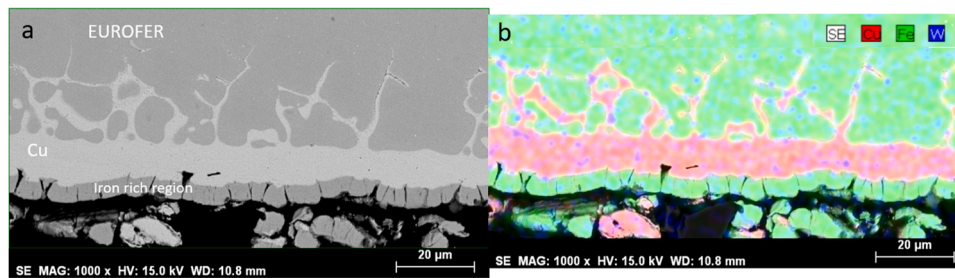
Fig. 10. (a) SEM and (b) EDS map distribution of EUROFER cross section piece of sample #16.

A deeper understanding of the failure process could be extracted from [Fig. 10a and 10b](#), where a cross section of EUROFER fractured piece of sample #16 is shown. According to the images, fracture occurred between the region rich in Fe and the diffusion layer. However, transversal cracks that connected the fracture surface with the copper band are observed. Those cracks suggest that this iron rich layer could propagate, under certain circumstances, the cracks generated in the

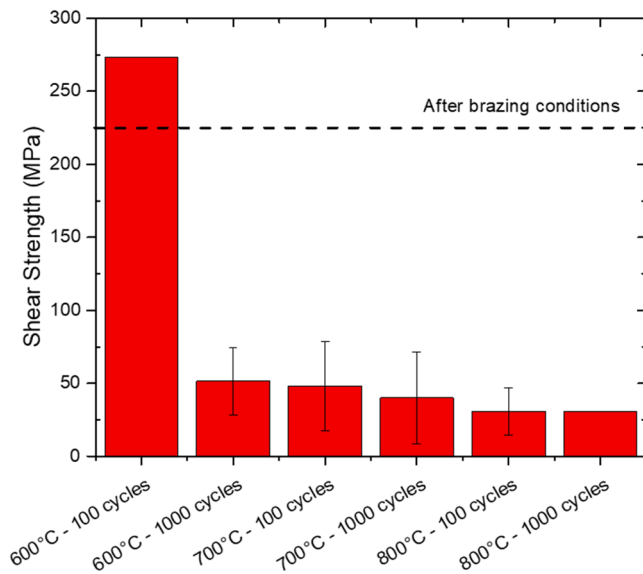
Fig. 11. Shear strength of W-EUROFER joints subjected to different HHF conditions of W surface temperature and number of cycles.

The shear strength of the joints is shown in Fig. 11. The shear strength of the sample tested at 600/498 °C, 2 MW/m<sup>2</sup> and 100 cycles is around 275 MPa, in this case only one sample survived to this condition, the other were examined by SEM to study the failure mechanisms, as

was previously discussed. Only one sample could be tested because the other two were removed from the cooling structure during the cycling test. The shear strength dropped down to 50 MPa after 1000 cycles. This value is lower than that reported for joints at as-brazing conditions (225 MPa) because of the formation of cracks at the edges of the joint between the Cu band and the Fe rich region. This effect was intensified as the W surface temperature and the number of cycles was increased. It was an expected behavior since the temperature gradient between the hot W surface and the cooling copper structure increases with the surface temperature and, therefore, the stresses generated by the mismatch of the CTE also do. These stresses are generated and accumulated in each cycle generating residual stresses and cracks that contribute to the reduction of the strength of the joint.

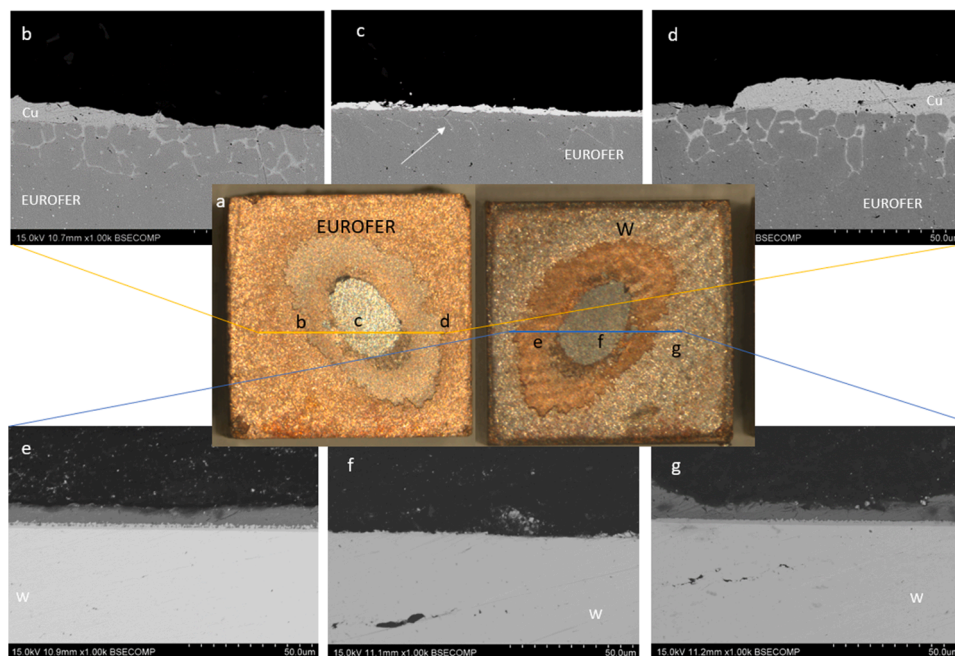
Fig. 12. (a) Stereoscopic image of fracture surfaces of sample #28 subjected to 700 °C 1000 cycle after the shear test. Cross section images obtained by SEM of the fracture surfaces following the depicted line in (b), (c) and (d) EUROFER base material and (e), (f) and (g) tungsten base material.

A representative example obtained by stereoscopic microscopy of the joint fracture surface after shear test is shown in Fig. 12a. All samples showed similar fracture pattern consisting of two concentric rings located approximately at the center of the surface. These rings, which showed different tonalities in the optical images (Fig. 12a), represented

A detailed analysis of the cross sections fracture surface at different zones following the lines depicted in Fig. 12a shows that in the outermost ring (Fig. 12a and 12c), the fracture propagated following the copper band-Fe rich region interface. In this case, copper remained adhered to the EUROFER base material giving to it this characteristic tonality in the images. Fig. 12a and 12c were taken in the zone where fracture mechanism shifted from the mechanism explained above to the one that dominated in the inner ring (Fig. 12c). In this case, the crack propagated following the diffusion layer – Fe rich region interface. One

some W base material were detached and remained adhered to the EUROFER base material (arrow in Fig. 12c) demonstrating the higher adherence of this interface.

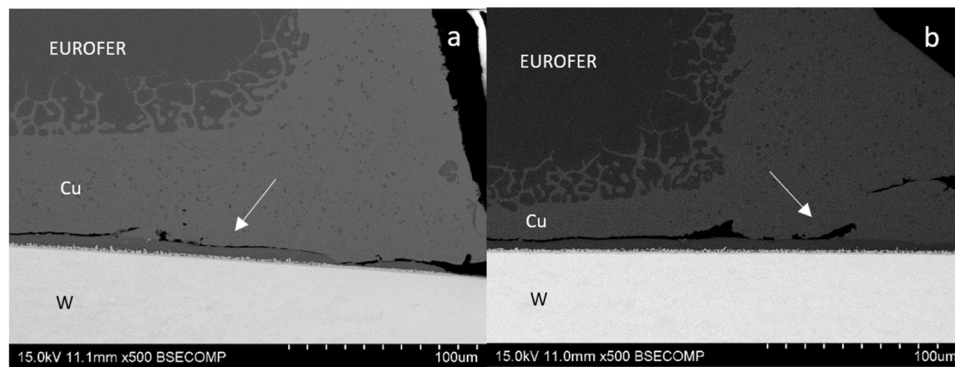
Fig. 13. Detail of nucleated cracks of different samples before shear tests subjected to 600 °C for 100 cycles (#2)– 1000 cycles (#8), (a) and (b), respectively.

explanation of this behavior is that cracks nucleated at the copper band-Fe rich region interface, as the microstructural study demonstrated by the observation carried out in samples before the shear tests (Fig. 13a and 13b). Their formation occurred during the HHF tests mainly in the outermost part of the joint, where the presence of the copper band is thicker and continuous. Then, the crack propagated during the early stage of the shear test. However, once the crack reached the inner part of the joint, the copper band was thinner and, at some point, discontinuous. Therefore, the propagation could not follow this interface and shifted to the diffusion layer-Fe rich region interface. The cross-section examination demonstrated that in this zone, the diffusion layer and

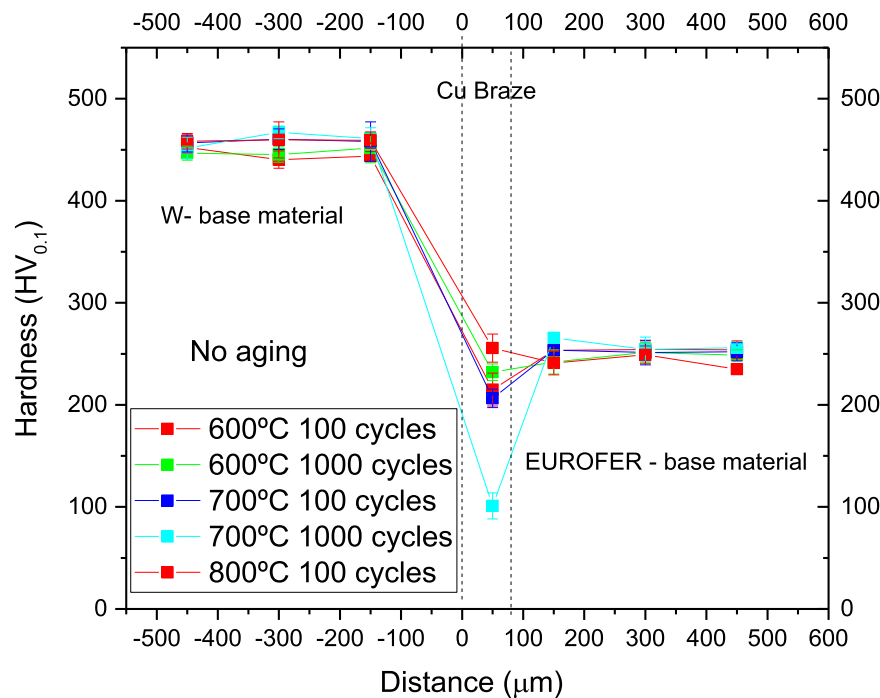
Fig. 14. Vickers microhardness profiles of W-EUROFER joints for the different HHF test conditions.

To evaluate the thermal effects on the base materials caused by the HHF tests, microhardness profiles were traced from one base material to the other through the braze. The results indicated that microhardness of both base materials was not affected neither by the aging process nor by the HHF tests (Fig. 14). In the case of tungsten, microhardness kept constant for all conditions and corresponded to the hardness of base material in as-received conditions (440 HV<sub>0.1</sub>) (Kim et al., 2021).
