## Material choice for first ITER mirrors under erosion conditions

The behaviour of different candidate materials for ITER mirrors under erosion conditions is investigated in TEXTOR tokamak. Results of experiments are presented along with an assessment of applicability of the studied mirror concepts for ITER diagnostics. It is shown that all studied mirror concepts can be applied in ITER under mild erosion conditions (as in equatorial ports) when protective techniques are applied. Molybdenum single crystal mirrors demonstrated the best performance under stronger erosion conditions, corresponding to those expected in the upper diagnostic ports of ITER with gas fueling.

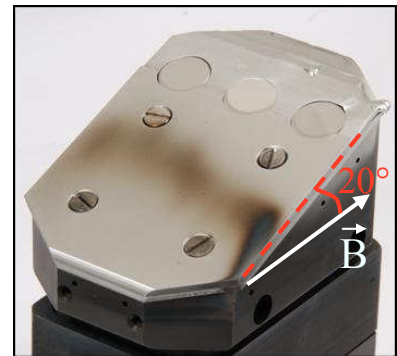
**Figure 1.** Test limiter with mirrors after exposure

Two experiments were performed with a test limiter with 3 mirrors exposed in the scrape-off-layer (SOL) plasma under ITER-relevant erosion-dominated conditions. Mirrors were installed at 20 degrees to the toroidal field direction (Fig.1). Edge plasma parameters were monitored with the supersonic helium beam diagnostics. First experiment was performed under mild erosion conditions: the total particle fluence to the center of each mirror was about  $5.9 \times 10^{24}$  ions/m<sup>2</sup>. Plasma parameters
