# YAlO<sub>3</sub>—A Novel Environmental Barrier Coating for Al<sub>2</sub>O<sub>3</sub>/Al<sub>2</sub>O<sub>3</sub>–Ceramic Matrix Composites

**Abstract:** Ceramic matrix composites (CMCs) are promising materials for high-temperature applications. Environmental barrier coatings (EBCs) are needed to protect the components against water vapor attack. A new potential EBC material, YAlO<sub>3</sub>, was studied in this paper. Different plasma-spraying techniques were used for the production of coatings on an alumina-based CMC, such as atmospheric plasma spraying (APS) and very low pressure plasma spraying (VLPPS). No bond coats or surface treatments were applied. The performance was tested by pull-adhesion tests, burner rig tests, and calcium-magnesium-aluminum-silicate (CMAS) corrosion tests. The samples were subsequently analyzed by means of X-ray diffraction, scanning electron microscopy, and energy-dispersive X-ray spectroscopy. Special attention was paid to the interaction at the interface between coating and substrate. The results show that fully crystalline and good adherent YAlO<sub>3</sub> coatings can be produced without further substrate preparation such as surface pretrea

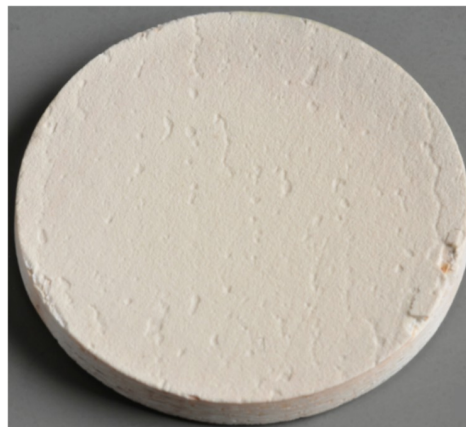
**Figure 9.** Photograph of VLPPS  $\text{YAlO}_3$  coating on FW12 after 1010 cycles of burner rig testing.

The thermal cycling tests were stopped after 1010 cycles (510 cycles at 1200 °C and 500 cycles at 1300 °C), which corresponds to the upper limit of the average lifetime of standard TBC samples in this test rig. During cycling, no macroscopic failure occurred (see Figure 9). SEM images of the VLPPS  $\text{YAlO}_3$  coatings after 1010 cycles are shown in Figure 10. The coating still shows a fine distributed porosity. The  $\text{Y}_3\text{Al}_5\text{O}_{12}$  containing reaction zone at the coating substrate interface was about 1–2 µm-thick. No growth took place within the duration of the test.

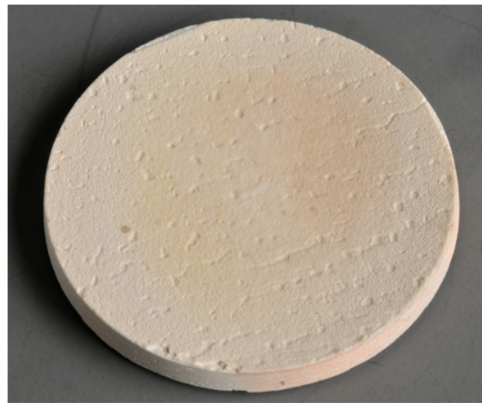
**Figure 11.** Photograph of VLPPS  $\text{YAlO}_3$  coating on FW 12 after 274 cycles in CMAS test rig.

The coating's resistance to CMAS corrosion was also investigated. The tests were stopped after 274 cycles, which corresponds to about twice the average lifetime of a typical YSZ coating in this rig. After 274 cycles, no macroscopic coating failure was observed (see Figure 11). The XRD measurements of the sample before and after the CMAS test are shown in Figure 12. Besides signals from the CMAS and the coating itself, the formation of calcium–yttrium silicate oxyapatite ( $\text{Ca}_2\text{Y}_8(\text{SiO}_4)_6\text{O}_2$ ) as a reaction product between  $\text{YAlO}_3$  and CMAS was observed. This phase was already observed for other Y-containing coatings [37,38]. In addition, the formation of Y-depleted yttrium aluminate  $\text{Y}_3\text{Al}_5\text{O}_{12}$  was observed accordingly. Turcer et al. [38] recently reported the excellent CMAS resistance of dense  $\text{YAlO}_3$  pellets due to the fast formation of a protective Ca–Y–Si apatite phase. Our results are in good agreement with those from Turcer et al.
